A Report on the Current Condition of the Hall

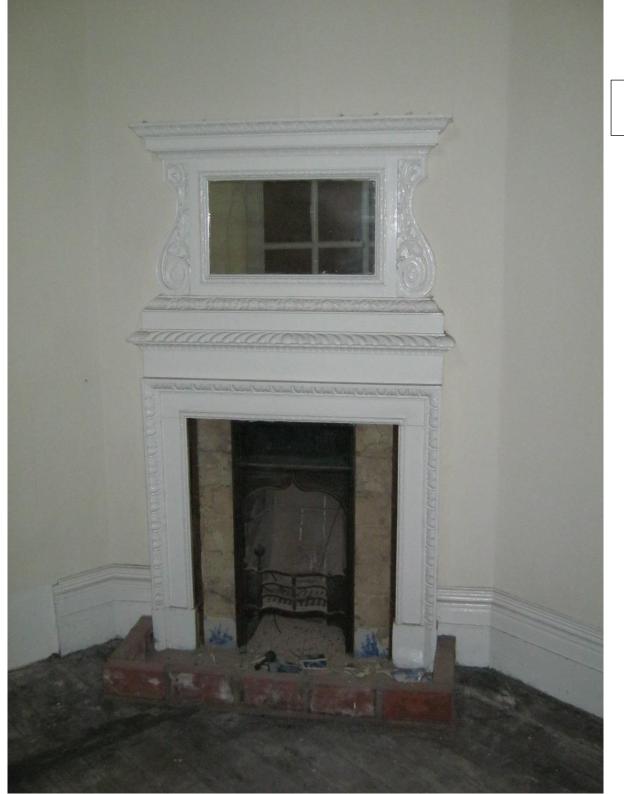
SAFE IS ON THE RIGHT OF THIS FIREPLACE

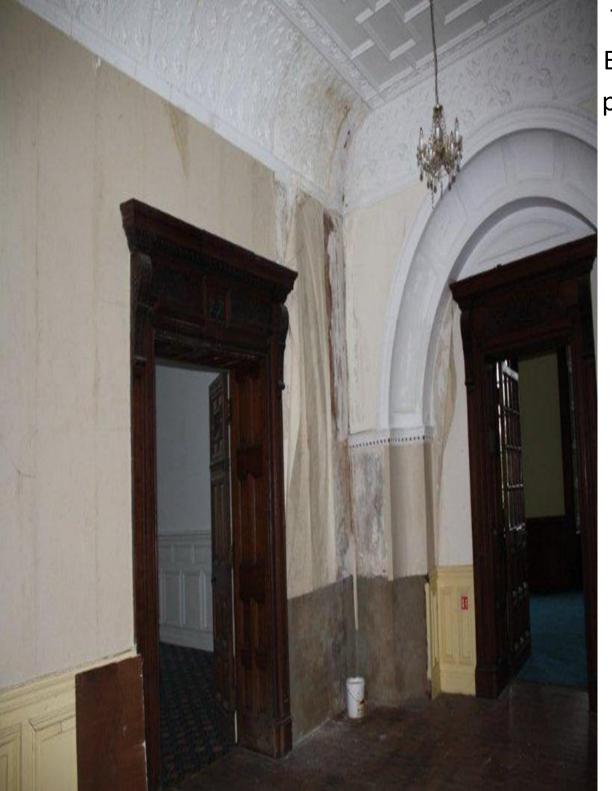
These are the doors to the Library and Ballroom (Please see details of guttering problem later in report as to cause

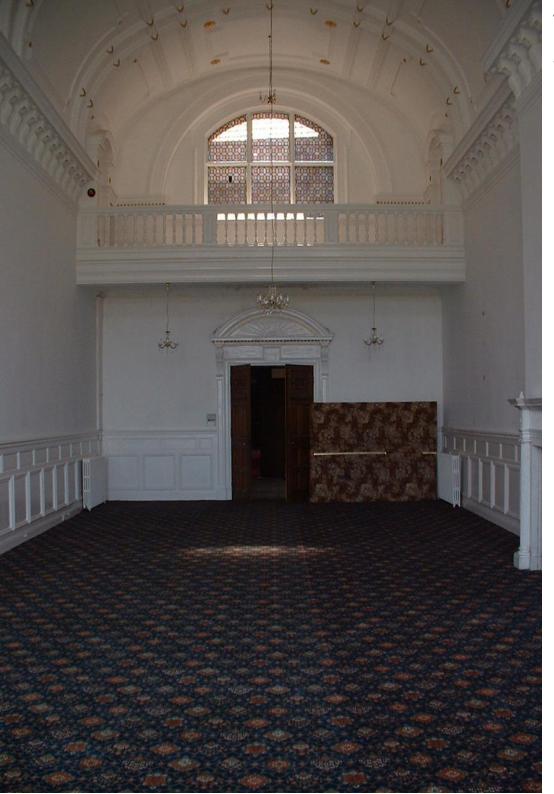
This is the Ballroom. There is water damage to the underside of the Minstrel Gallery

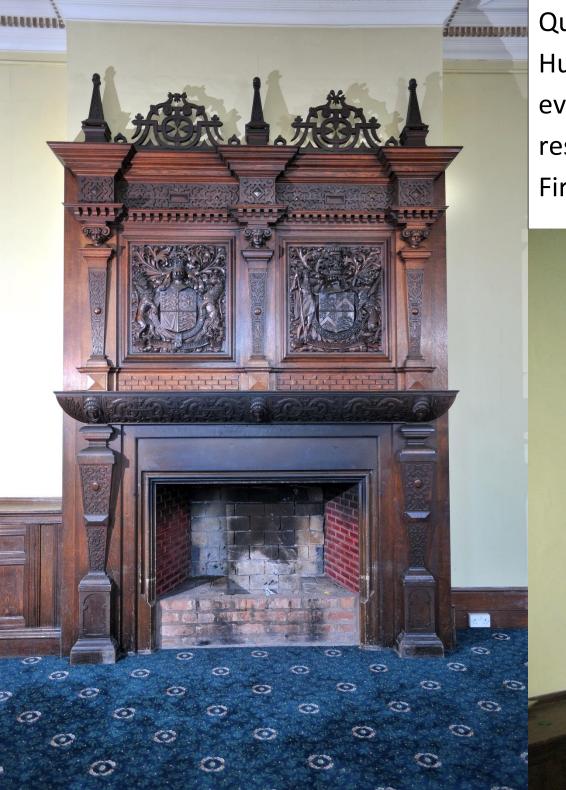
Queen Victoria's Coat of Arms and Hugh Robert Hughes' Coat of Arms were removed on the evening of the 9th October 2013. The people responsible tried to remove the whole Fireplace without success.

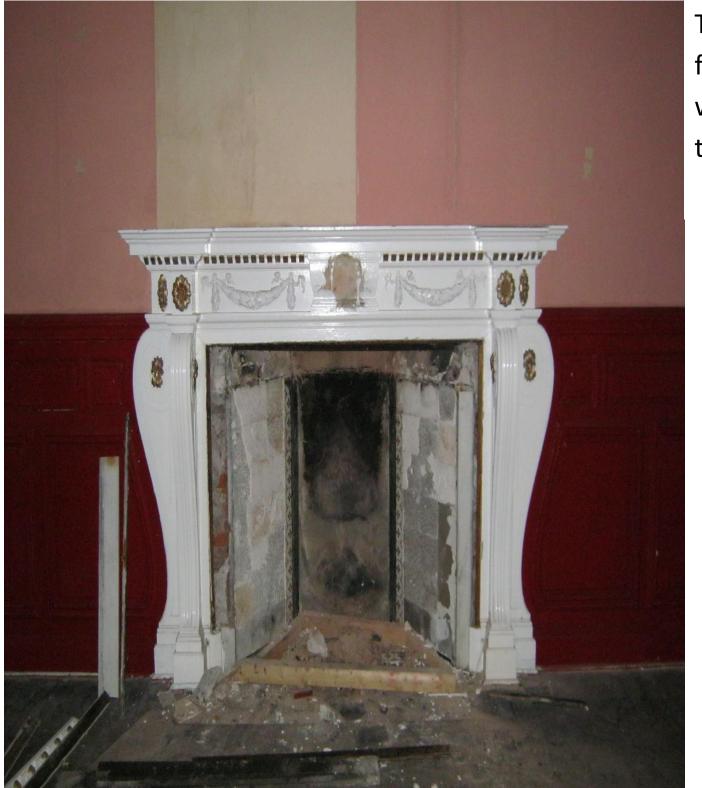
This is the Fire place on the West facing wall of the Drawing Room it was damaged at the same time as the others.

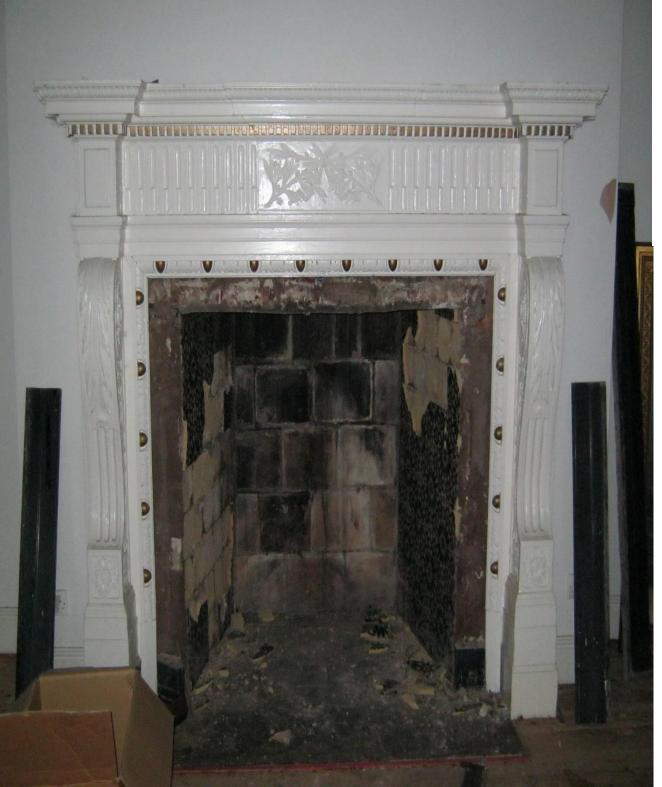
This is the Dining Room Fireplace which was also damaged in October 2013

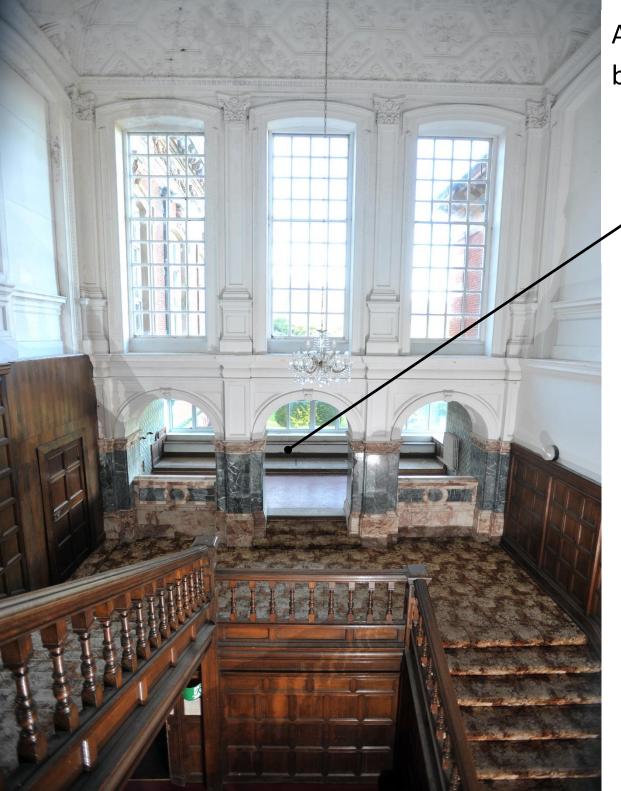
A panel of Marble installed 1936 – 40 has been smashed whilst trying to be removed

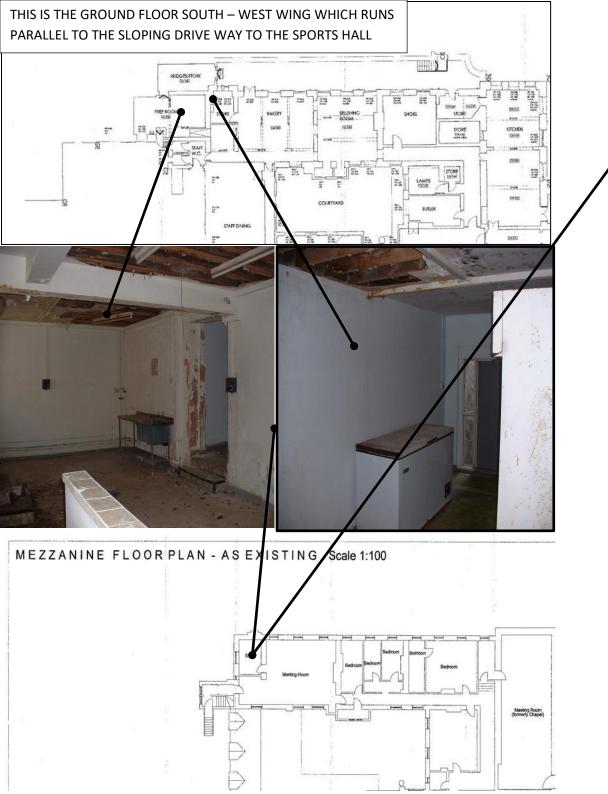
THIS SECTION OF THE HALL IS THE FLAT ROOFED AREA AT THE SOUTH WEST CORNER OF THE HALL NEAR TO WHERE THE SLOPING DRIVE PASSES THE GAS TANK ENCLOSURE. AS WITH A LOT OF FLAT ROOVES THIS ONE HAS LEAKED FOR AT LEAST 20 YEARS. THE FLOOR BELOW HAS BECOME ROTTEN AND GIVEN WAY INTO THE KITCHEN AREA BELOW.

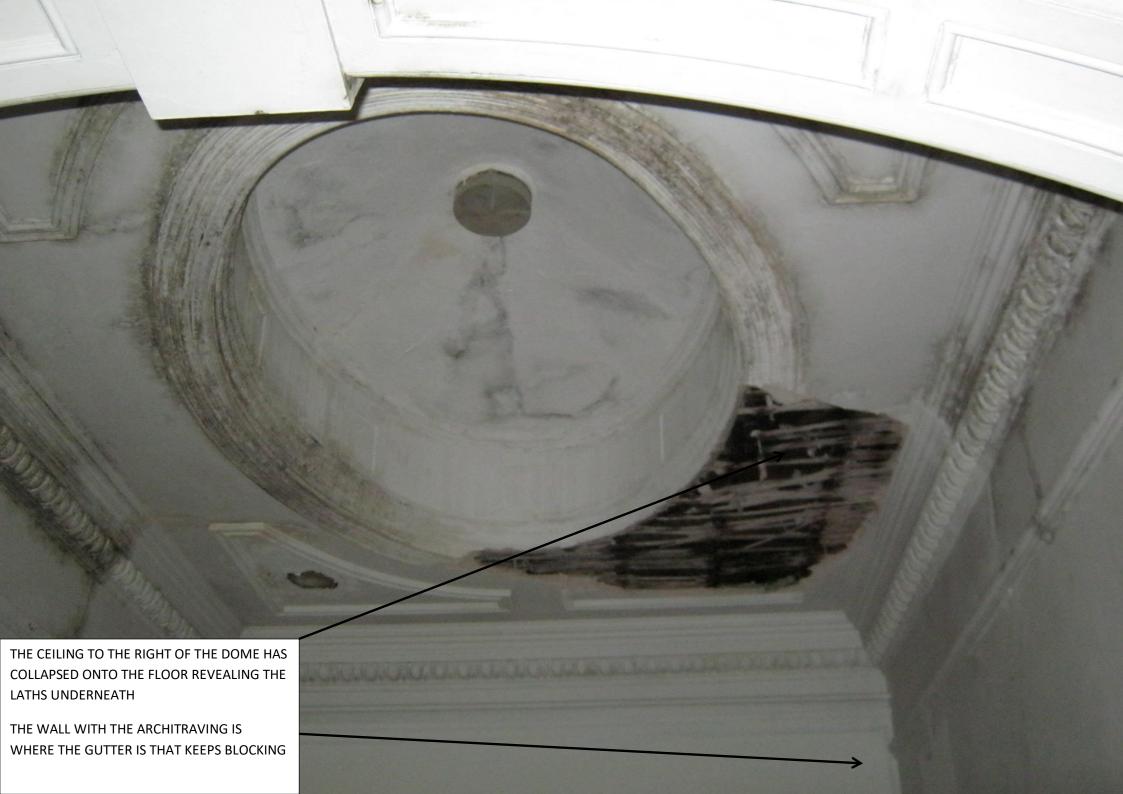
During the rebuilding of Kinmel Hall an error was made with the drainage that runs across the roof of the Ballroom adjoining the end wall of the SECOND FLOOR Corridor (as shown in the photo).

In the top end of the Down Pipe that runs down the far left hand corner at the back of the ballroom a leaf trap was inserted to stop debris getting into the pipe

Unfortunately it was put in upside down

As a result, at regular intervals, the Trap becomes blocked with leaves etc. As a result the Gutter (shown in the plans) fills with rainwater, which then seeps under the lead flashing and into the building. For the most part the water finds its way to the void containing the Down Pipe that is supposed to get rid of the water. This may also be the cause of the Dry Rot on the back wall of the Drawing Room and Ball Room.

Following a recent visit to the Hall it would appear that the damp has affected the ceiling of the First Floor Landing.

As the Hall is built on a Steel Scaffold it is possible that there are voids running through the ceilings of the hall – as there are under the floor of the Salon – allowing the damp to penetrate wider than the single wall affected directly by the blocked gutter which may be part of the reason for the Dry Rot in the casement of the Library Windows

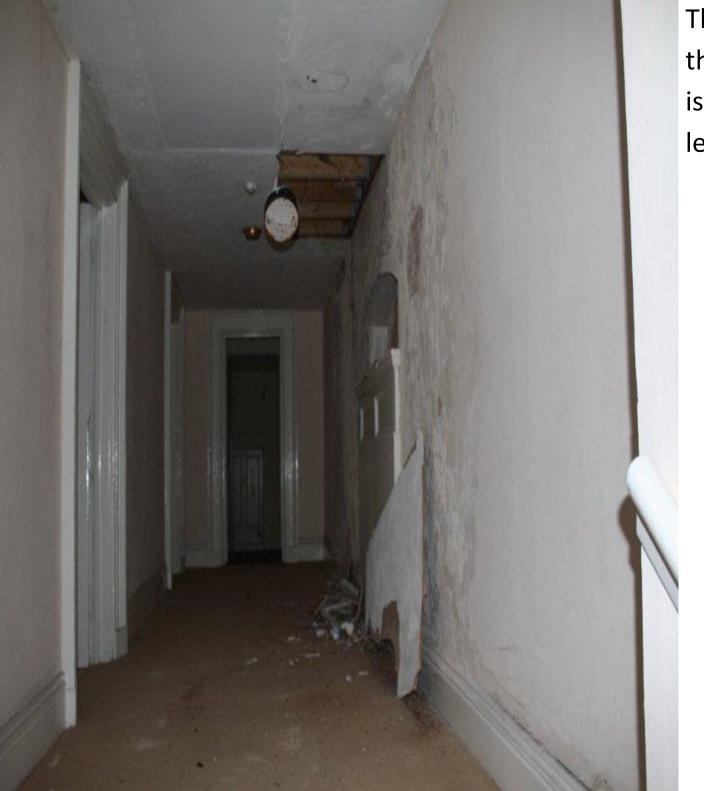
This is the Second Floor Landing on the East Front. The Collapsed Ceiling is a long standing problem due to a leak in the roof

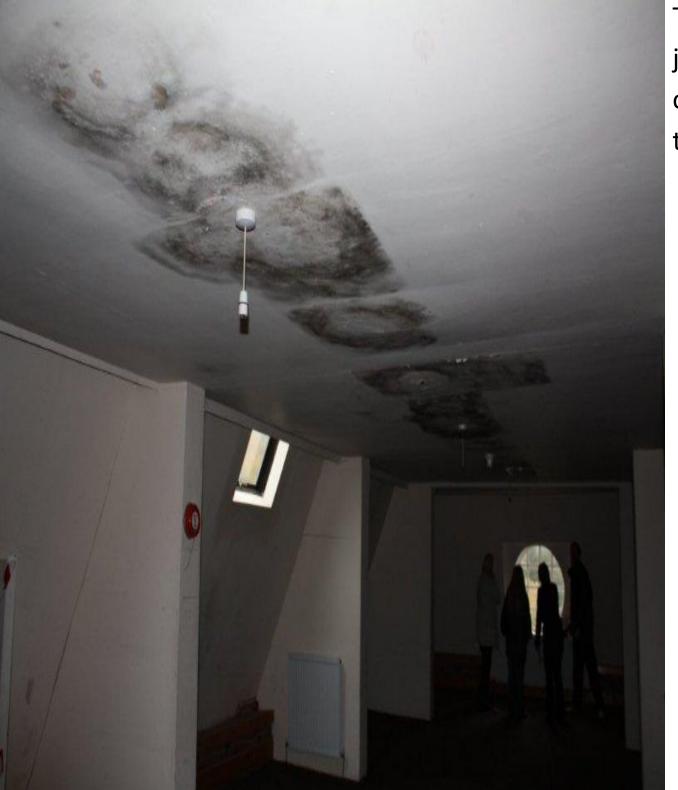
There is a collapsed section of ceiling just out of shot at the top right hand corner of this picture which shows the room in the roof of the Chapel.

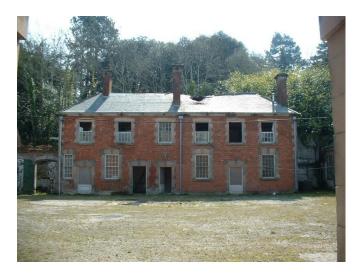
THIS SECTION OF THE HALL WAS STILL BEING USED BY PAYING GUESTS AS LATE AS OCTOBER 1995 AND MAYBE EVEN LATER.

THE AREA WHERE THE ROOF HAS COLLAPSED CONTAINS BATHROOMS AND SHOWERS.
WHILST I HAVE NOT BEEN IN THIS PART SINCE THE 90'S IT IS MY UNDERSTANDING THAT
THIS COLLAPSE HAS BROUGHT DOWN THE SECOND FLOOR INTO THE FIRST FLOOR

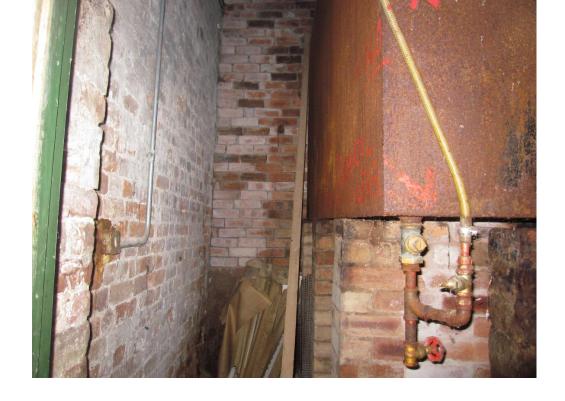
THERE IS A CENTRAL HEATING SYSTEM AT THE BACK OF THE SMALLER HALL WHICH WAS NOT INSPECTED WHEN THE FIRE RISK ASSESSMENT WAS CARRIED OUT IN 2012 AND AS THE RECEIVERS WERE NOT AWARE OF ITS EXISTENCE IT WAS NOT DRAINED.

THE CURRENT OWNERS 'CLAIM' THEY HAVE EMPTIED IT BUT AS THEY WERE FOUND TO BE REMOVING THE ASBESTOS WITHOUT THE CORRECT PERMITS OR PROTECTIVE CLOTHING IT IS ANYONES GUESS WHERE IT WAS EMPTIED TO IF AT ALL. IT IS OIL FIRED AND HAS ITS OWN TANK

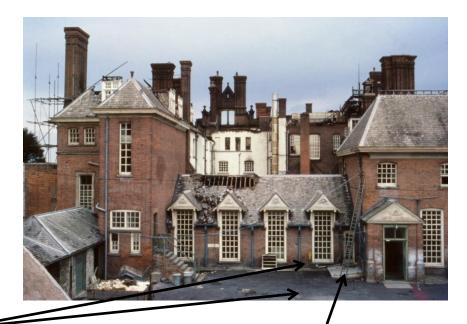
THERE IS A FIRE HYDRANT POINT OUTSIDE THE SOUTH END OF THE HALL AS SHOWN BY THE MARKER TO THE LEFT OF THE WINDOW.

THIS WAS THE WATER SUPPLY POINT USED BY THE VINCE FAMILY WHEN THE RECONSTRUCTION OF THE HALL BEGAN IN 1978. THIS WAS BECAUSE THE MAINS SUPPLY COULD NOT BE TURNED ON WHEN THE HALL WAS AS SHOWN IN THE PICTURE

THE SUPPLY INTO THE HALL BRANCHES OF AT THIS POINT AND ENTERS THE HALL UNDER THE TRAP DOOR TO THE CELLAR

DURING MY VISIT ON THE 14TH AUGUST IT WAS DISCOVERED THAT THE PIPE THAT SUPPLIES WATER TO THE THREE FIRE HOSE REEL POINTS IN THE MAIN HALL HAD BEEN SMASHED AND WATER WAS POURING OUT OF IT, INTO A BARREL OF FAT AND FROM THERE INTO THE GRID IN THE FLOOR OF THE CELLAR WHICH FEEDS INTO THE SEPTIC TANK IN THE PARK. AT THE NORTH END OF THE HALL THE LAST TWO GRIDS IN THE FLOOR OF THE CORRIDOR WERE UNDER AT LEAST 7 INCHES OF 'WATER' WHICH WAS A CLEAR SIGN THAT THERE IS A PROBLEM WITH THE SEPTIC TANK OR THE PIPE TO IT.

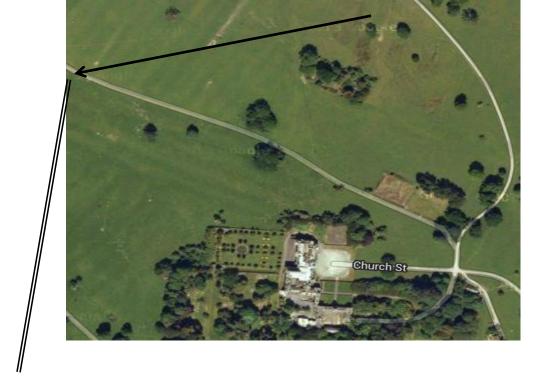
DURING MY VISIST ON THE 11TH OCTOBER 2013 I DISCOVERED THAT THE FIRE HYDRANT PIPE WAS NO LONGER POURING WATER.

THE BUILDER HAD CAPPED THE PIPE OFF AND CONVERTED IT TO A DOMESTIC SUPPLY USING POLY PIPE.

THE BLUE POLY-PIPE WAS FED THROUGH THE CELLAR AND UP TO THE FIRST FLOOR WHERE IT TERMINATED AT THE WALL MOUNTED WATER HEATER IN THE VICTORIA SUITE KITCHEN.
