A Report on the Current Condition of the Hall

FOREWORD
'TRAGEDY TO TRIUMPH'
Courtesy of Mrs Elaine Boxhall nee Southern
PE Teacher 1950 – 55
Clarendon school for Girls
KINMEL HALL
1946 – 1975

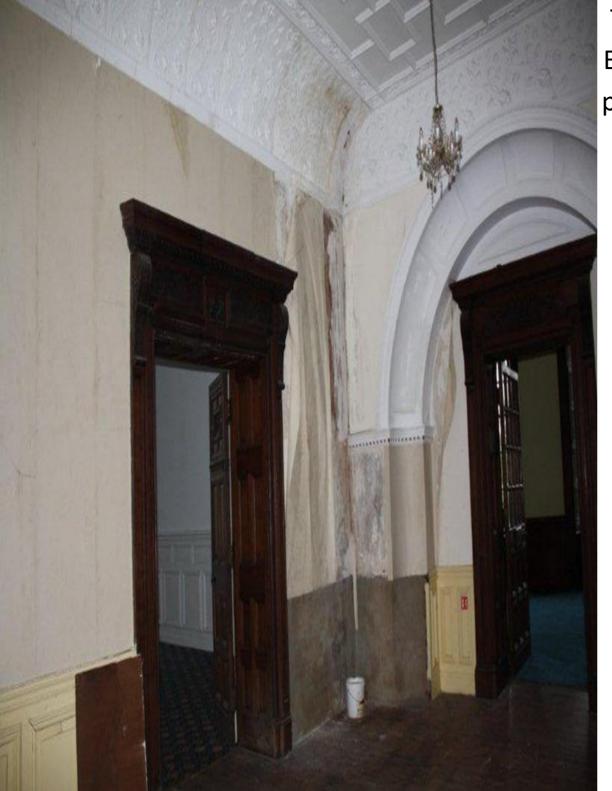
This is the door way from the Main Hall leading to the Reception.

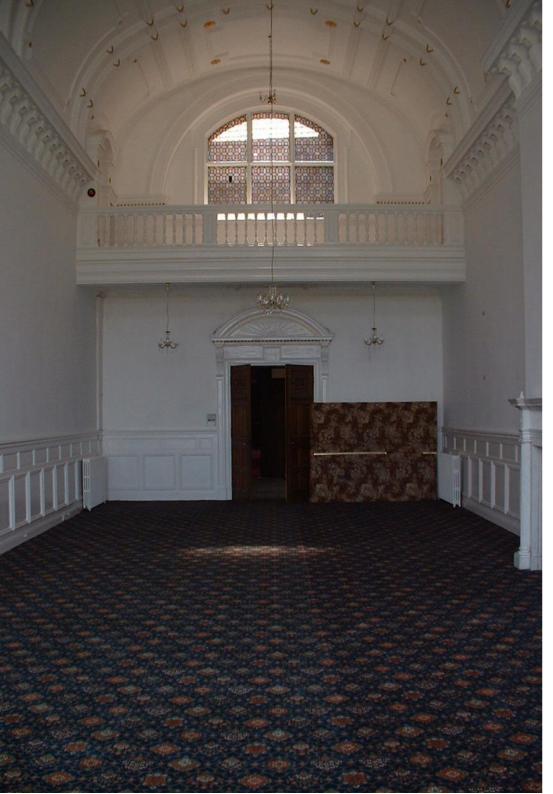
These are the doors to the Library and Ballroom (Please see details of guttering problem later in report as to cause

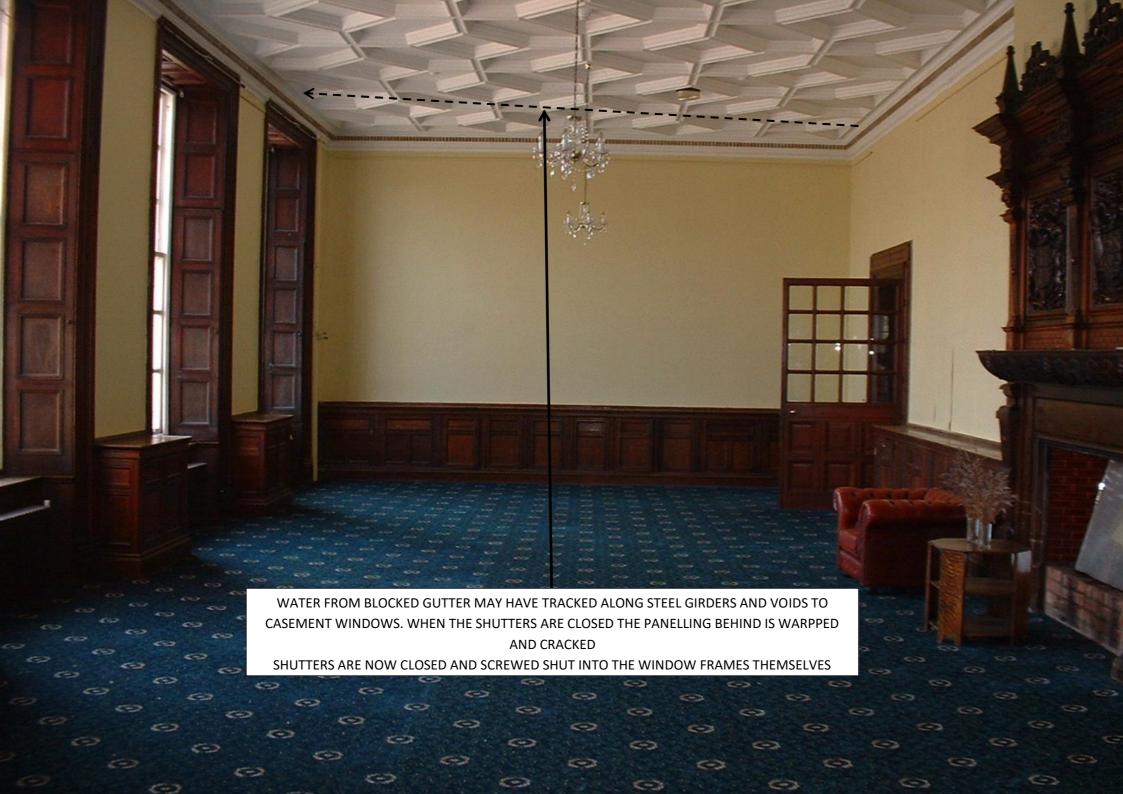
This is the Ballroom. There is water damage to the underside of the Minstrel Gallery

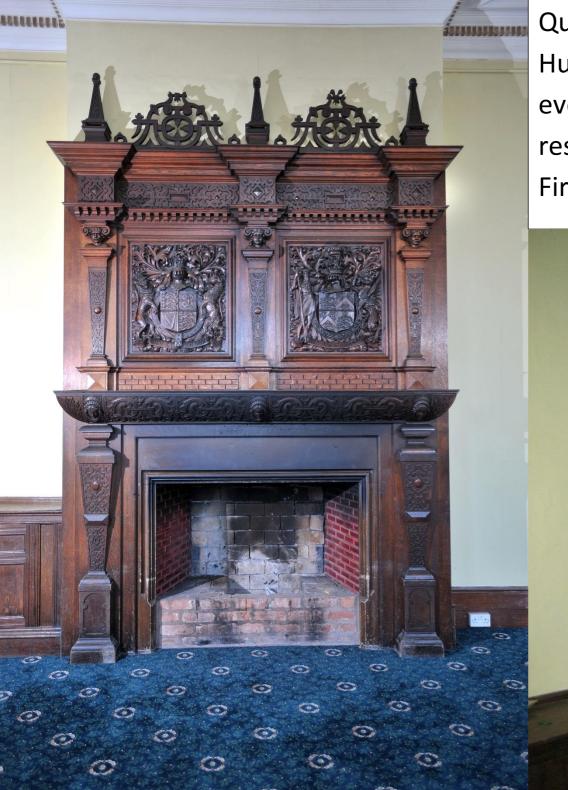
Queen Victoria's Coat of Arms and Hugh Robert Hughes' Coat of Arms were removed on the evening of the 9th October 2013. The people responsible tried to remove the whole Fireplace without success.

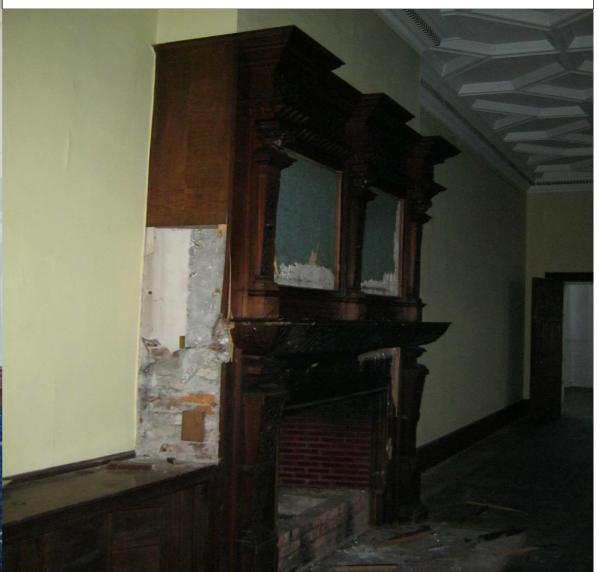
This is the Fire place on the West facing wall of the Drawing Room it was damaged at the same time as the others.

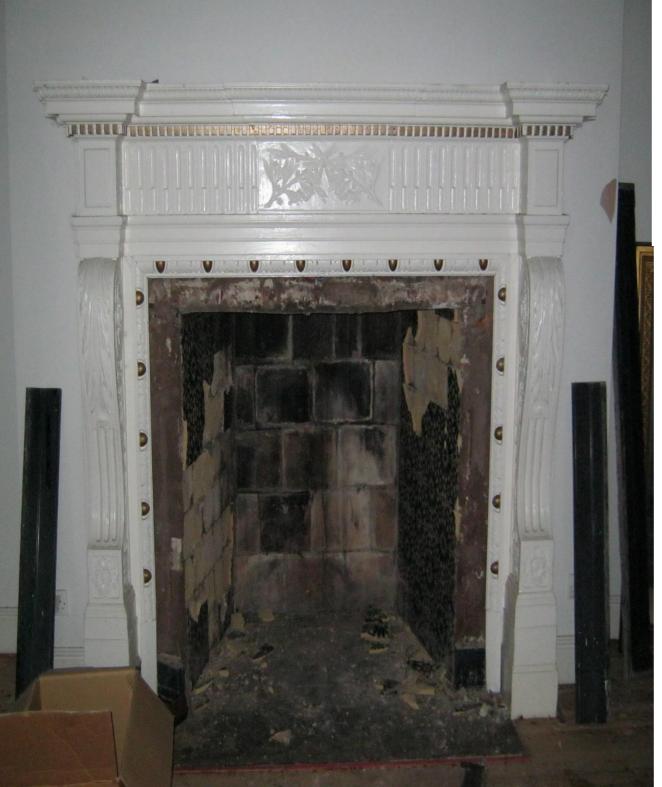
This is the Dining Room Fireplace which was also damaged in October 2013

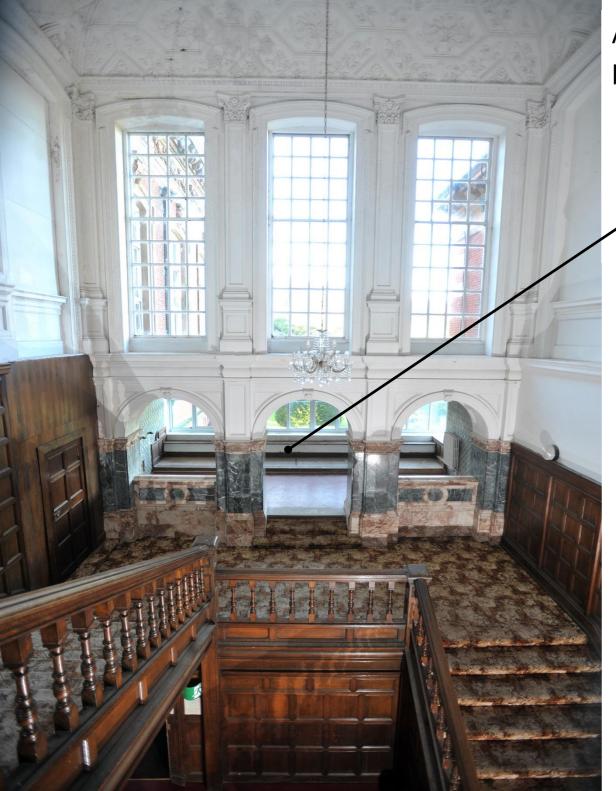
A panel of Marble installed 1936 – 40 has been smashed whilst trying to be removed

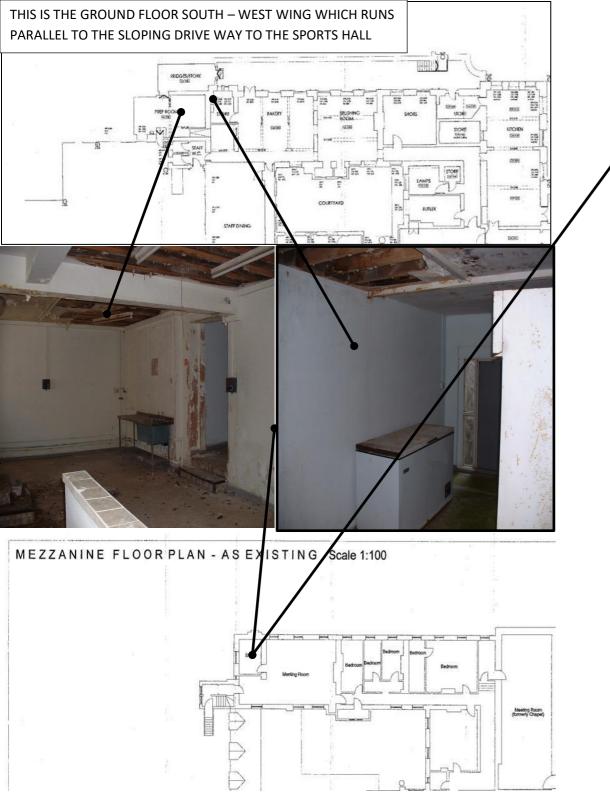
THIS SECTION OF THE HALL IS THE FLAT ROOFED AREA AT THE SOUTH WEST CORNER OF THE HALL NEAR TO WHERE THE SLOPING DRIVE PASSES THE GAS TANK ENCLOSURE. AS WITH A LOT OF FLAT ROOVES THIS ONE HAS LEAKED FOR AT LEAST 20 YEARS. THE FLOOR BELOW HAS BECOME ROTTEN AND GIVEN WAY INTO THE KITCHEN AREA BELOW.

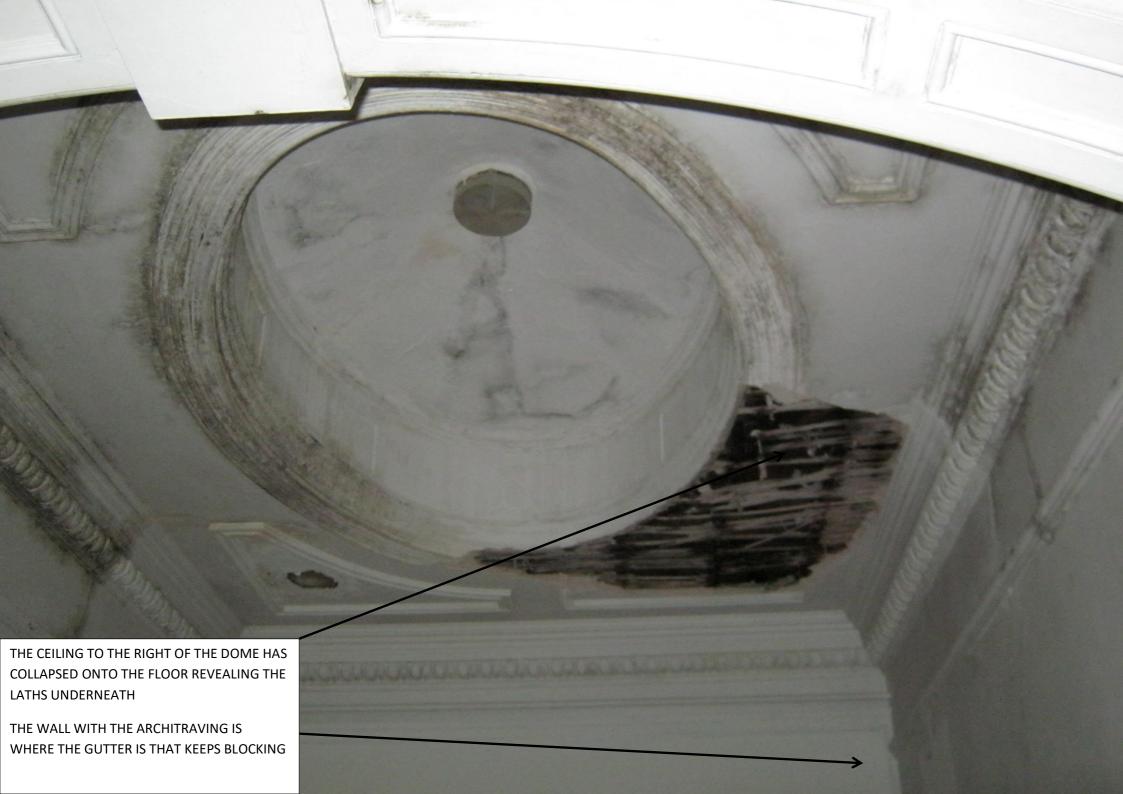
During the rebuilding of Kinmel Hall an error was made with the drainage that runs across the roof of the Ballroom adjoining the end wall of the SECOND FLOOR Corridor (as shown in the photo).

In the top end of the Down Pipe that runs down the far left hand corner at the back of the ballroom a leaf trap was inserted to stop debris getting into the pipe

Unfortunately it was put in upside down

As a result, at regular intervals, the Trap becomes blocked with leaves etc. As a result the Gutter (shown in the plans) fills with rainwater, which then seeps under the lead flashing and into the building. For the most part the water finds its way to the void containing the Down Pipe that is supposed to get rid of the water. This may also be the cause of the Dry Rot on the back wall of the Drawing Room and Ball Room.

Following a recent visit to the Hall it would appear that the damp has affected the ceiling of the First Floor Landing.

As the Hall is built on a Steel Scaffold it is possible that there are voids running through the ceilings of the hall – as there are under the floor of the Salon – allowing the damp to penetrate wider than the single wall affected directly by the blocked gutter which may be part of the reason for the Dry Rot in the casement of the Library Windows

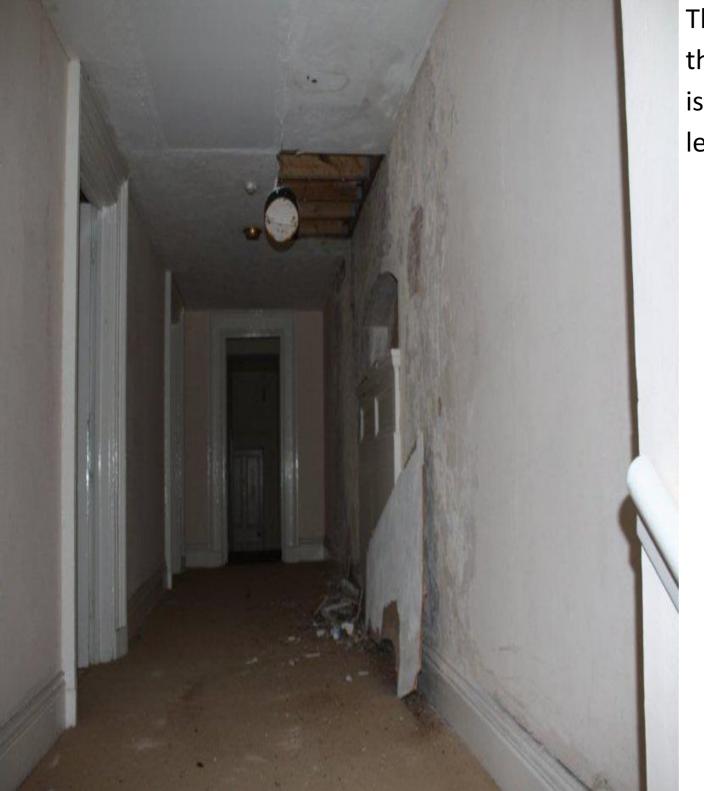
This is the Second Floor Landing on the East Front. The Collapsed Ceiling is a long standing problem due to a leak in the roof

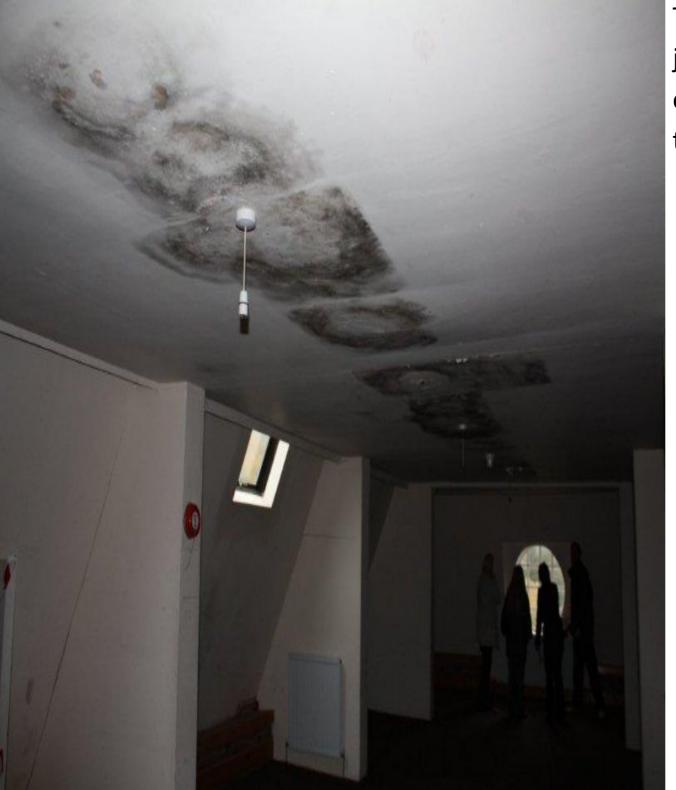
There is a collapsed section of ceiling just out of shot at the top right hand corner of this picture which shows the room in the roof of the Chapel.

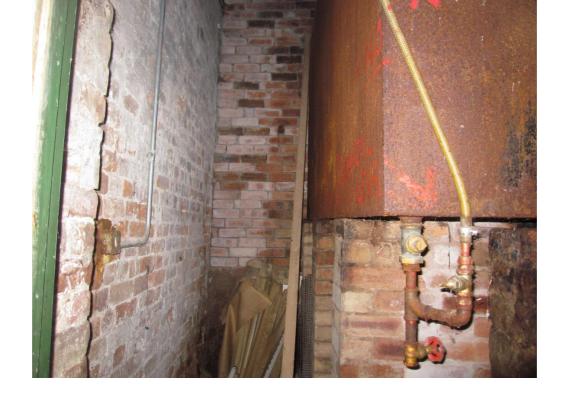
THERE IS A CENTRAL HEATING SYSTEM AT THE BACK OF THE SMALLER HALL WHICH WAS NOT INSPECTED WHEN THE FIRE RISK ASSESSMENT WAS CARRIED OUT IN 2012 AND AS THE RECEIVERS WERE NOT AWARE OF ITS EXISTENCE IT WAS NOT DRAINED.

THE CURRENT OWNERS 'CLAIM' THEY HAVE EMPTIED IT BUT AS THEY WERE FOUND TO BE REMOVING THE ASBESTOS WITHOUT THE CORRECT PERMITS OR PROTECTIVE CLOTHING IT IS ANYONES GUESS WHERE IT WAS EMPTIED TO IF AT ALL. IT IS OIL FIRED AND HAS ITS OWN TANK

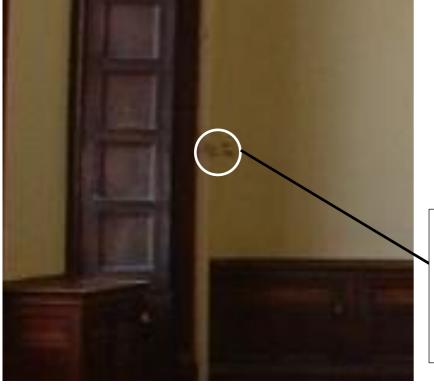
THE ONLY POSSIBLE CHANCE THAT HAS STOPPED THE UPPER FLOORS OF THE MAIN HALL NOT FLOODING IS THAT THESE GATE TAPS ARE CLOSED. THEY CUT OFF THE SUPPLY OF WATER TO THE UPPER FLOORS OF THE MAIN HALL ONLY

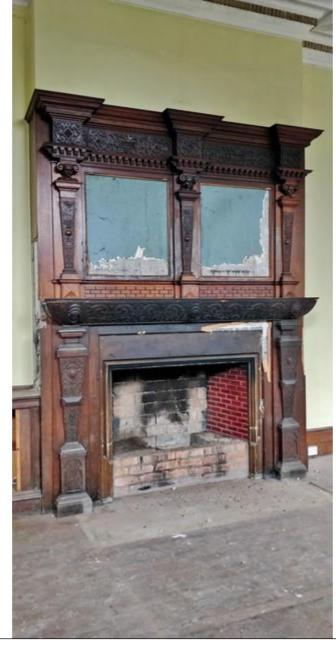
The Oak carved Library Fireplace damaged by thieves in October 2013. The panel on the left should hold Queen Victoria's Coat of Arms and the panel on the right should hold the Coat of Arms of H R Hughes created from the Coats of Arms of the tribes of Wales as depicted in the Fireplace at Kinmel Manor Hotel which came from the Hall.

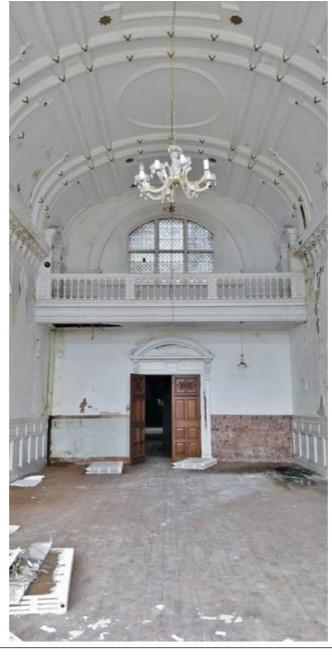
The Ballroom complete with its Minstrel Gallery and sprung dance floor. The damage visible in the left hand corner of the image is due to the down pipe referred to earlier in this document

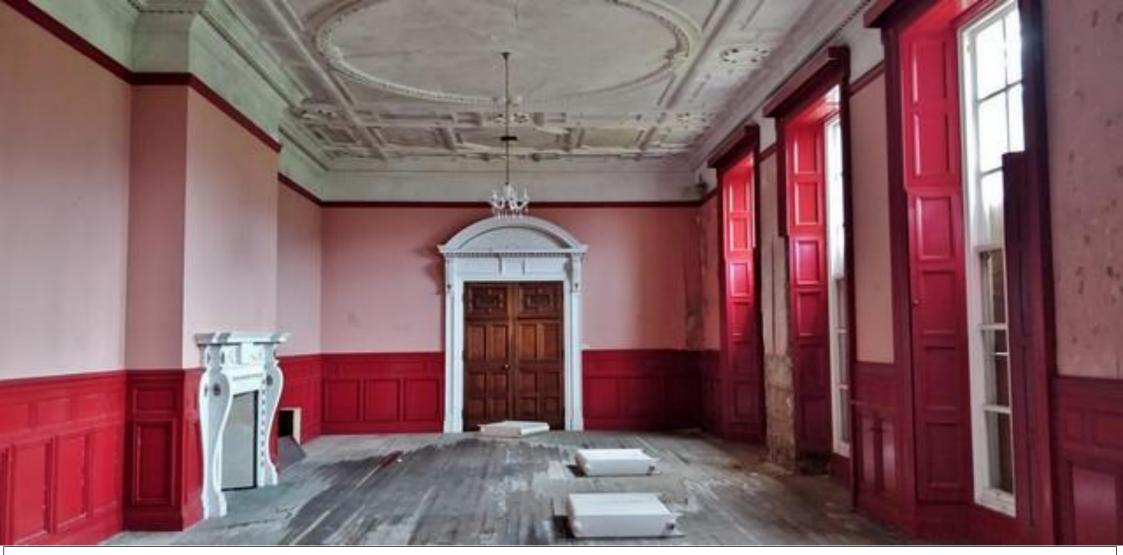
The Drawing Room. The wood paneling is as previously stated the wrong colour. The removal of the radiators is a new occurrence. The damage to the fireplace was done in October 2013

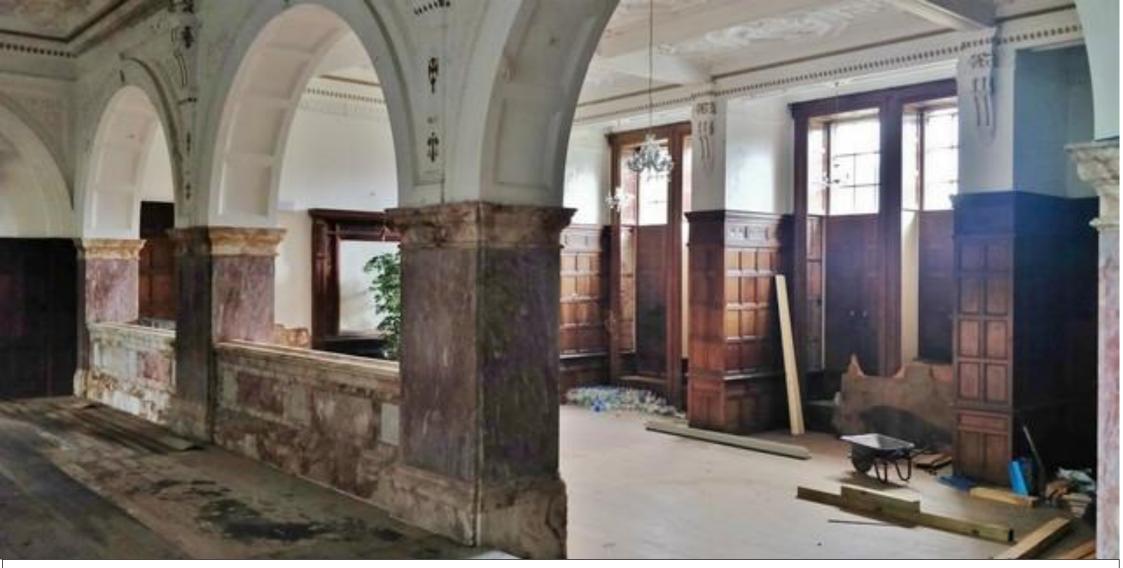
The Sunken Lounge.

The fireplace seen here comes from another estate in Cheshire. The correct fireplace is in Kinmel Manor Hotel.

The bottled water visible in the corner is there because the mains supply to the Hall needs repairing
