KINMEL HALL

A Report on the Current Condition of the Hall

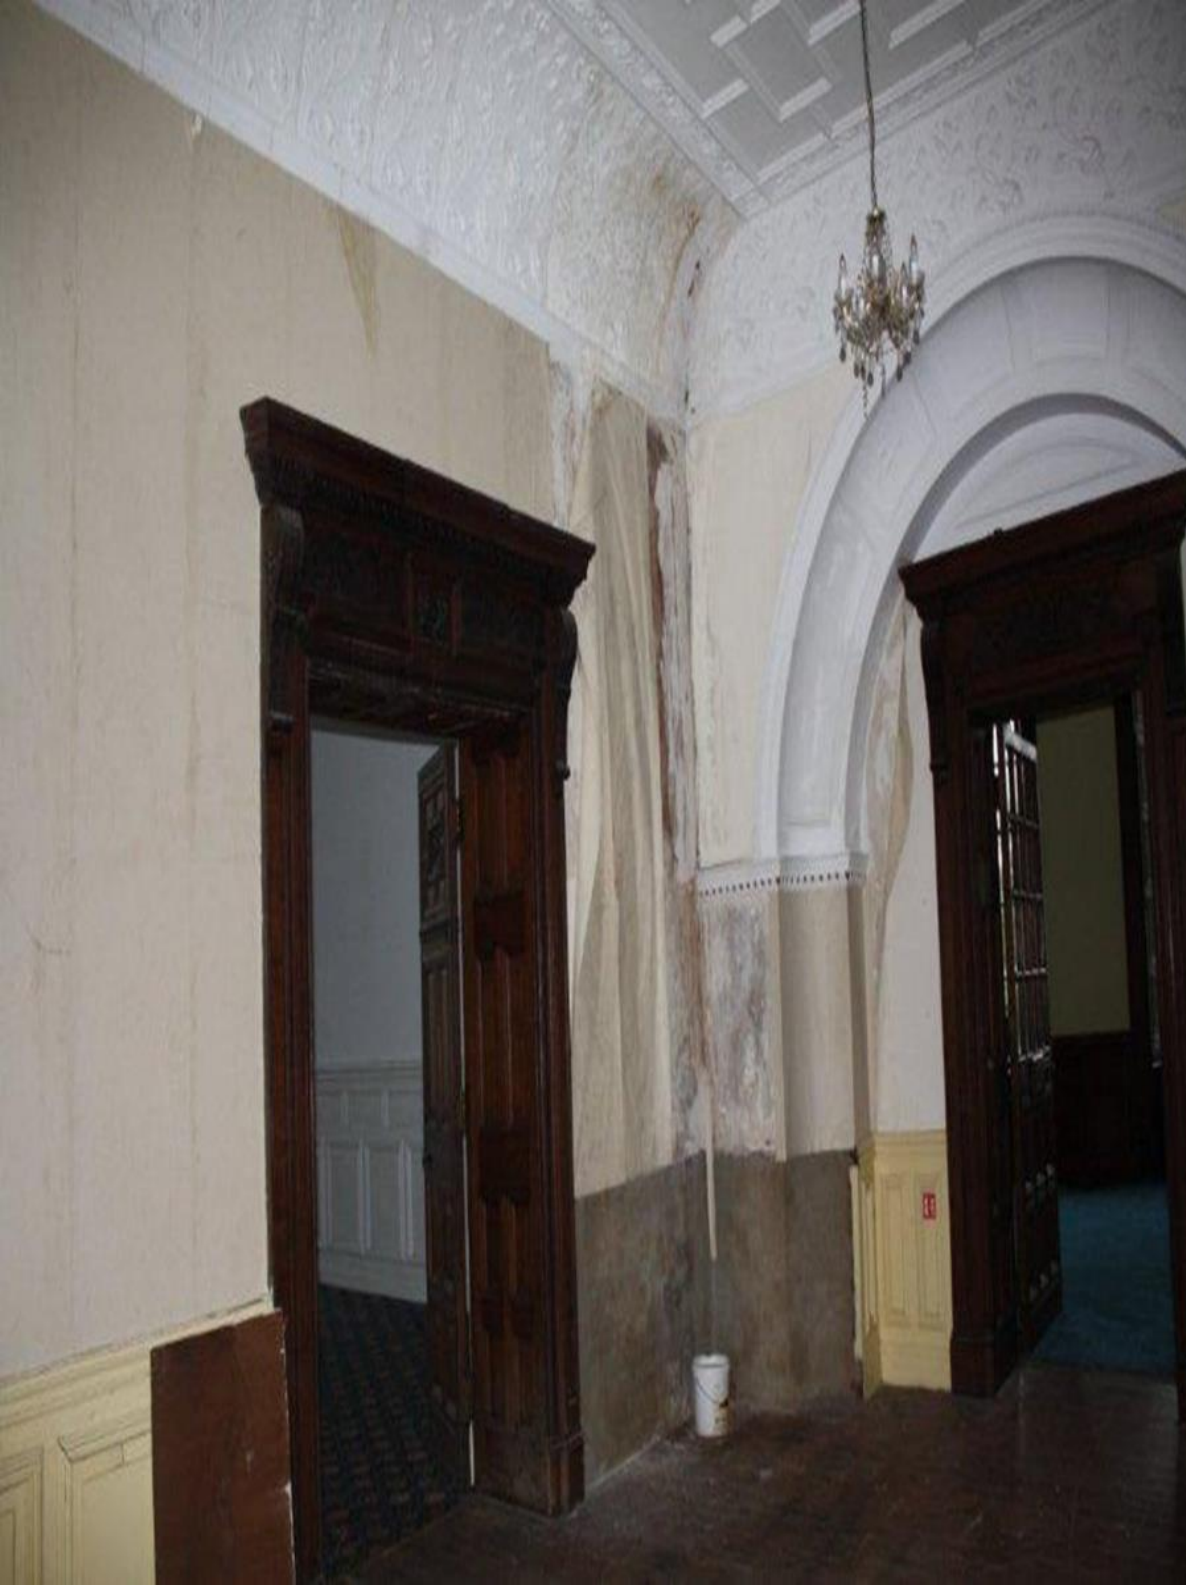
These are the doors to the Library and Ballroom (Please see details of guttering problem later in report as to cause)

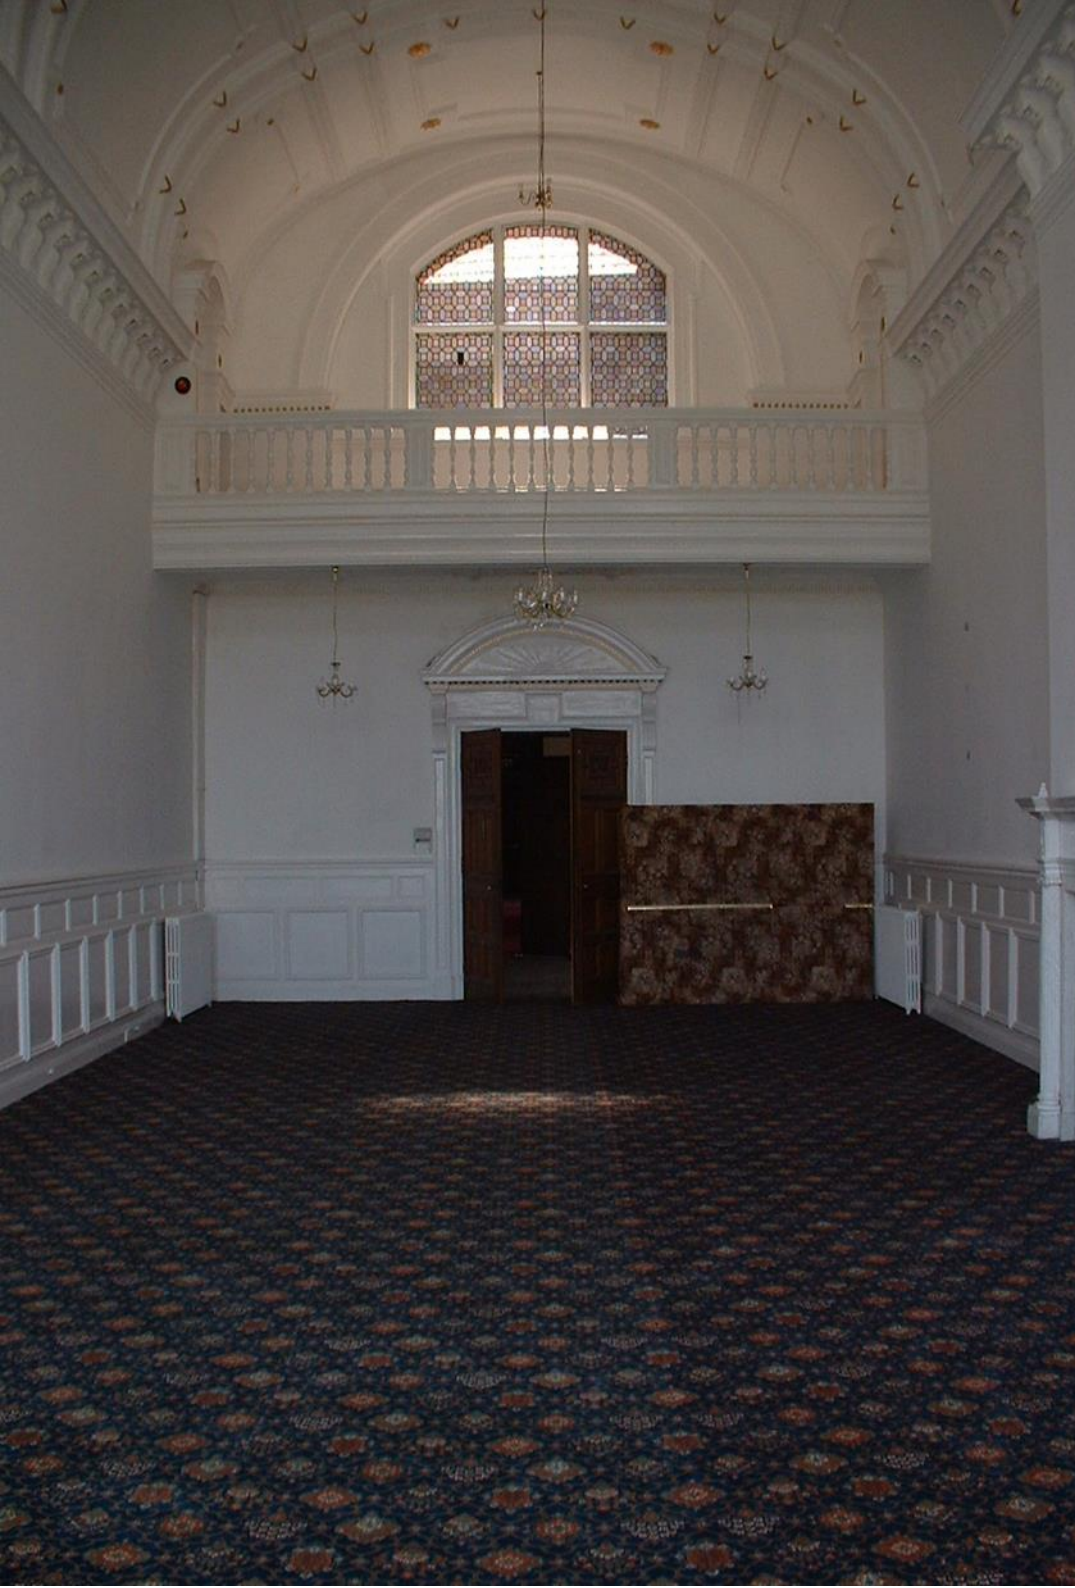
This is the Ballroom. There is water damage to the underside of the Minstrel Gallery

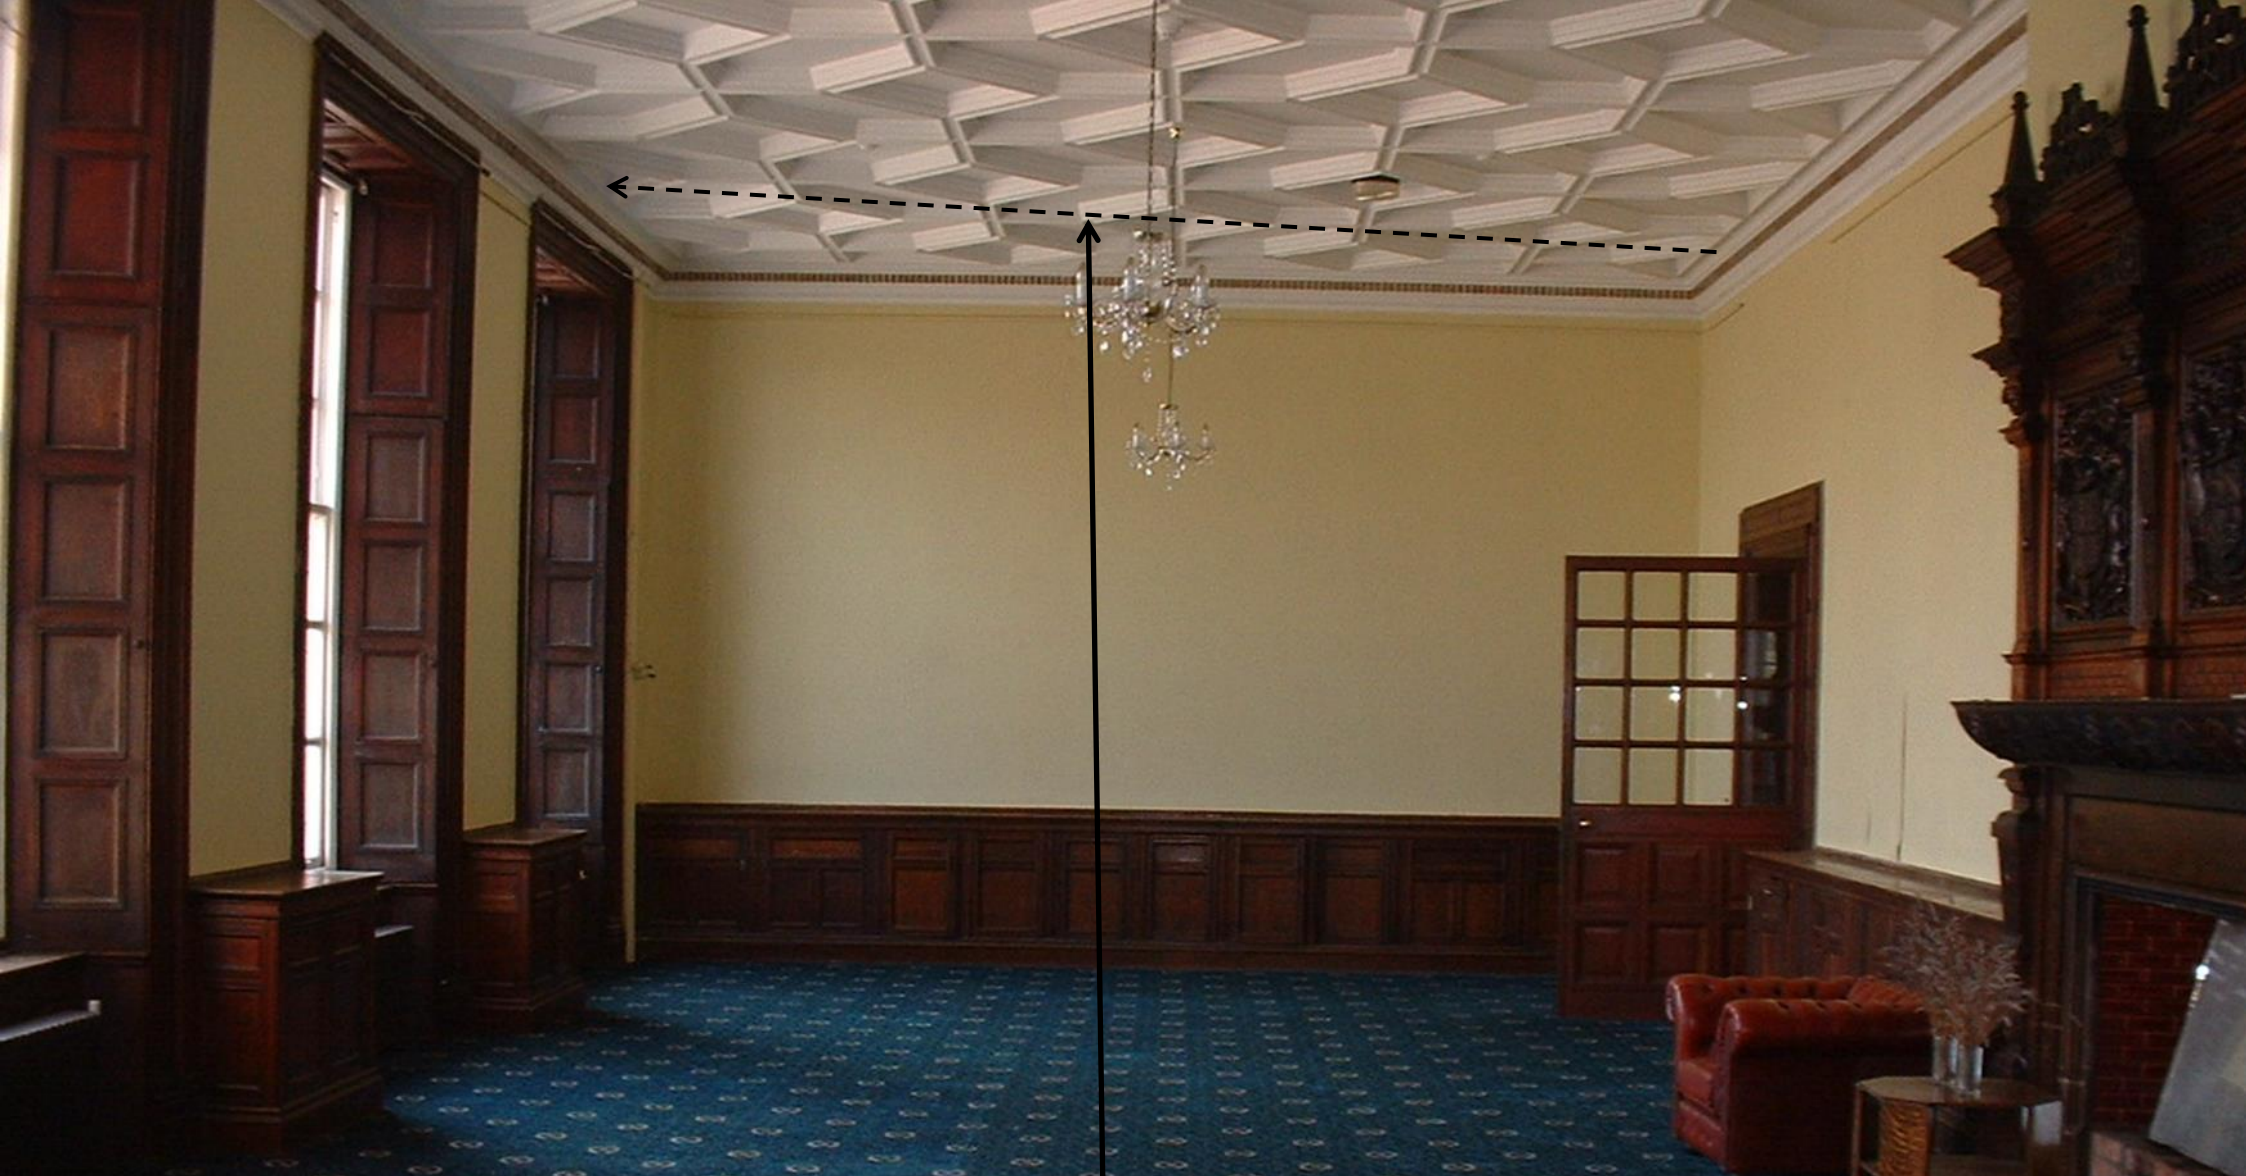
WATER FROM BLOCKED GUTTER MAY HAVE TRACKED ALONG STEEL GIRDERS AND VOIDS TO CASEMENT WINDOWS. WHEN THE SHUTTERS ARE CLOSED THE PANELLING BEHIND IS WARPPED AND CRACKED
SHUTTERS ARE NOW CLOSED AND SCREWED SHUT INTO THE WINDOW FRAMES THEMSELVES

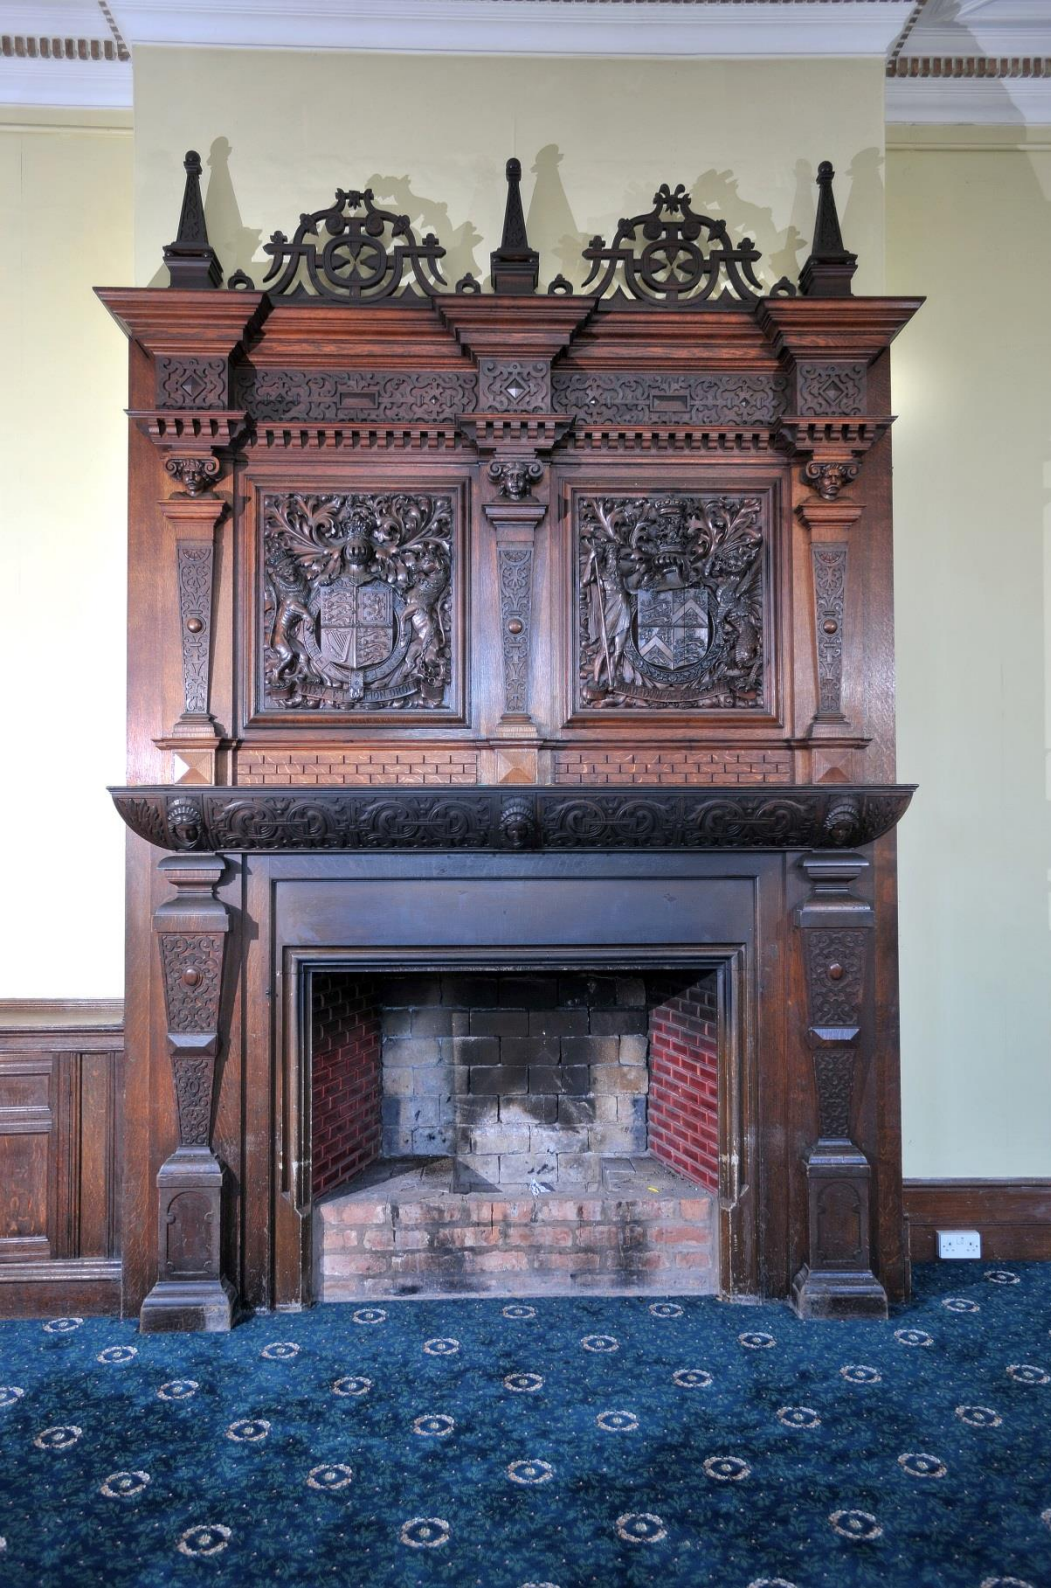
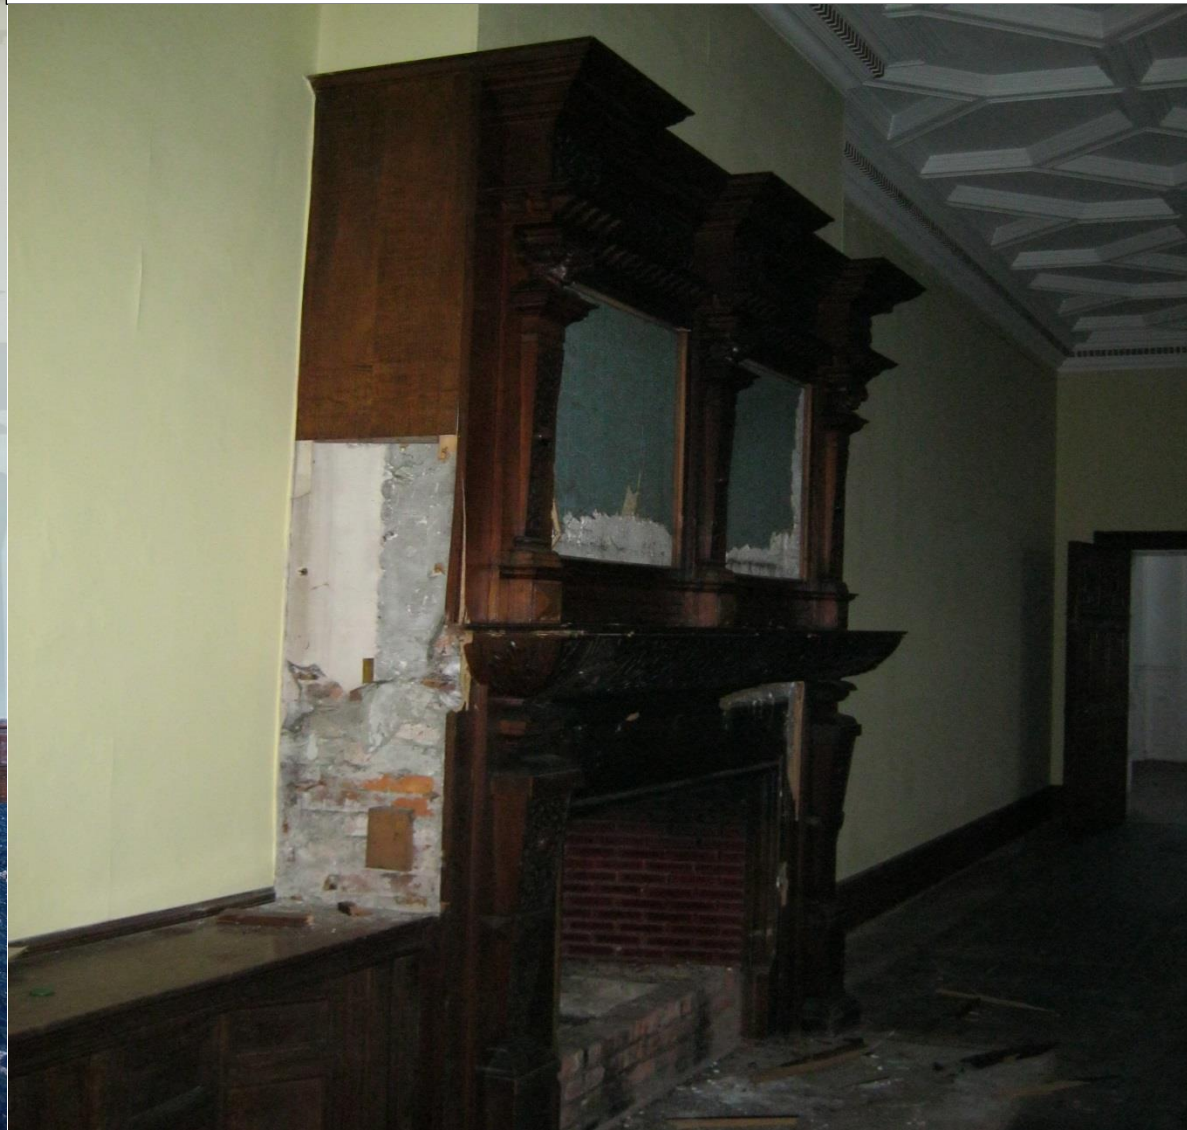
Queen Victoria's Coat of Arms and Hugh Robert Hughes' Coat of Arms were removed on the evening of the 9th October 2013. The people responsible tried to remove the whole Fireplace without success.

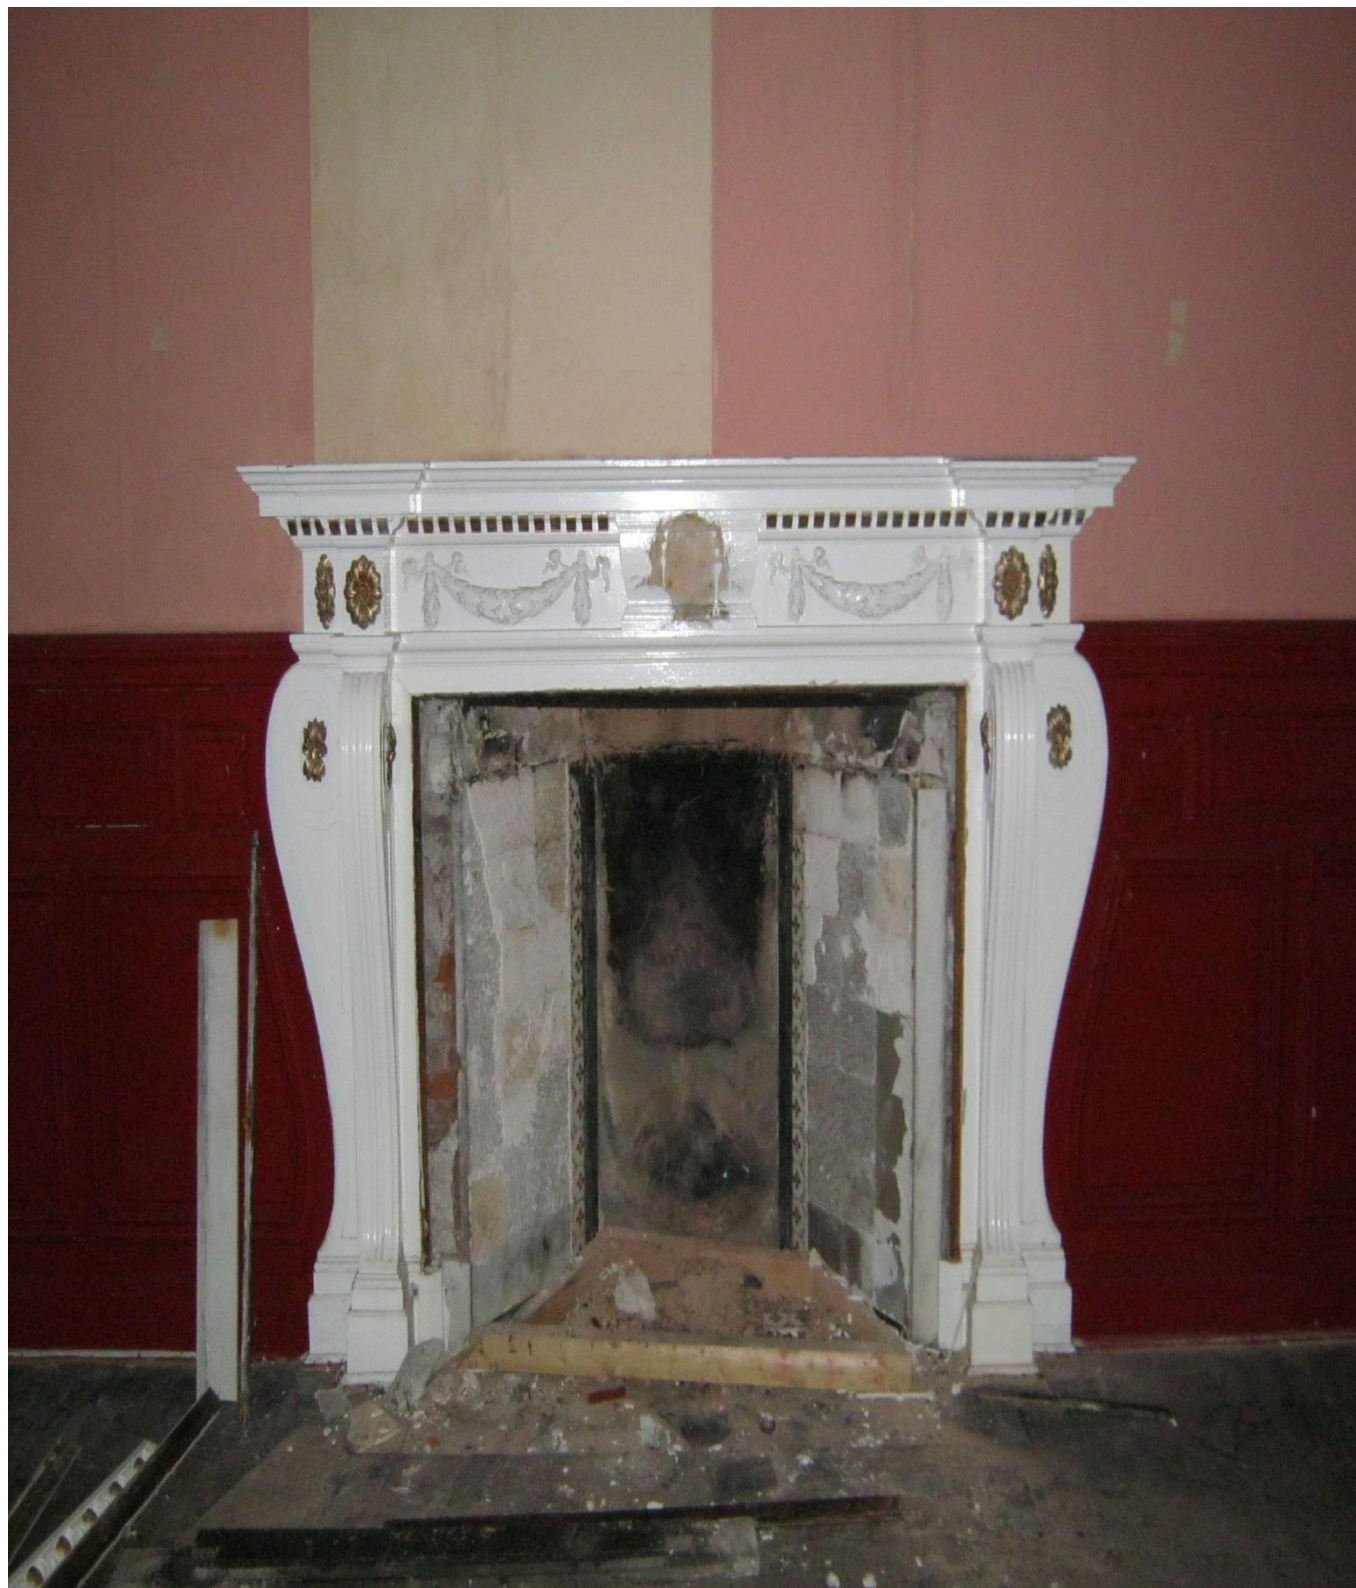
This is the Fire place on the West facing wall of the Drawing Room it was damaged at the same time as the others.

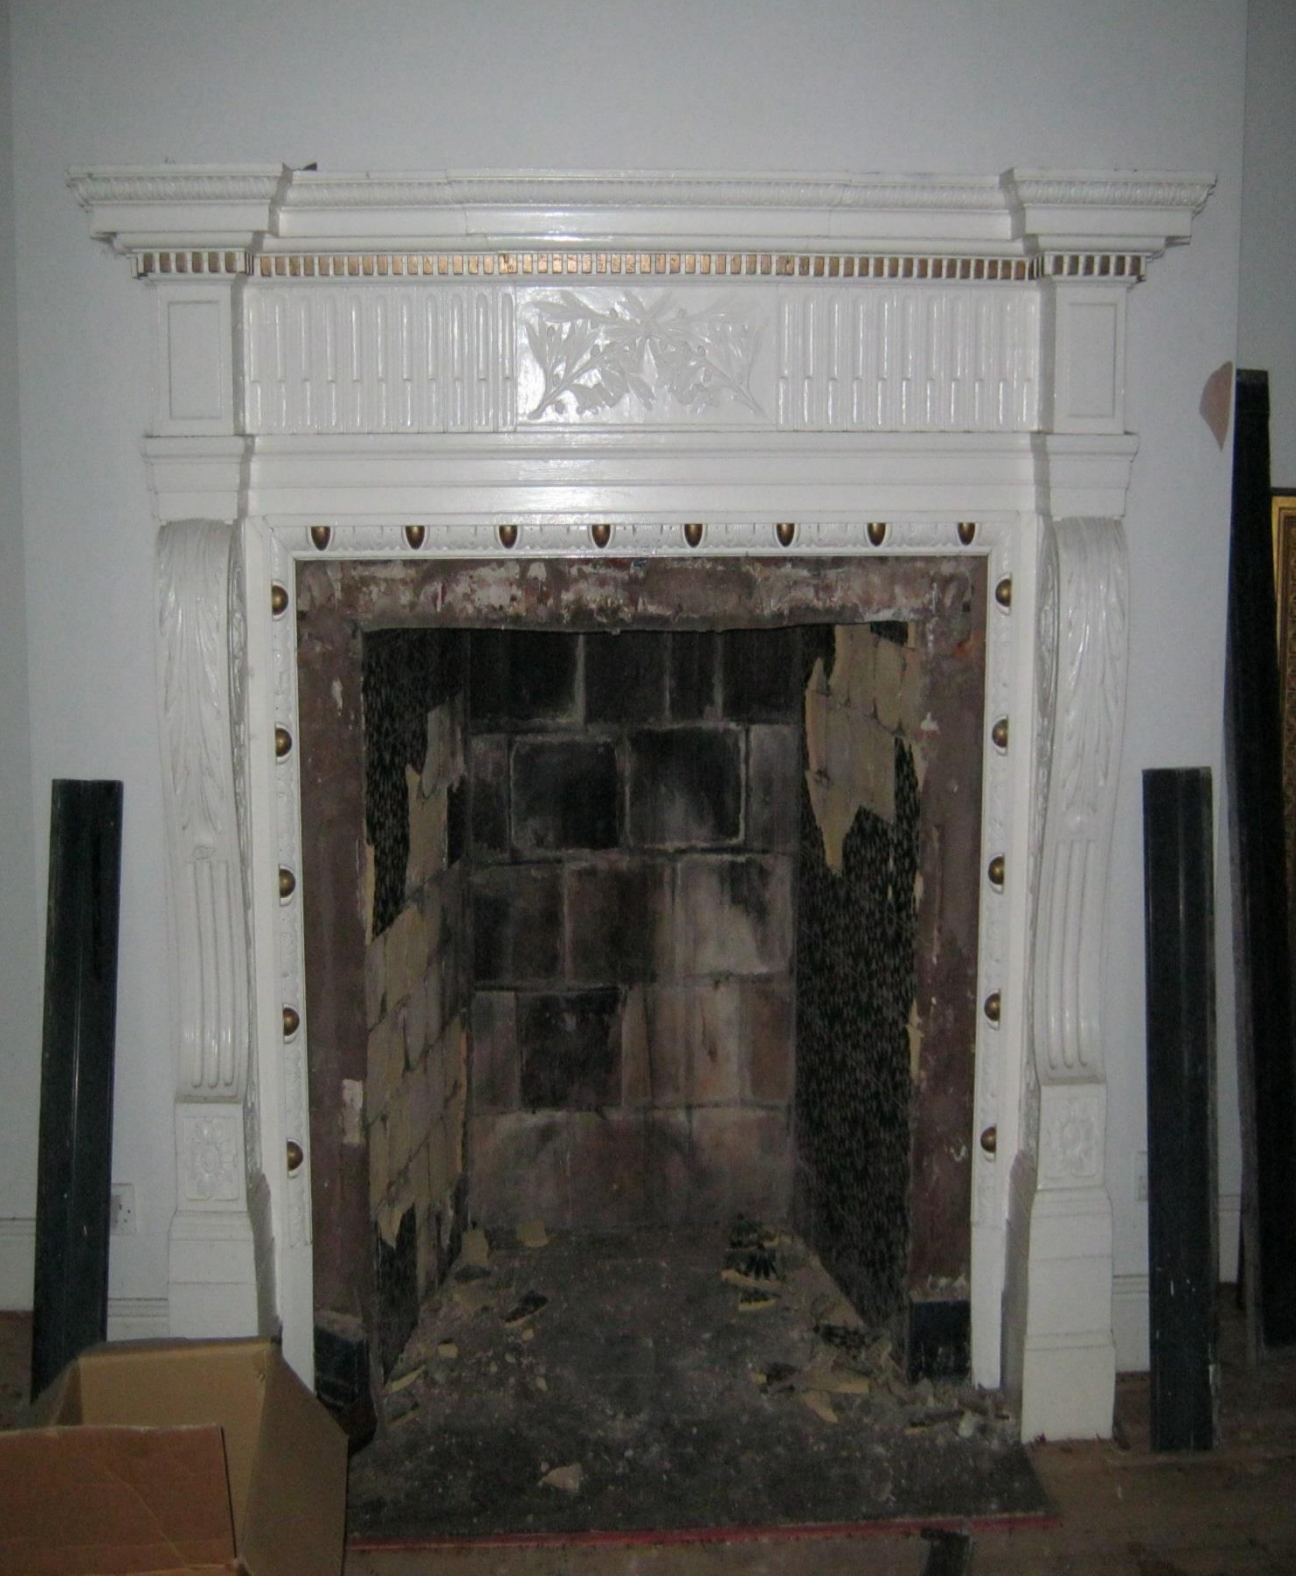
This is the Dining Room Fireplace
which was also damaged in October
2013

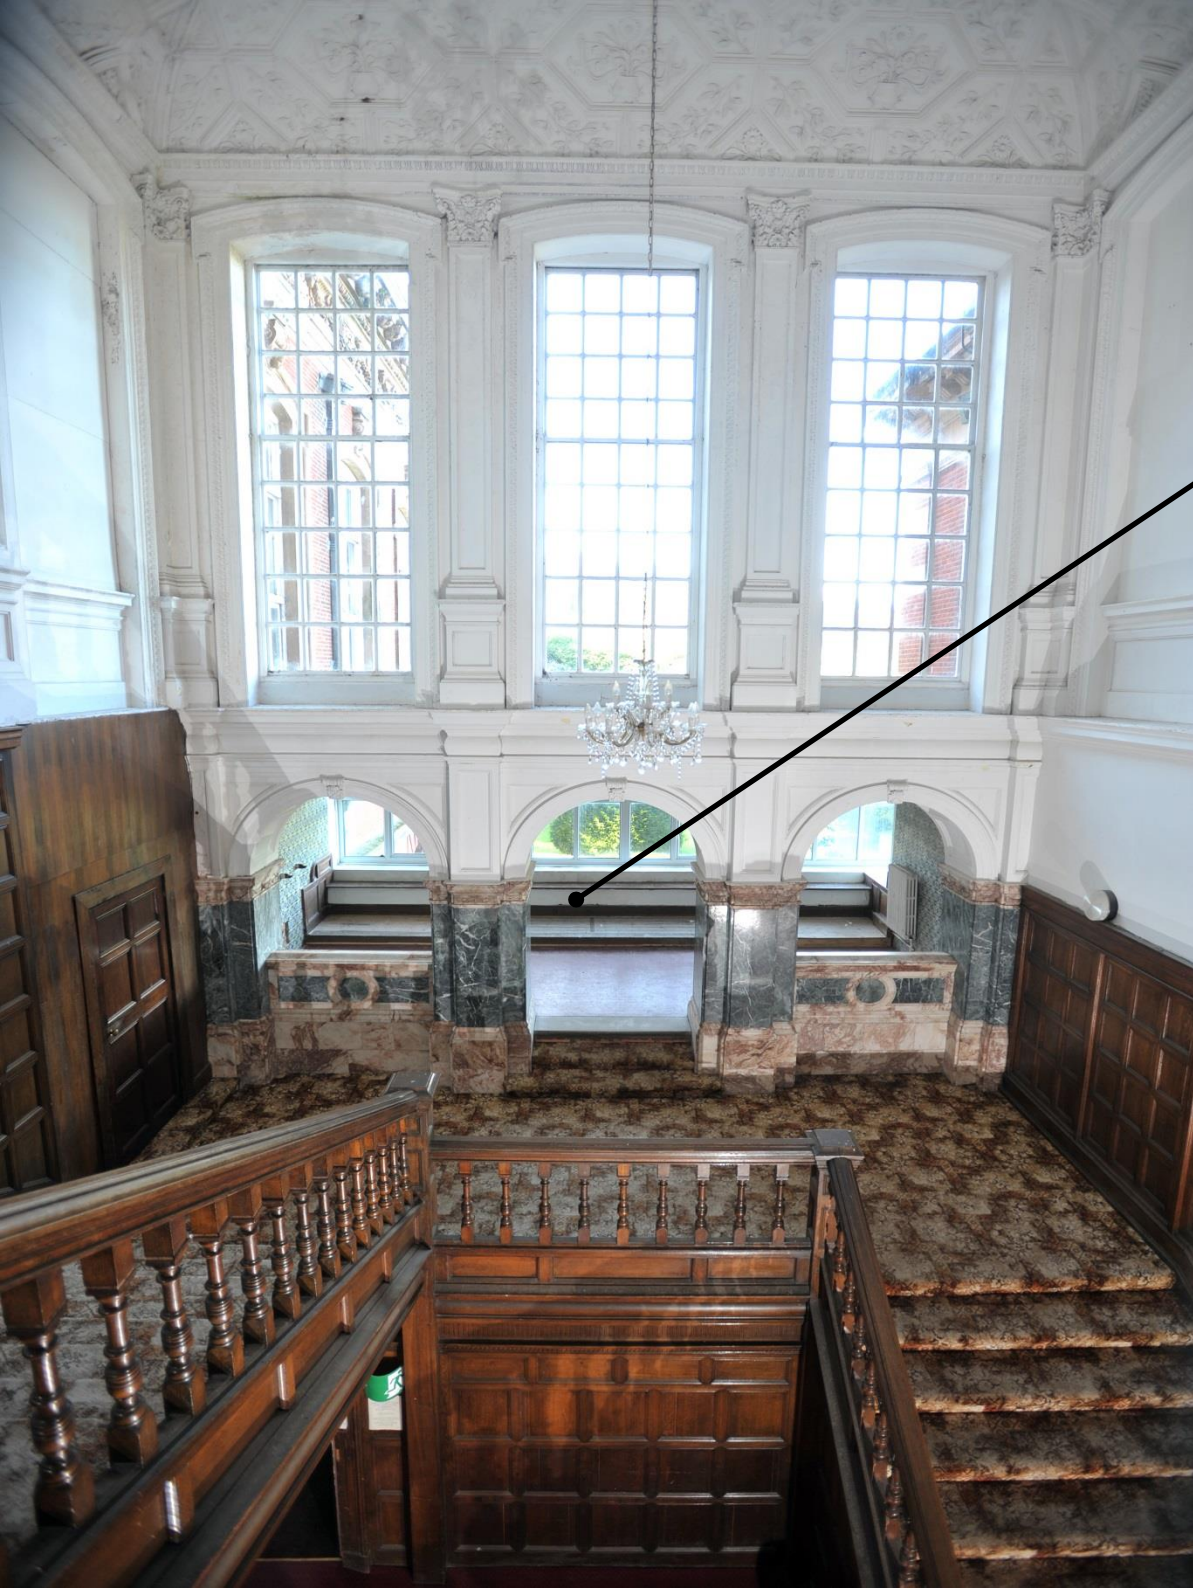
A panel of Marble installed 1936 – 40 has been smashed whilst trying to be removed

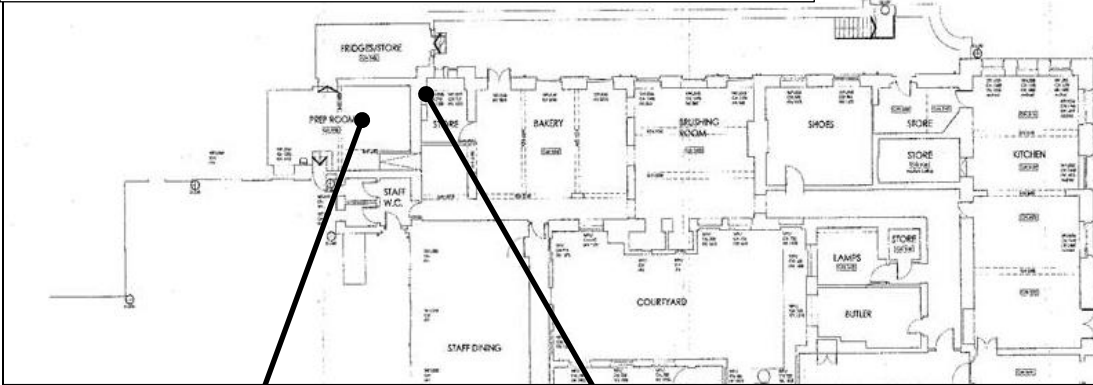
THIS IS THE GROUND FLOOR SOUTH – WEST WING WHICH RUNS PARALLEL TO THE SLOPING DRIVE WAY TO THE SPORTS HALL

THIS SECTION OF THE HALL IS THE FLAT ROOFED AREA AT THE SOUTH WEST CORNER OF THE HALL NEAR TO WHERE THE SLOPING DRIVE PASSES THE GAS TANK ENCLOSURE. AS WITH A LOT OF FLAT ROOFS THIS ONE HAS LEAKED FOR AT LEAST 20 YEARS. THE FLOOR BELOW HAS BECOME ROTTEN AND GIVEN WAY INTO THE KITCHEN AREA BELOW.

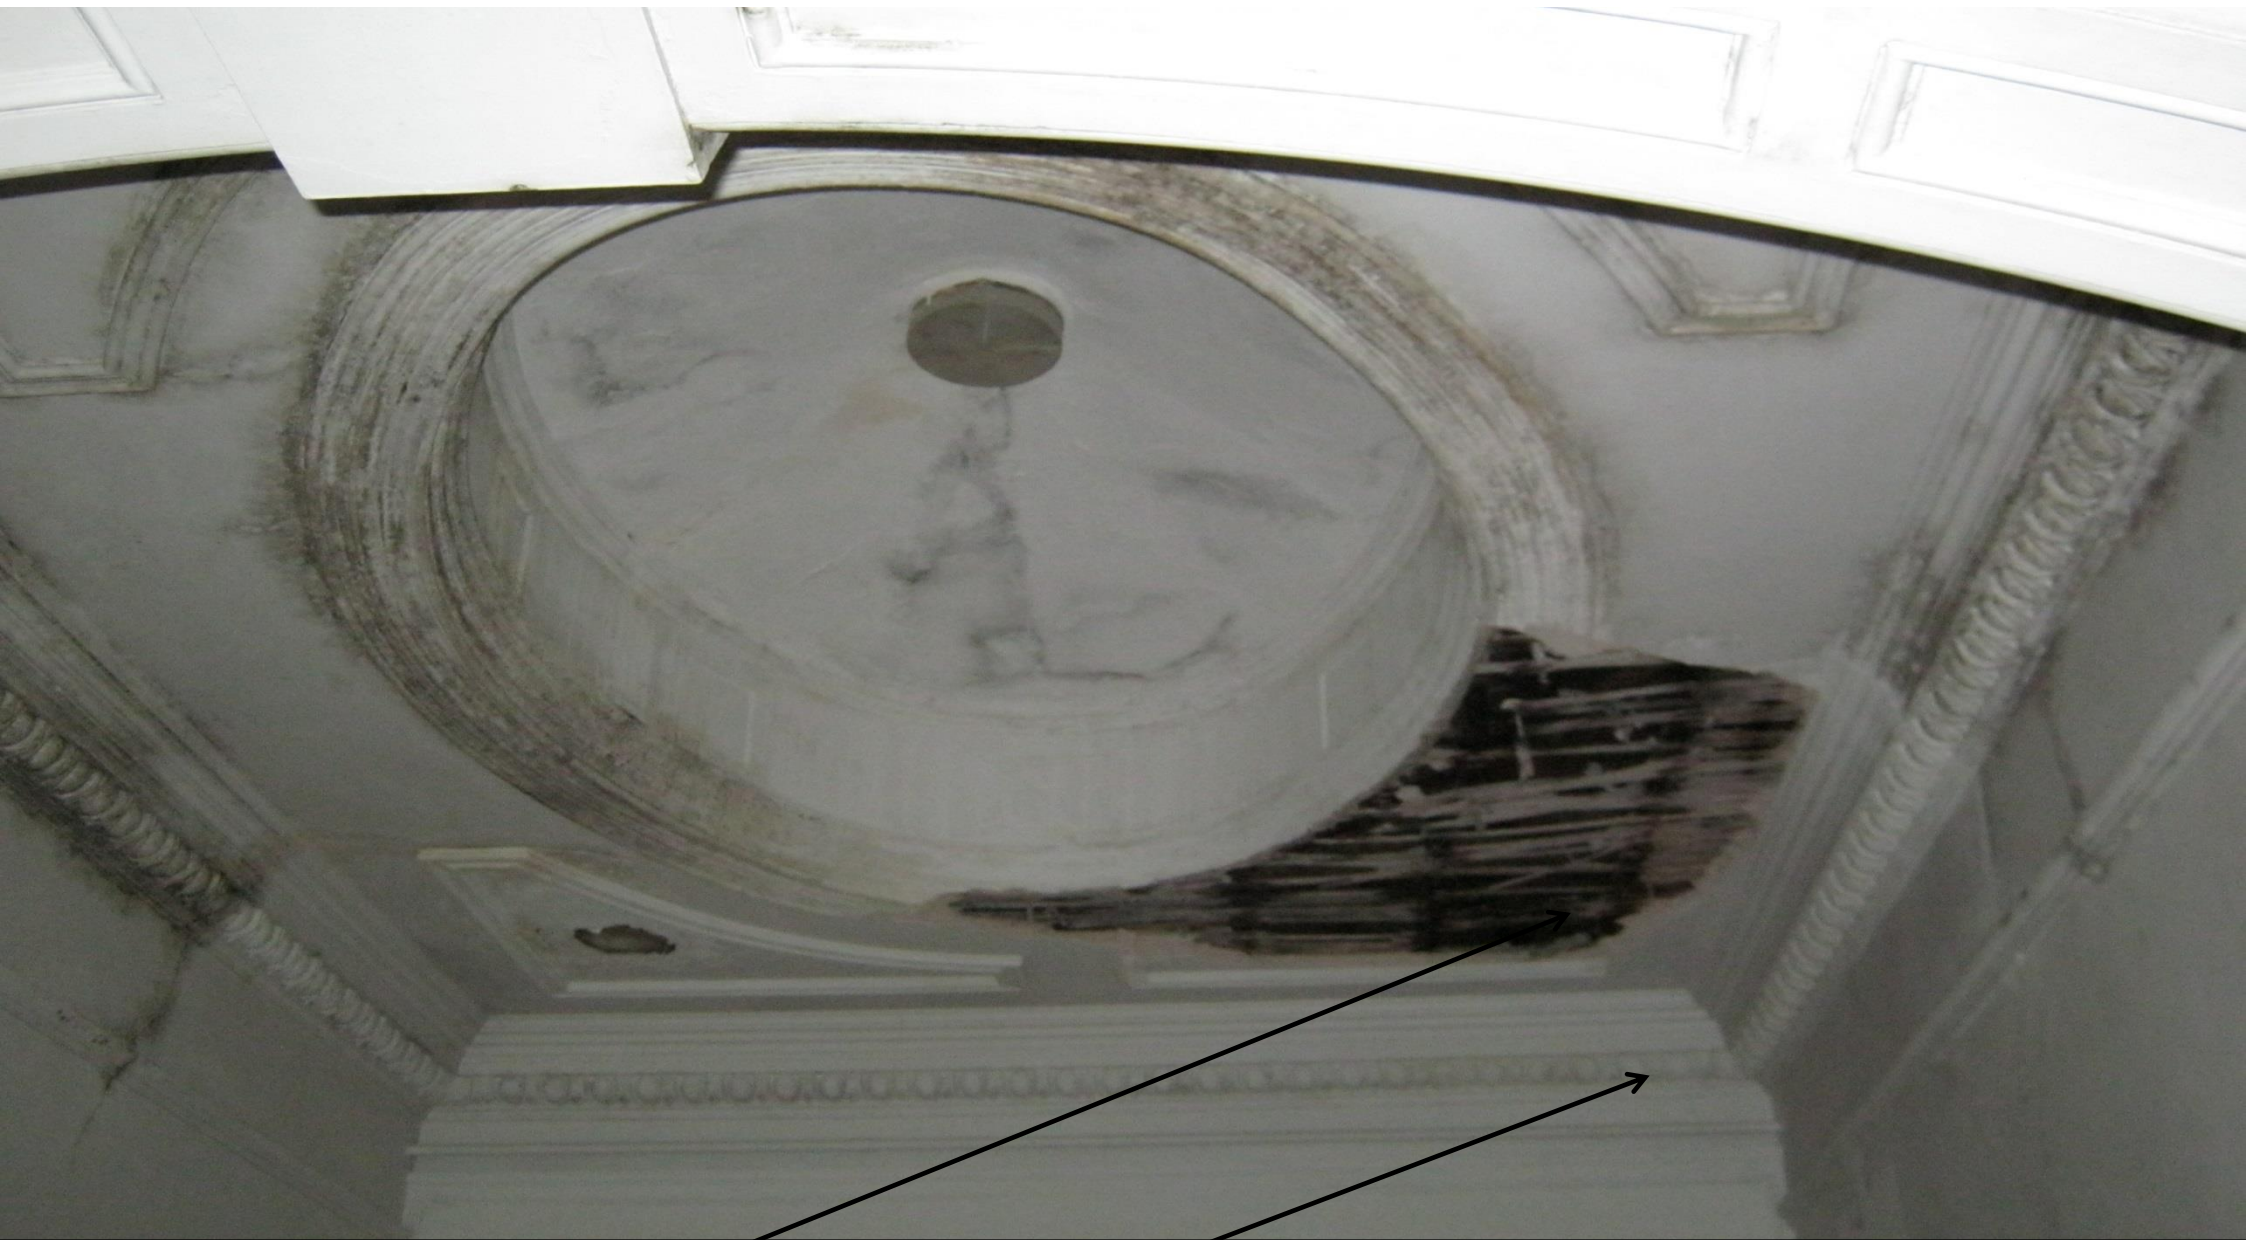
During the rebuilding of Kinmel Hall an error was made with the drainage that runs across the roof of the Ballroom adjoining the end wall of the SECOND FLOOR Corridor (as shown in the photo).

In the top end of the Down Pipe that runs down the far left hand corner at the back of the ballroom a leaf trap was inserted to stop debris getting into the pipe

Unfortunately it was put in upside down

As a result, at regular intervals, the Trap becomes blocked with leaves etc. As a result the Gutter (shown in the plans) fills with rainwater, which then seeps under the lead flashing and into the building. For the most part the water finds its way to the void containing the Down Pipe that is supposed to get rid of the water. This may also be the cause of the Dry Rot on the back wall of the Drawing Room and Ball Room.

THE CEILING TO THE RIGHT OF THE DOME HAS COLLAPSED ONTO THE FLOOR REVEALING
THE LATHS UNDERNEATH

THE WALL WITH THE ARCHITRAVING IS WHERE THE GUTTER IS THAT KEEPS BLOCKING

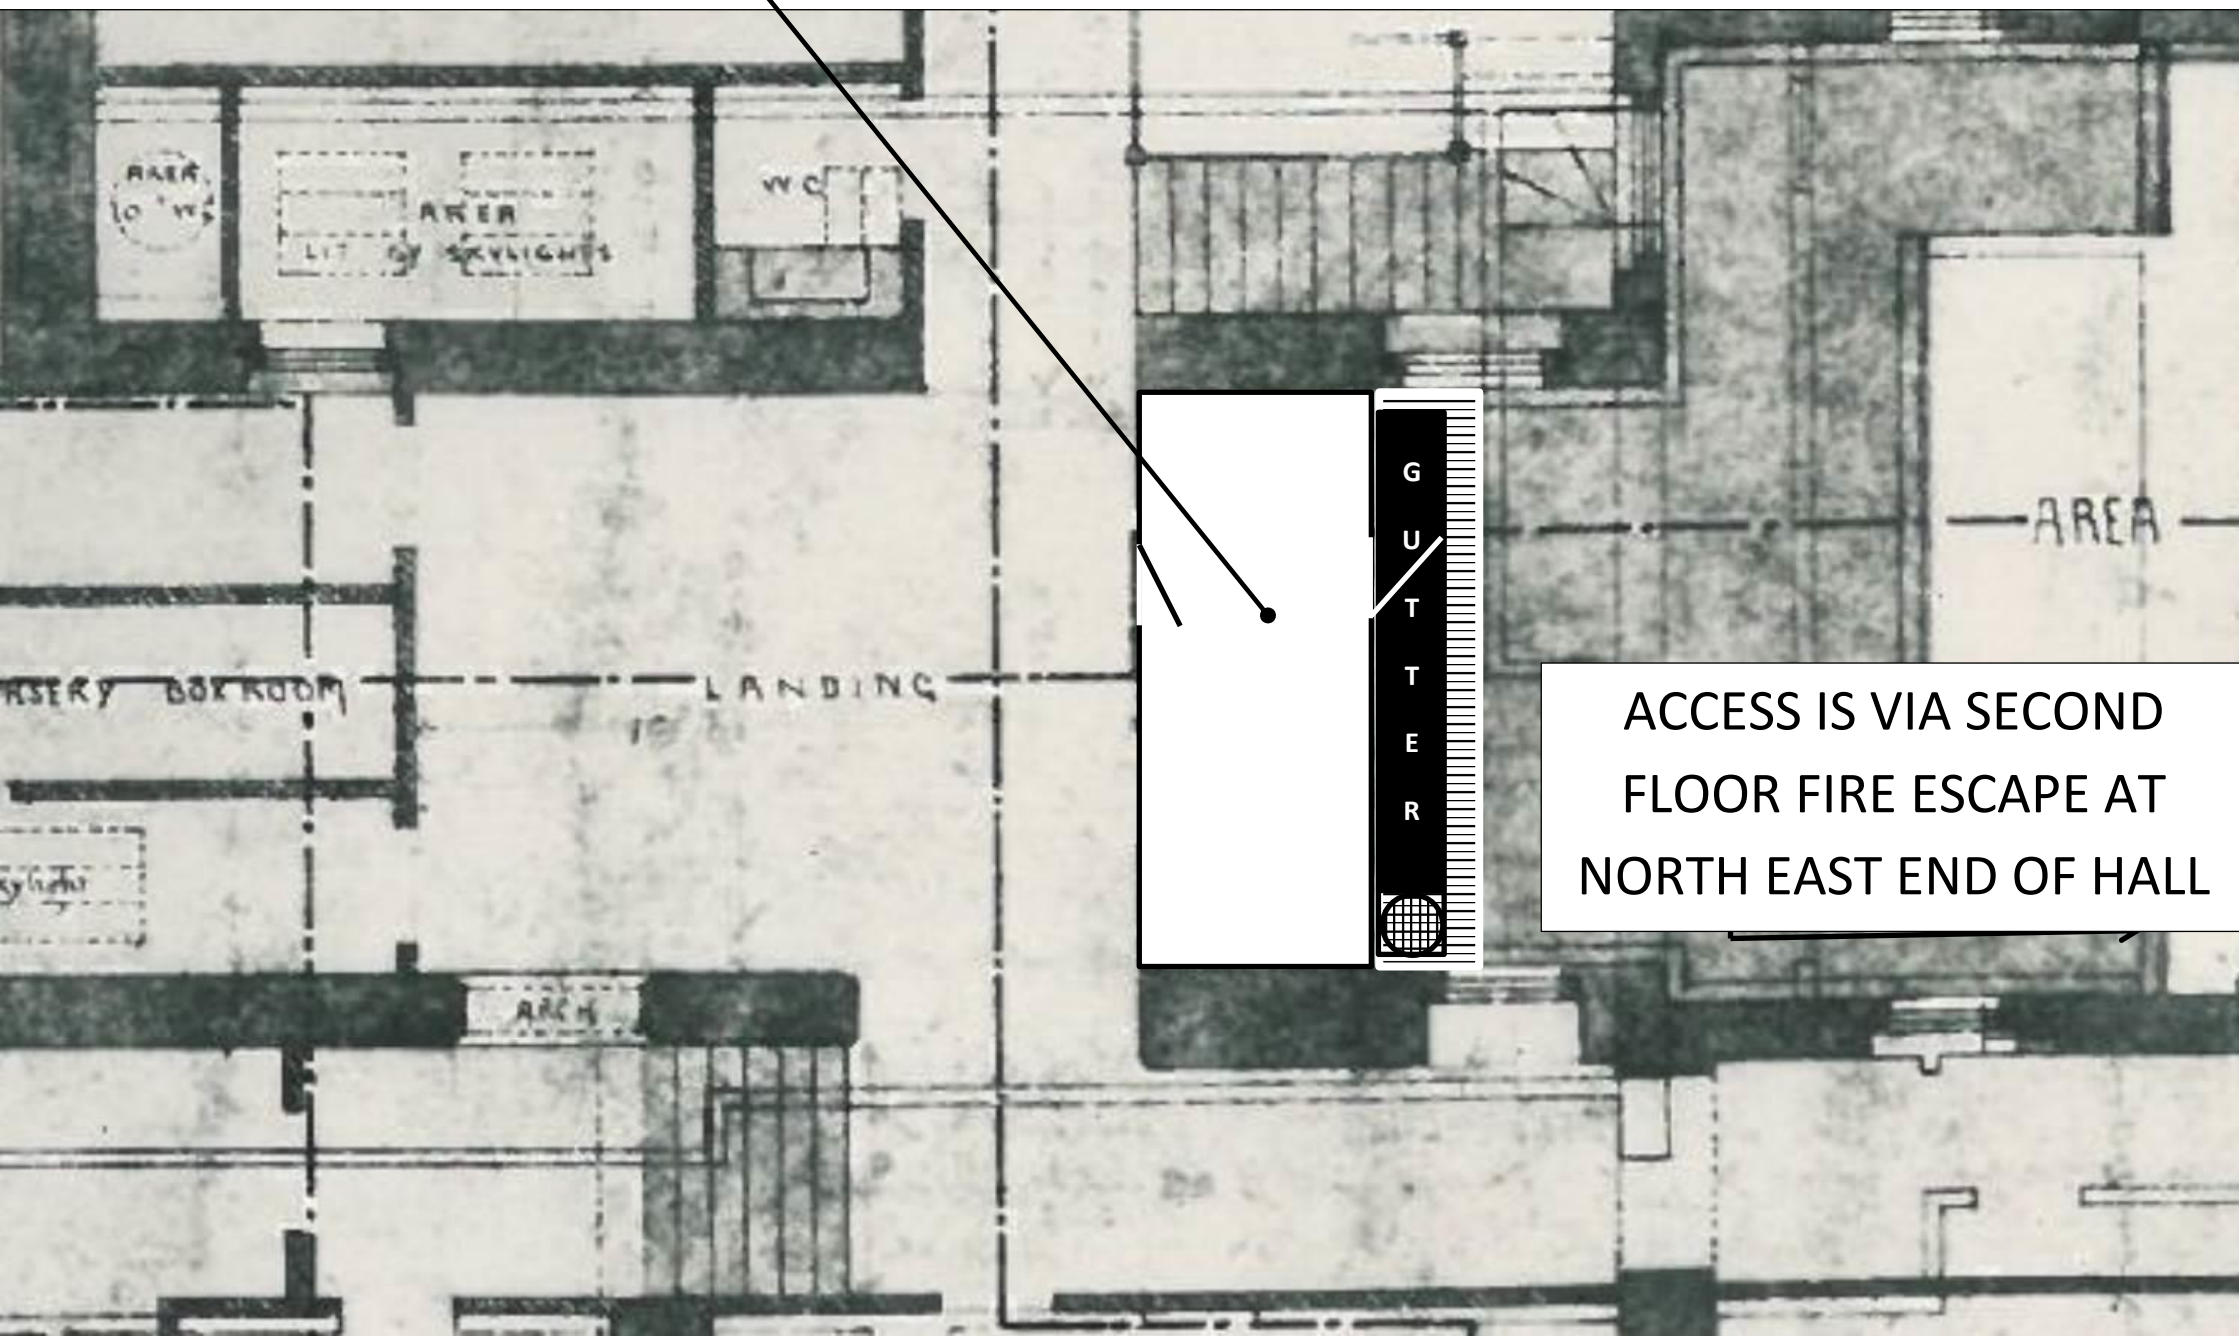
THE GUTTER CAUSING THE PROBLEM IS UNDERNEATH THE FIRE ESCAPE ACCESSED FROM THE
SECOND FLOOR LANDING
(See photo below)

ACCESS IS VIA SECOND
FLOOR FIRE ESCAPE AT
NORTH EAST END OF HALL
