KINMEL HALL

A Report on the Current Condition of the Hall

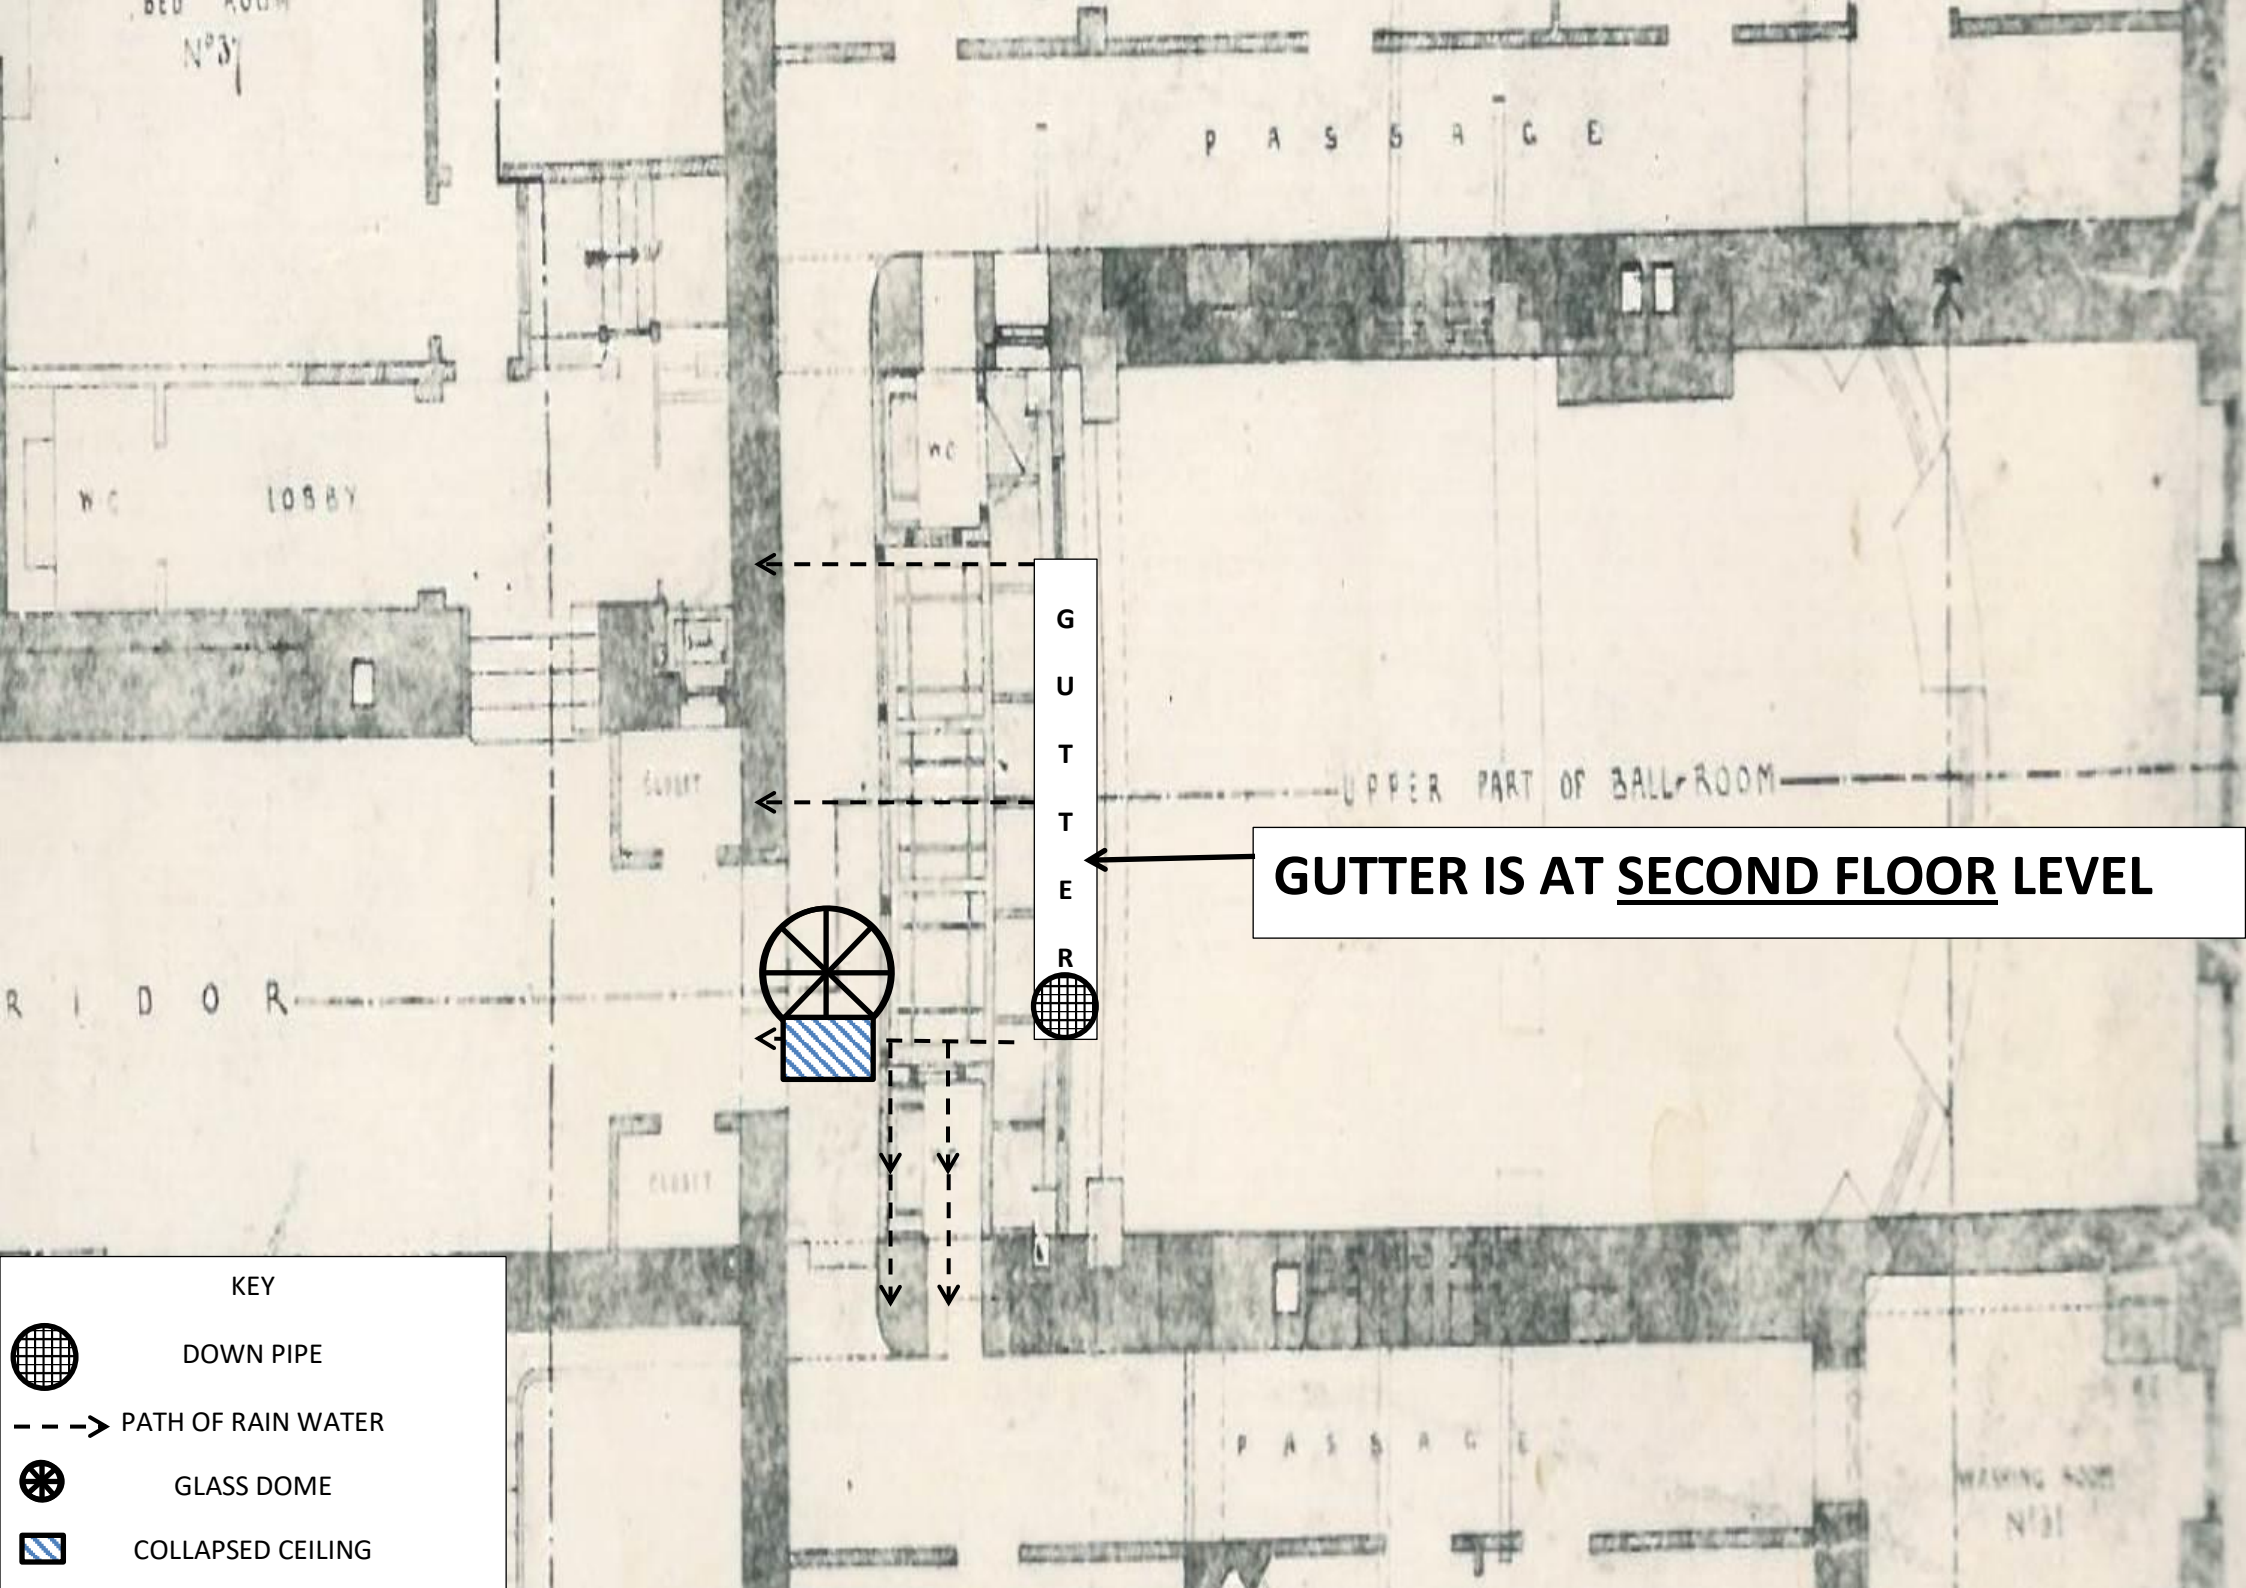
GUTTER IS AT SECOND FLOOR LEVEL

THE GUTTER CAUSING THE PROBLEM IS UNDERNEATH THE FIRE ESCAPE ACCESSED FROM
THE SECOND FLOOR LANDING

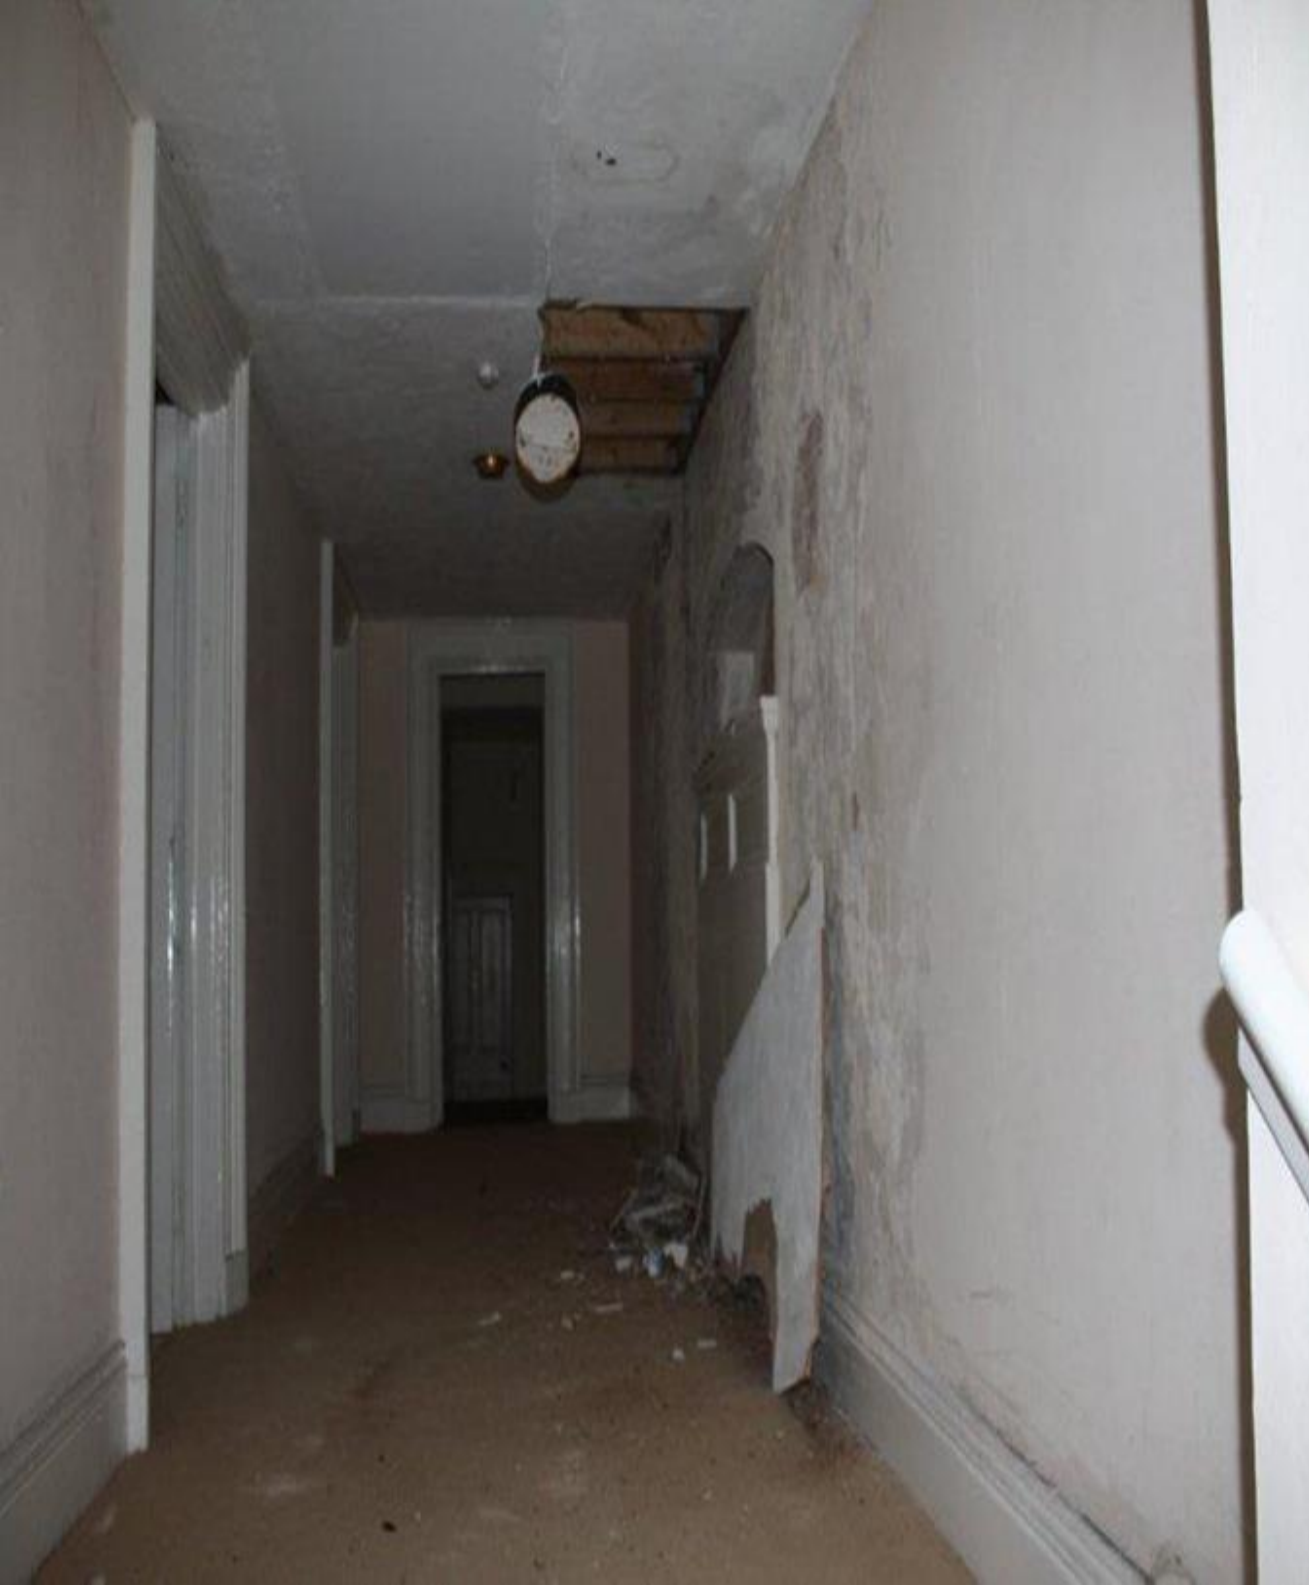
This is the Second Floor Landing on the East Front. The Collapsed Ceiling is a long standing problem due to a leak in the roof

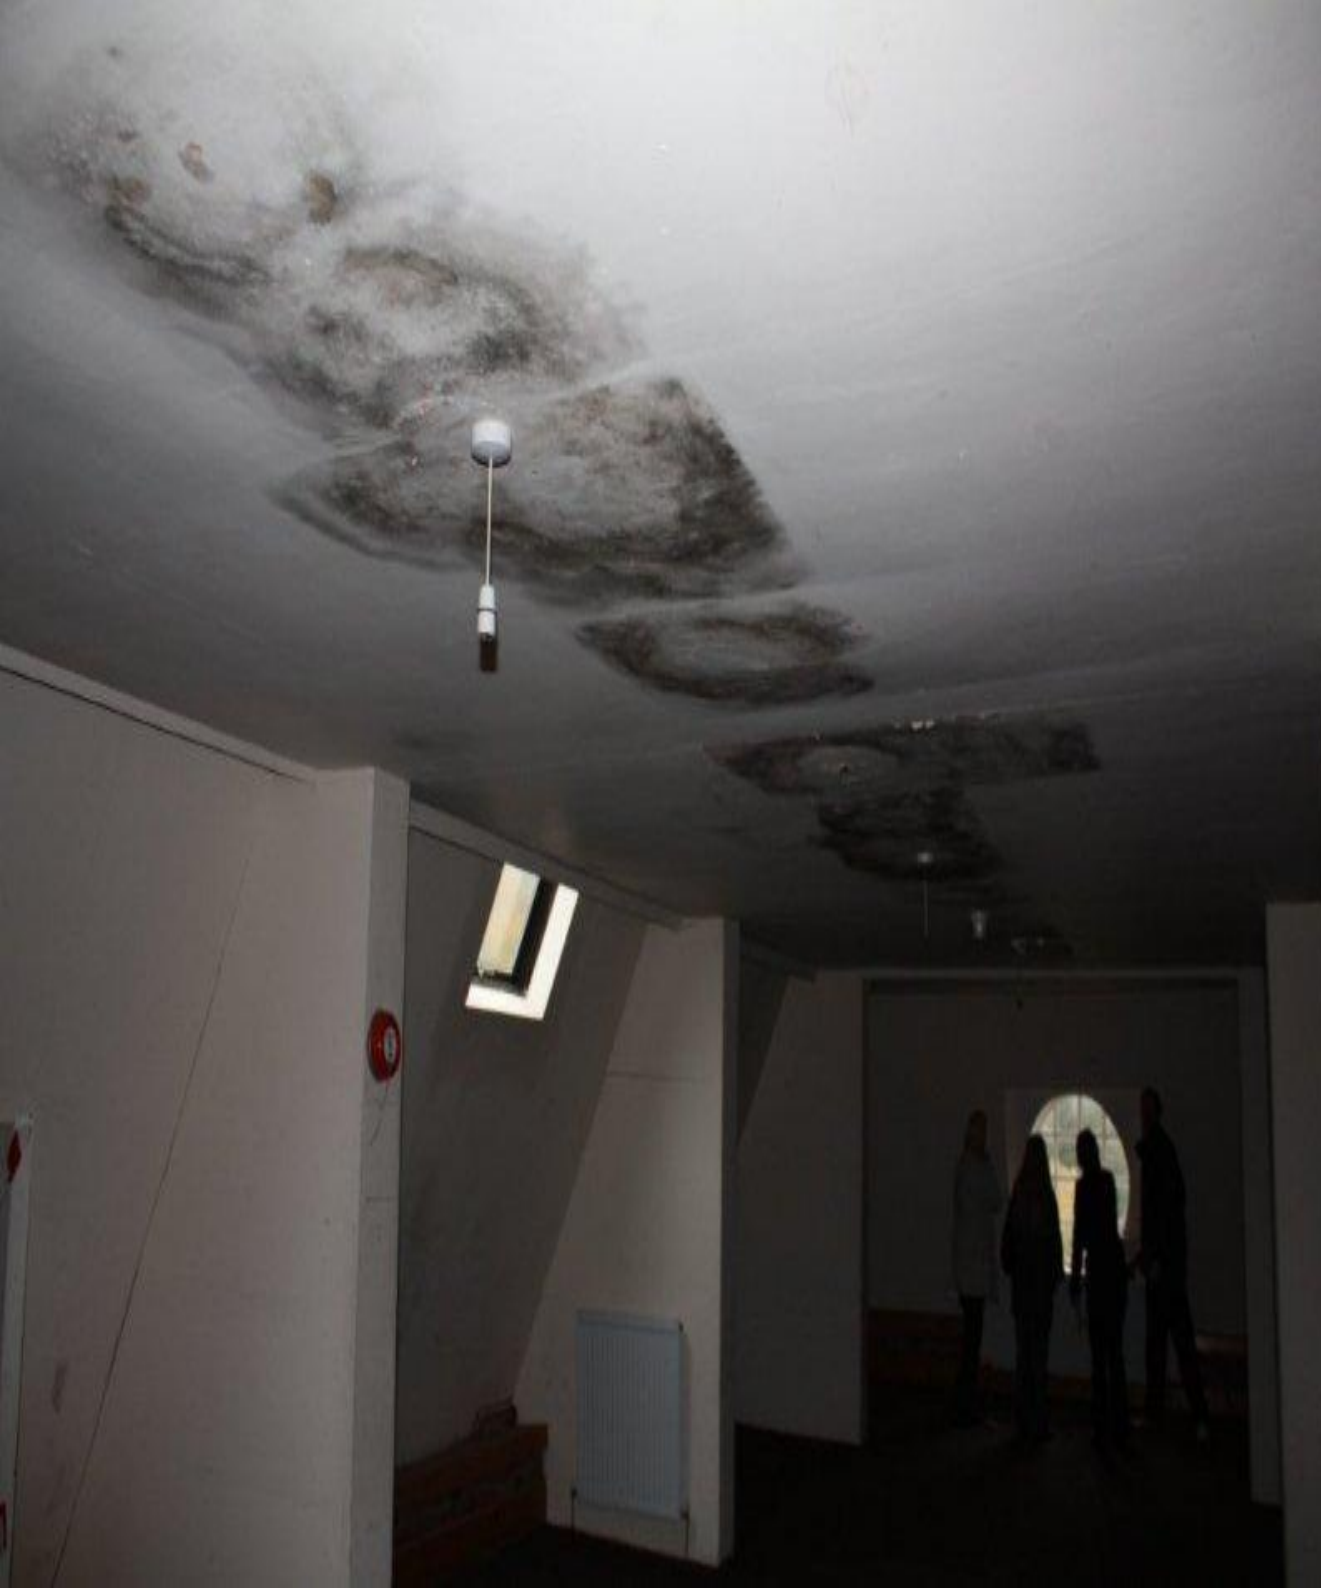
There is a collapsed section of ceiling just out of shot at the top right hand corner of this picture which shows the room in the roof of the Chapel.

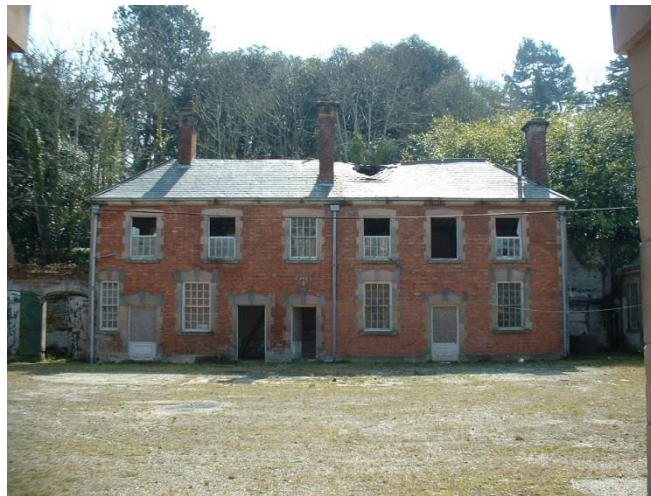
THIS SECTION OF THE HALL WAS STILL BEING USED BY PAYING GUESTS AS LATE AS OCTOBER 1995 AND MAYBE EVEN LATER.

THE AREA WHERE THE ROOF HAS COLLAPSED CONTAINS BATHROOMS AND SHOWERS. WHILST I HAVE NOT BEEN IN THIS PART SINCE THE 90'S IT IS MY UNDERSTANDING THAT THIS COLLAPSE HAS BROUGHT DOWN THE SECOND FLOOR INTO THE FIRST FLOOR

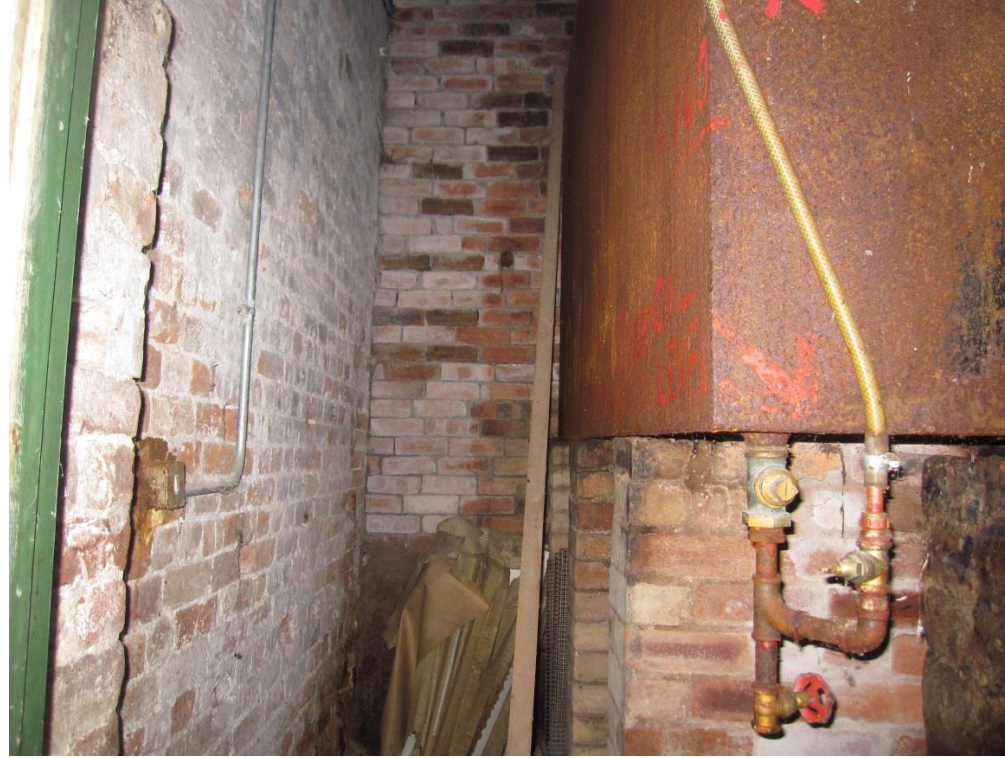
THERE IS A CENTRAL HEATING SYSTEM AT THE BACK OF THE SMALLER HALL WHICH WAS NOT INSPECTED WHEN THE FIRE RISK ASSESSMENT WAS CARRIED OUT IN 2012 AND AS THE RECEIVERS WERE NOT AWARE OF ITS EXISTENCE IT WAS NOT DRAINED.

THE CURRENT OWNERS 'CLAIM' THEY HAVE EMPTIED IT BUT AS THEY WERE FOUND TO BE REMOVING THE ASBESTOS WITHOUT THE CORRECT PERMITS OR PROTECTIVE CLOTHING IT IS ANYONES GUESS WHERE IT WAS EMPTIED TO IF AT ALL.

IT IS OIL FIRED AND HAS ITS OWN TANK

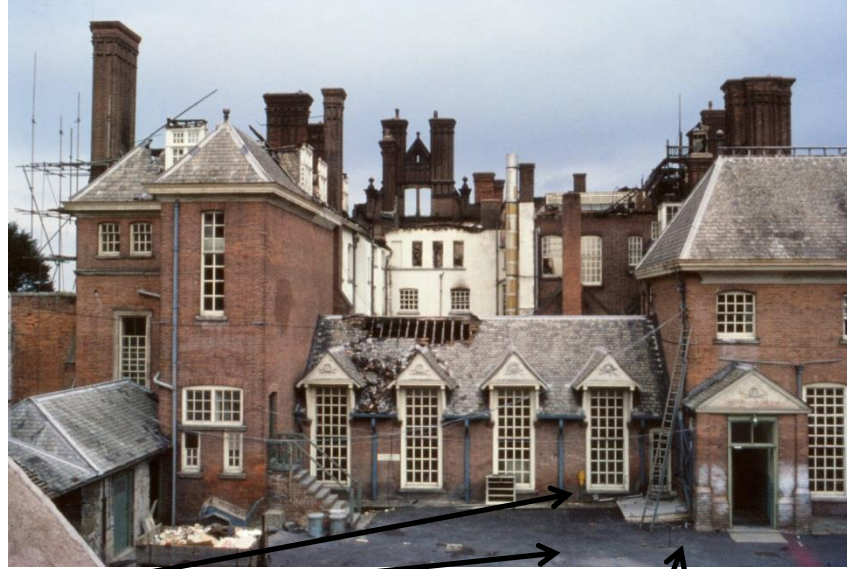
THERE IS A FIRE HYDRANT POINT OUTSIDE THE SOUTH END OF THE HALL AS SHOWN BY THE MARKER TO THE LEFT OF THE WINDOW. THIS WAS THE WATER SUPPLY POINT USED BY THE VINCE FAMILY WHEN THE RECONSTRUCTION OF THE HALL BEGAN IN 1978. THIS WAS BECAUSE THE MAINS SUPPLY COULD NOT BE TURNED ON WHEN THE HALL WAS AS SHOWN IN THE PICTURE

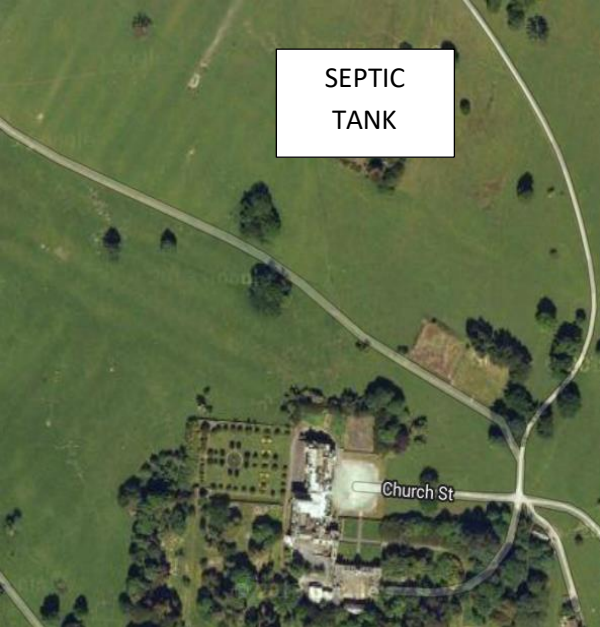
DURING A VISIT ON THE 14TH AUGUST IT WAS DISCOVERED THAT THE PIPE THAT SUPPLIES WATER TO THE THREE FIRE HOSE REEL POINTS IN THE MAIN HALL HAD BEEN SMASHED AND WATER WAS POURING OUT OF IT, INTO A BARREL OF FAT AND FROM THERE INTO THE GRID IN THE FLOOR OF THE CELLAR WHICH FEEDS INTO THE SEPTIC TANK IN THE PARK. AT THE NORTH END OF THE HALL THE LAST TWO GRIDS IN THE FLOOR OF THE CORRIDOR WERE UNDER AT LEAST 7 INCHES OF 'WATER' WHICH WAS A CLEAR SIGN THAT THERE IS A PROBLEM WITH THE SEPTIC TANK OR THE PIPE TO IT. (SEE NEXT PAGE)

DURING A VISIT ON THE 11TH OCTOBER 2013 IT WAS DISCOVERED THAT THE FIRE HYDRANT PIPE WAS NO LONGER POURING WATER. THE BUILDER HAD CAPPED THE PIPE OFF AND CONVERTED IT TO A DOMESTIC SUPPLY USING POLY PIPE.
