## 'THE CROWN OF W E NESFIELD'S CAREER' - KINMEL HALL, ST GEORGES, ABERGELE NORTH WALES

A Report on the Current Condition of the Hall

The details are not complete but go a long way to show how the Hall has deteriorated as a result of 14 years of Neglect, Vandalism

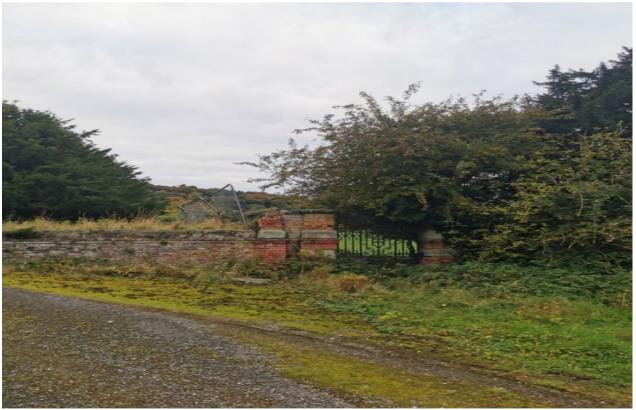
THIS GATEWAY LEADS ONTO 5,000 ACRES OF FARMLAND BUT NOT SECURED

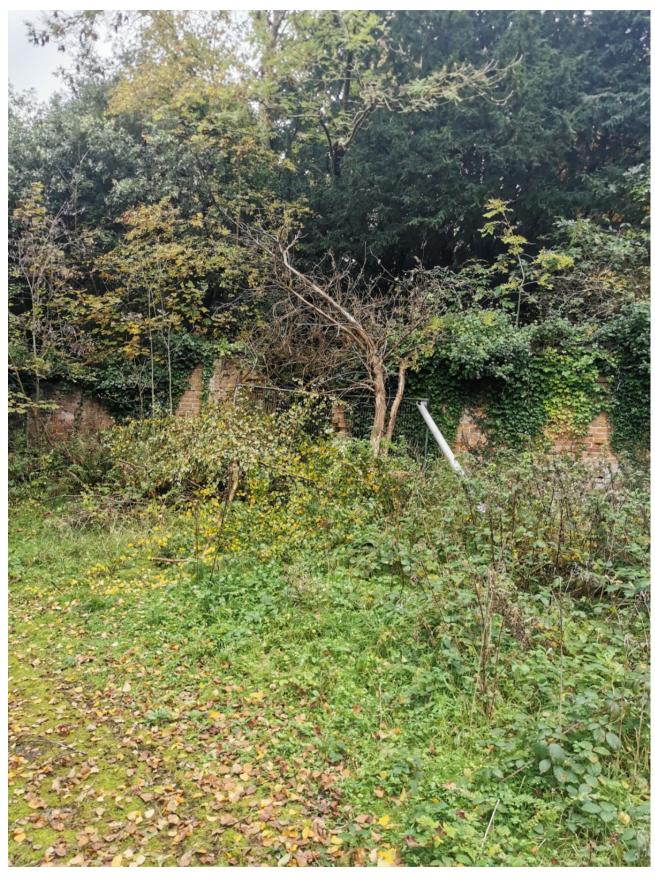
THIS DOORWAY IS INTO THE 1936 SPORTS HALL WHICH HAS A COLLAPSED SUSPENDED CEILING MADE OF 95% BONDED ASBESTOS 'ASBESTOLUX' CEILING TILES INSTALLED IN THE 1980'S. THE BUILDING ALSO HAS ITS ORIGINAL CORRUGATED ASBESTOS ROOF

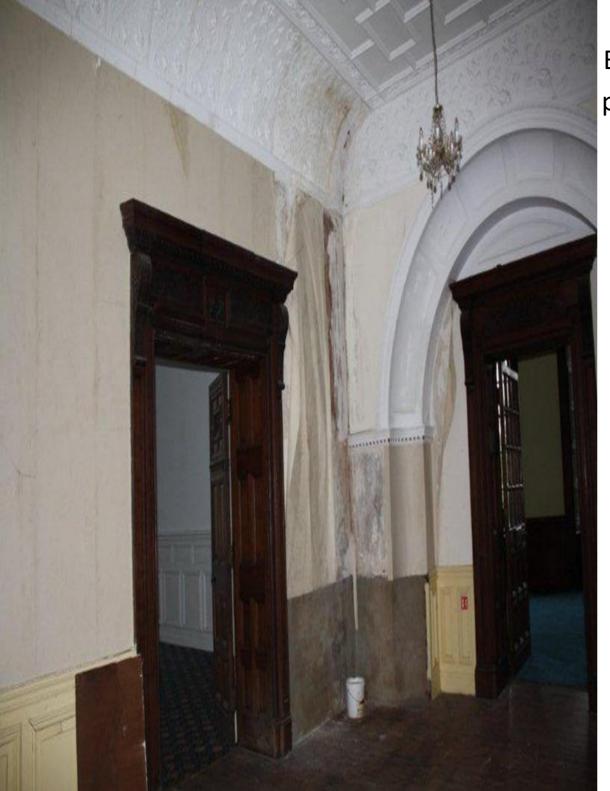
This is the door way from the Main Hall leading to the Reception.

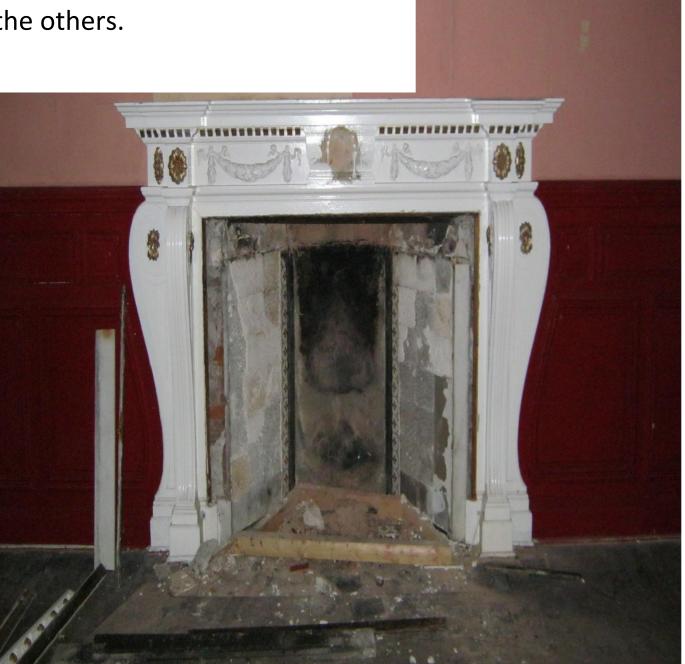
This is the Fire place on the West facing wall of the Drawing Room it was damaged at the same time as the others.

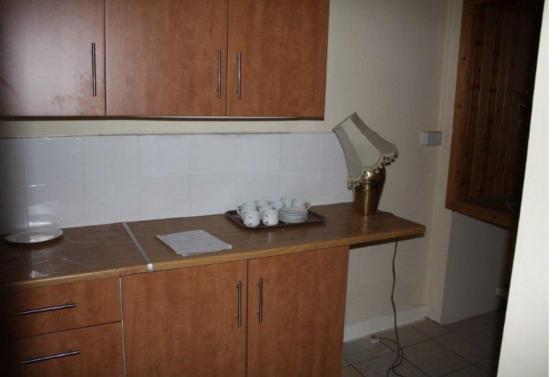
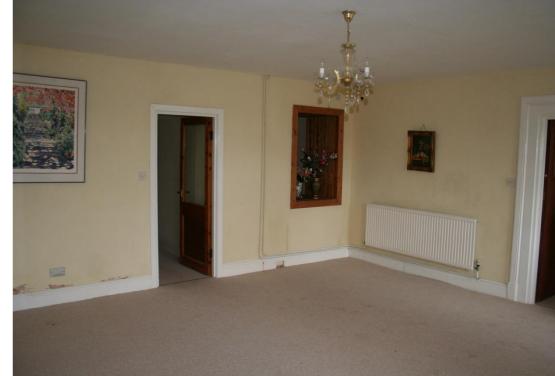
25<sup>TH</sup> OCTOBER 2011 14<sup>TH</sup> AUGUST 2013

A panel of Marble installed 1936 – 40 has been smashed whilst trying to be removed

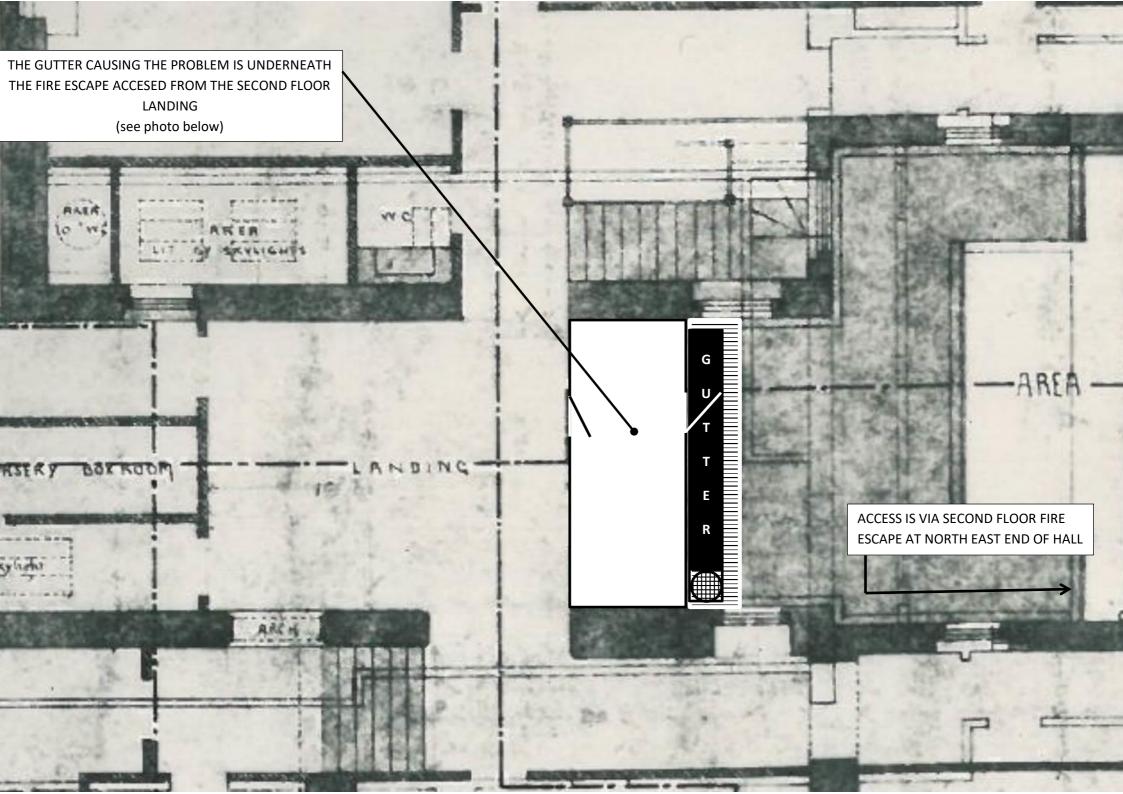
During the rebuilding of Kinmel Hall an error was made with the drainage that runs across the roof of the Ballroom adjoining the end wall of the SECOND FLOOR Corridor (as shown in the photo).

In the top end of the Down Pipe that runs down the far left hand corner at the back of the ballroom a leaf trap was inserted to stop debris getting into the pipe

As a result, at regular intervals, the Trap becomes blocked with leaves etc. As a result the Gutter (shown in the plans) fills with rainwater, which then seeps under the lead flashing and into the building. For the most part the water finds its way to the void containing the Down Pipe that is supposed to get rid of the water. This may also be the cause of the Dry Rot on the back wall of the Drawing Room and Ball Room.

As the Hall is built on a Steel Scaffold it is possible that there are voids running through the ceilings of the hall – as there are under the floor of the Salon – allowing the damp to penetrate wider than the single wall affected directly by the blocked gutter which may be part of the reason for the Dry Rot in the casement of the Library Windows

Due to Kinmel's design it is UNLIKELY that damp has penetrated from the outside unless the trenches have become water logged or blocked

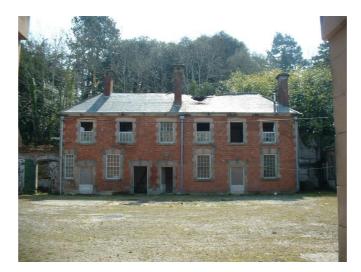
THIS SECTION OF THE HALL WAS STILL BEING USED BY PAYING GUESTS AS LATE AS OCTOBER 1995 AND MAYBE EVEN LATER.

THE AREA WHERE THE ROOF HAS COLLAPSED CONTAINS BATHROOMS AND SHOWERS.
WHILST I HAVE NOT BEEN IN THIS PART SINCE THE 90'S IT IS MY UNDERSTANDING THAT
THIS COLLAPSE HAS BROUGHT DOWN THE SECOND FLOOR INTO THE FIRST FLOOR

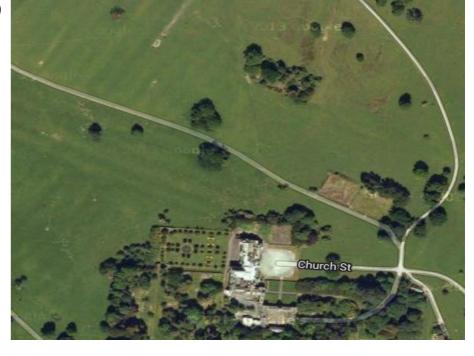
THERE ARE FIVE SETS OF STOP TAPS LOCATED BY THE CLUMP OF TREES NEAR TO THE TENNIS
COURTS OUTSIDE THE GROUNDS OF THE HALL

TWO SUPPLY WATER TO THE HOUSES ON THE OPPOSITE SIDE OF THE CROSS ROADS TO THE HALL, ONE SUPPLIES WATER TO THE WATER TROUGHS ON THE PARK. ONE SUPPLIES WATER TO THE FIRE HYDRANT FOR THE HALL AND THE OTHER ONE SUPPLIES THE HALL ITSELF BUT NONE OF THEM ARE
