FOREWORD
'TRAGEDY TO TRIUMPH'
Courtesy of Mrs Elaine Boxhall nee Southern
PE Teacher 1950 – 55
Clarendon school for Girls
KINMEL HALL
1946 – 1975
By the Marquess of Anglesey,
DL, FSA, FR Hist S, Hon FRIBA, FRSL.

FROM TRIUMPH BACK TO TRAGEDY!

The details are not complete but go a long way to show how the Hall has deteriorated as a result of 14 years of Neglect, Vandalism

LOCATION OF SERVICES, LEAKS AND FLOODED AREAS AS AT OCTOBER 2013

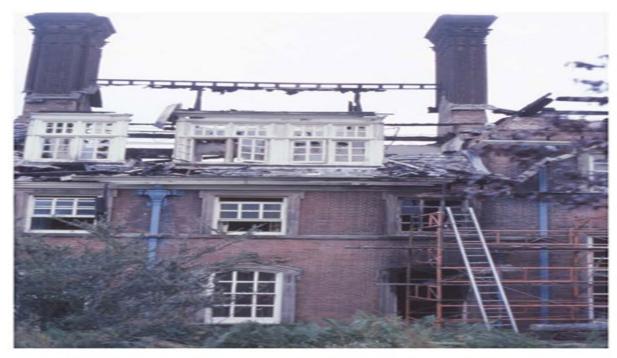
The Blackened Window Identifies the Start Of The Fire

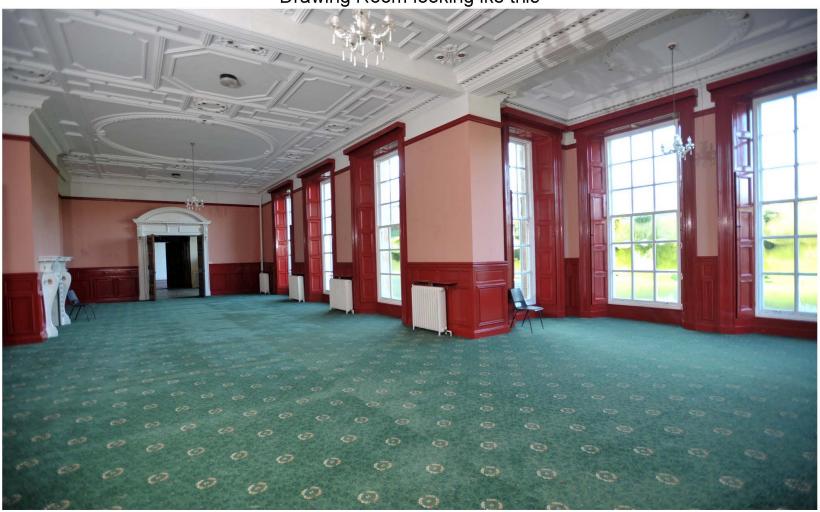
Unfortunately the running costs of such a huge building were far more than John Fox had realised When a serious mistake was made by the suppliers of the paint for the Hall which resulted in the Drawing Room looking lke this

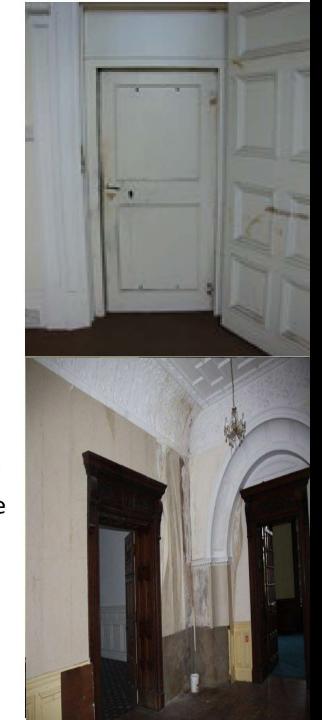
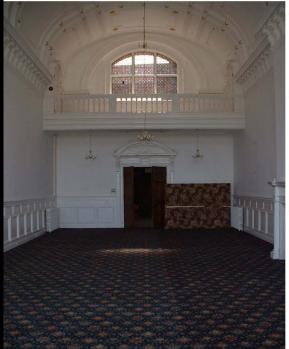
This is the
Ballroom. There is
water damage to
the underside of
the Minstrel
Gallery

Water from blocked gutter may have tracked along steel girders and voids to casement windows. When the shutters are closed the panelling behind is warped and cracked. Shutters are now closed and screwed shut into the window

frames

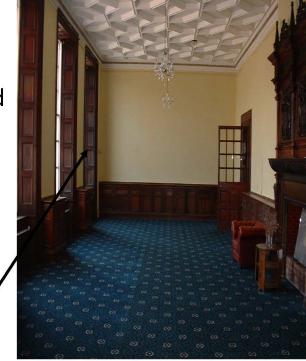
Queen Victoria's Coat of Arms and Hugh Robert Hughes' Coat of Arms were removed on the evening of the 9th October 2013. The people responsible tried to remove the whole Fireplace.

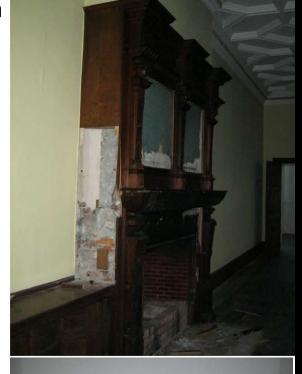
This is the Fire place on the West facing wall of the Drawing Room it was damaged at the same time as the others.

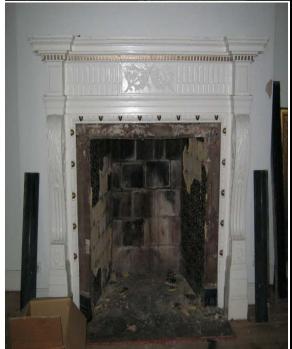
This is the Dining Room Fireplace which was also damaged in 2013.

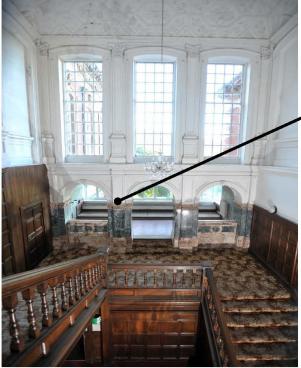
A panel of Marble installed 1936 – 40 has been smashed whilst trying to be removed

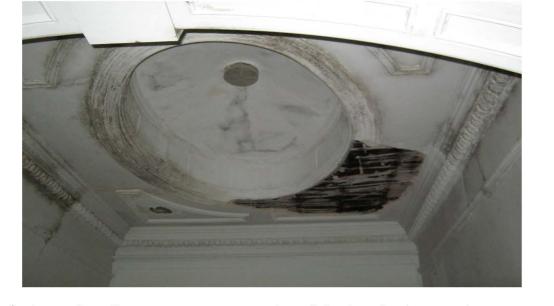
During the rebuilding of Kinmel Hall an error was made with the drainage that runs across the roof of the Ballroom adjoining the end wall of the SECOND FLOOR Corridor (as shown in the photo). In the top end of the Down Pipe that runs down the far left hand corner at the back of the ballroom a leaf trap was inserted to stop debris getting into the pipe Unfortunately it was put in upside down As a result, at regular intervals, the Trap becomes blocked with leaves etc. As a result the Gutter (shown in the plans) fills with rainwater, which then seeps under the lead flashing and into the building. For the most part the water finds its way to the void containing the Down Pipe that is supposed to get rid of the water. This may also be the cause of the Dry Rot on the back wall of the Drawing Room and Ball Room. Following a recent visit to the Hall it would appear that the damp has affected the ceiling of the First Floor Landing. As the Hall is built on a Steel Scaffold it is possible that there are voids running through the ceilings of the hall – as there are under the floor of the Salon – allowing the damp to penetrate wider than the single wall affected directly by the blocked gutter which may be part of the reason for the Dry Rot in the casement of the Library Windows Due to Kinmel's design it is UNLIKELY that damp has penetrated from the outside unless the trenches have become water logged or blocked

THE GUTTER CAUSING THE PROBLEM IS UNDERNEATH THE FIRE ESCAPE ACCESED FROM THE SECOND FLOOR LANDING

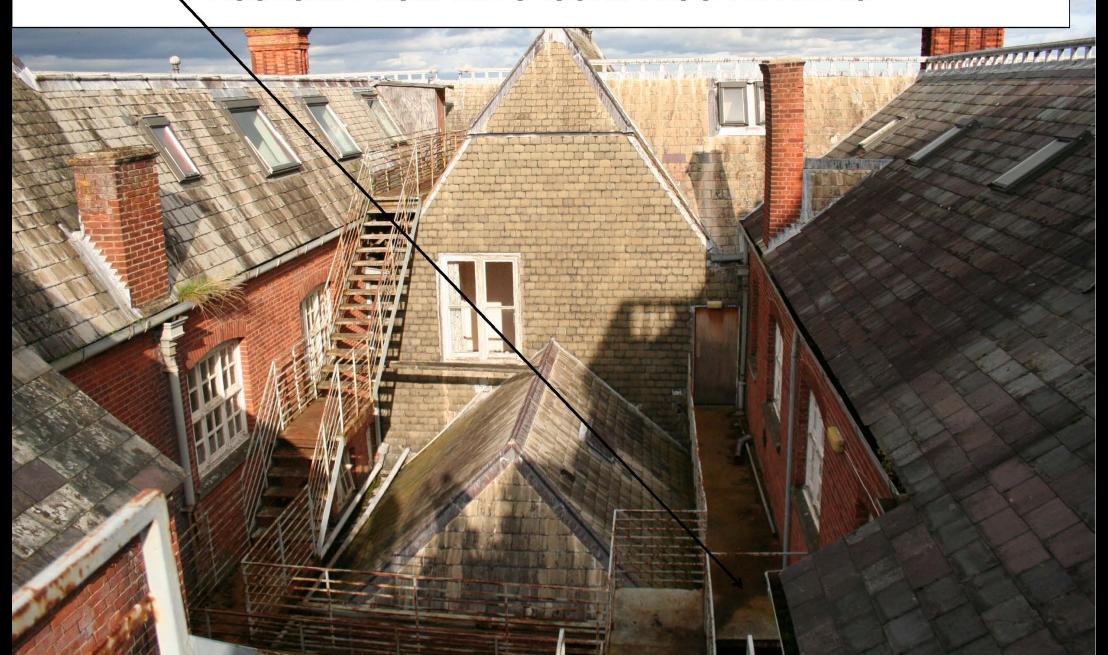
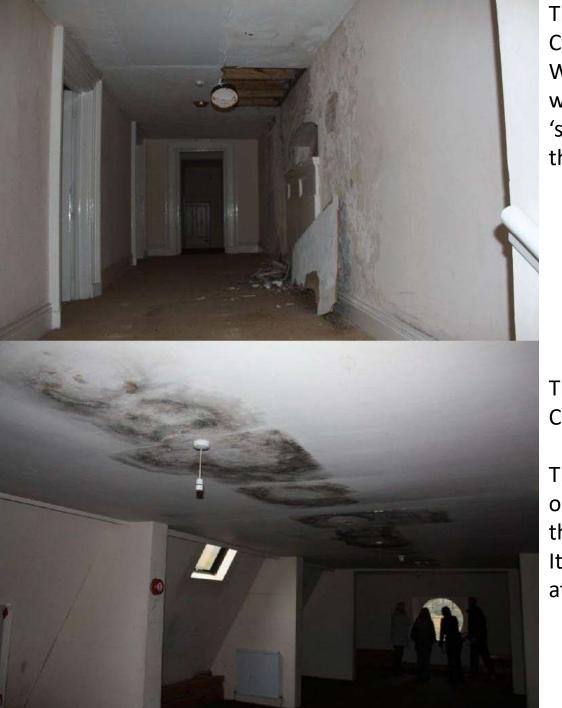
This is the Second Floor East Front Corridor.

Whilst the collapsed ceiling is due to water ingress the floor has always been 'springy as it is created over a void above the 'Victoria Suite' on the First Floor

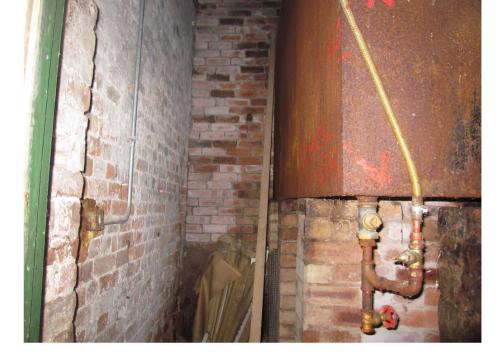
THERE IS A CENTRAL HEATING SYSTEM AT THE BACK OF THE SMALLER HALL WHICH WAS NOT INSPECTED WHEN THE FIRE RISK ASSESSMENT WAS CARRIED OUT IN 2012 AND AS THE RECEIVERS WERE NOT AWARE OF ITS EXISTENCE IT WAS NOT DRAINED.

THE CURRENT OWNERS 'CLAIM' THEY HAVE EMPTIED IT BUT AS THEY WERE FOUND TO BE REMOVING THE ASBESTOS WITHOUT THE CORRECT PERMITS OR PROTECTIVE CLOTHING IT IS ANYONES GUESS WHERE IT WAS EMPTIED TO IF AT ALL.

IT IS OIL FIRED AND HAS ITS OWN TANK

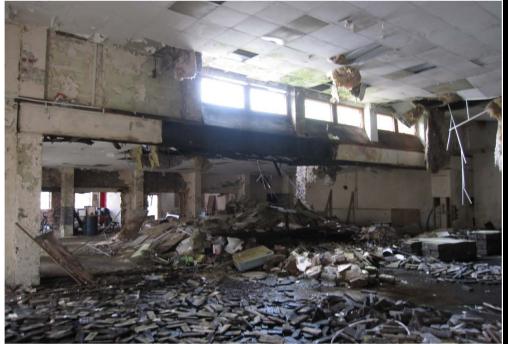
WHEN DERBYSHIRE INVESTMENTS TOOK OVER THE HALL IT HAD BECOME A DUMPING GROUND

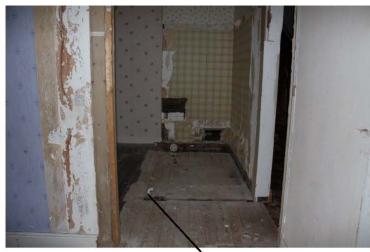
WHEN DERBYSHIRE INVESTMENTS REMOVED THE EN-SUITE BATHROOMS AND TOILETS THEY REMOVED ALL THE PARTITION WALLS LEAVING GAPS IN THE FLOORS BUT MORE IMPORTANTLY THEY DID NOT CAP OFF THE WATER PIPES. INSTEAD THEY SIMPLY CRIMPED THE ENDS OF THE PIPES AS IS THE CASE WITH THE PIPES IN THIS ROOM ON THE WEST FRONT OF THE HALL ON THE FIRST FLOOR AS A RESULT THERE IS A STRONG POSSIBILITY THAT IF THE MAINS ARE TURNED BACK ON FROM THE STOP TAP BY THE CROSS ROADS. THE HALL WILL FLOOD

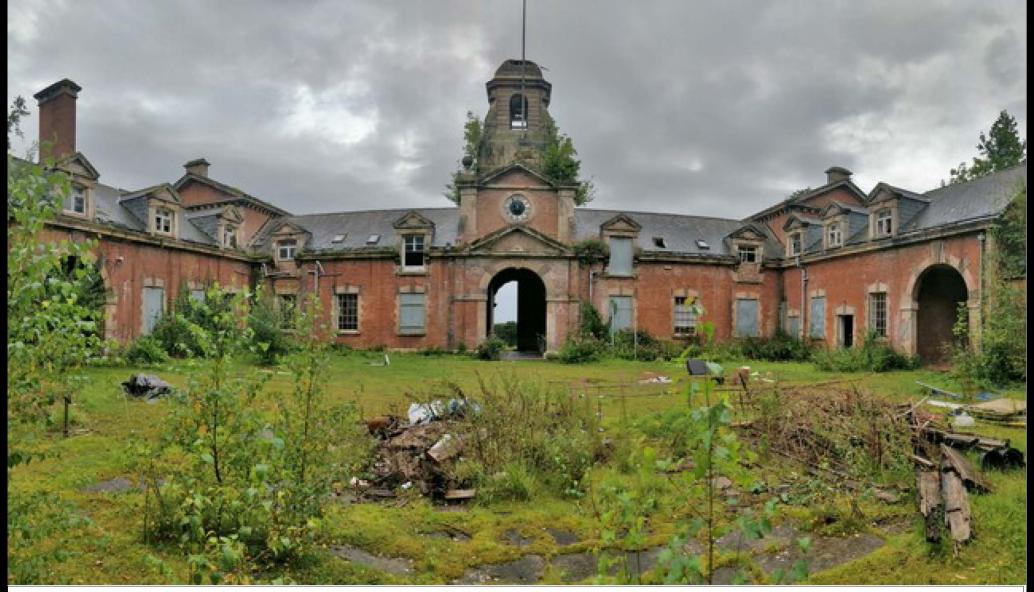
The Courtyard of the Stable Block (known as Kinmel Court) These rooms were used as Classrooms during Clarendon and Kinmel Boys School and Hospital wards during War time. The slates currently on the roof of the Clock Tower section of the Hall came off the roof of the garage which cannot be seen in the corner of the buildings to the right of the picture. The archway to the right gives access to the Sunken Driveway which brings you out in front of the Hall at the Cross Roads.

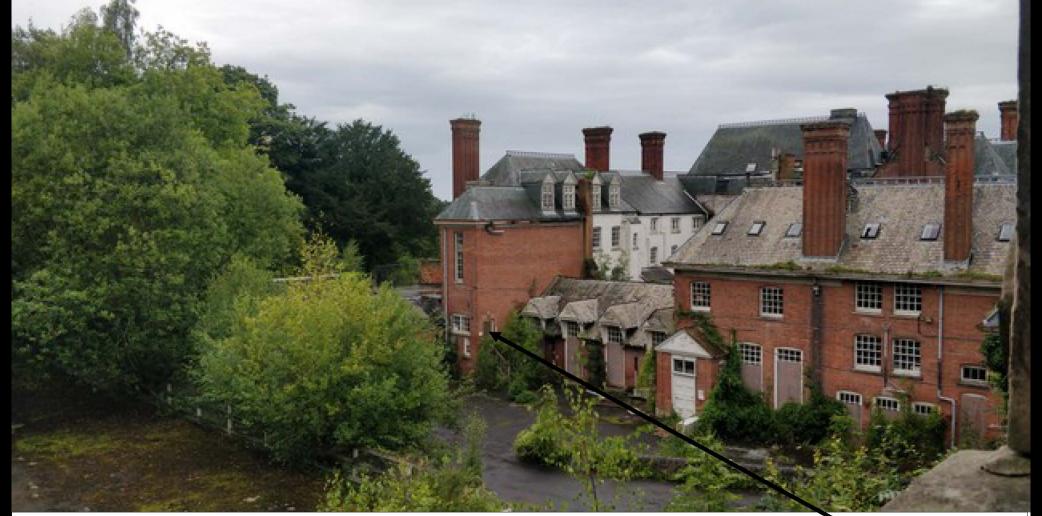
Martins Yard giving access to the old Servants Quarters, formerly the Biology labs from Clarendon and the Gymnasium from the Rheuma Spa. It was known as the Link and Close when Kinmel was a Conference Centre. The Link entrance can be seen in the form of the big white door in the middle of the image. The Close is accessed via the door hidden behind the foliage here

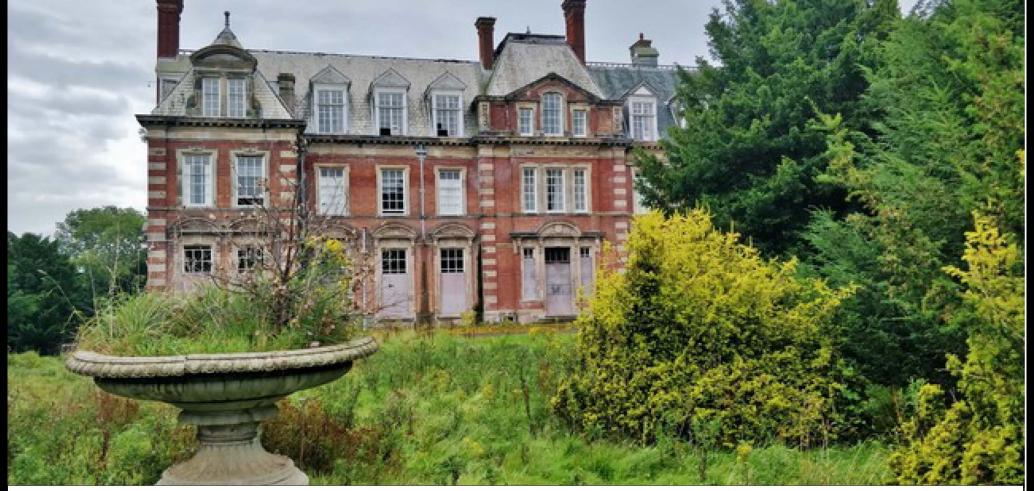
The Salon Entrance overlooking the Venetian Gardens. These were the first Formal Gardens Kinmel EVER had. They include an Ornamental Fountain powered originally by a Hydrostatic Ram which is still in situ beneath the Gardens

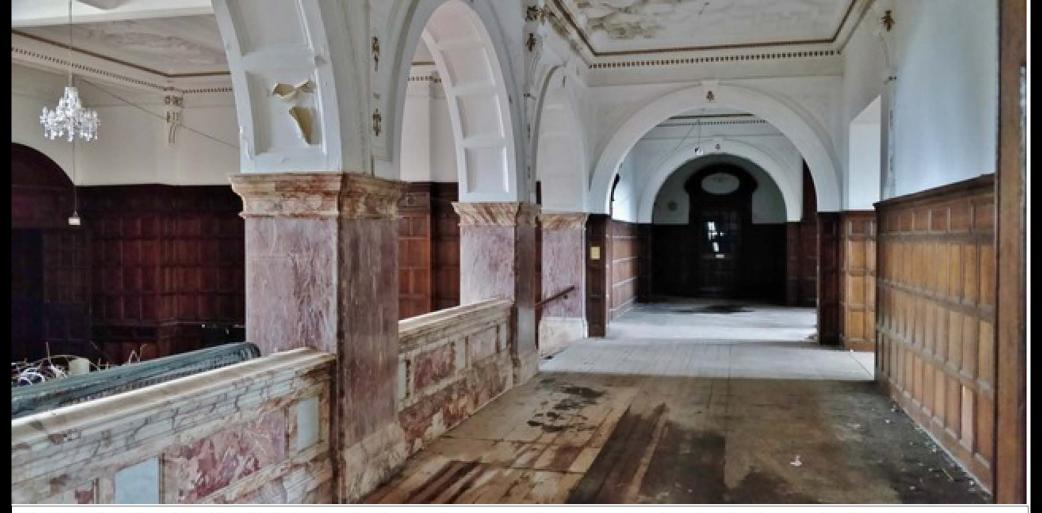
The Main Corridor of the Main Hall showing the Sunken Lounge and the former shop from the Conference Centre's days and the Music Room from Clarendon's time. The walls of the Sunken Lounge are of Sicilian Marble the details for which can be found in the V&A Archives

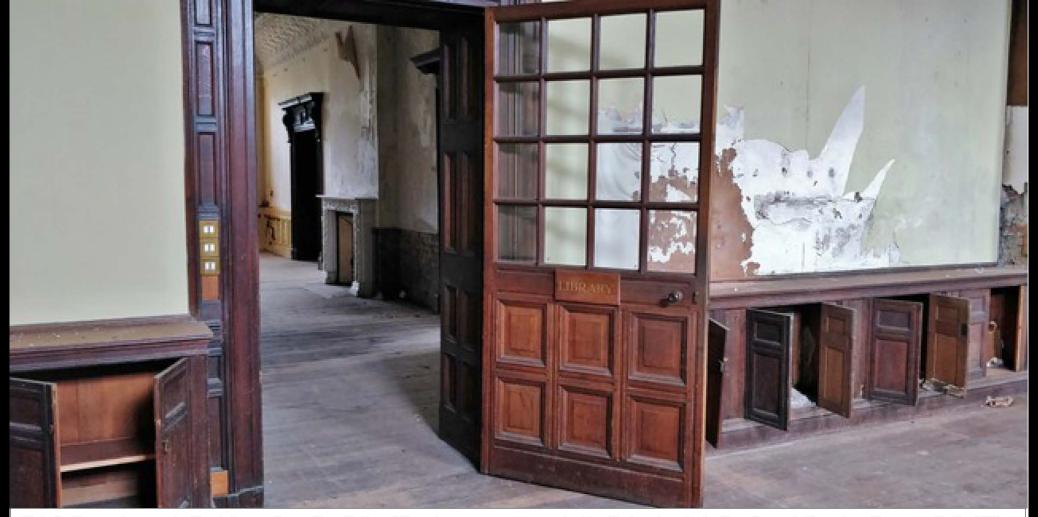
This is the entrance to the Library from the Salon. The door you can see in the Salon leads to the formal Drawing Room with its Pillar Box Red paneling!

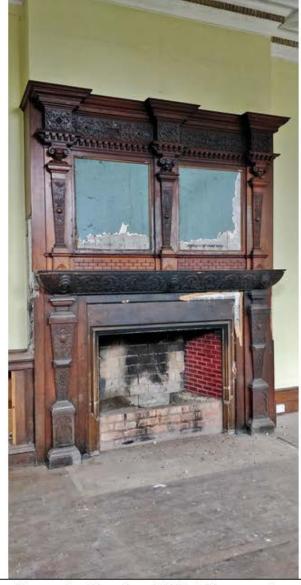
The Oak carved Library Fireplace damaged by thieves in October 2013. The panel on the left should hold Queen Victoria's Coat of Arms and the panel on the right should hold the Coat of Arms of H R Hughes created from the Coats of Arms of the tribes of Wales as depicted in the Fireplace at Kinmel Manor Hotel which came from the Hall.

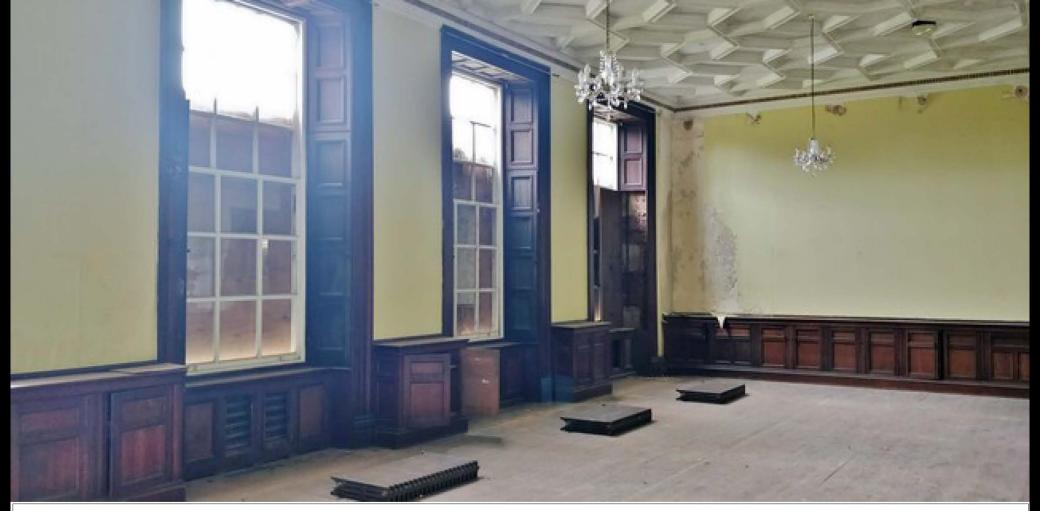
Three of the Full height windows in the Library. Surprisingly in these image the original oak shutters which survived the '75 fire are open. On my last visit they were bolted shut through the window frames!

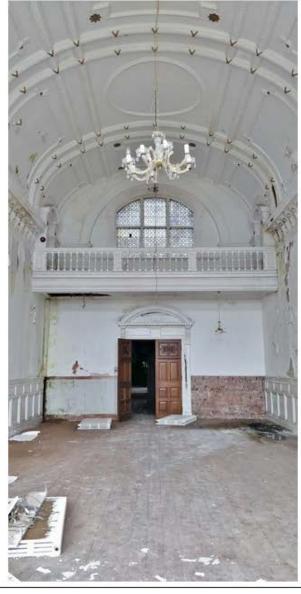
The Ballroom complete with its Minstrel Gallery and sprung dance floor. The damage visible in the left hand corner of the image is due to the down pipe referred to earlier in this document

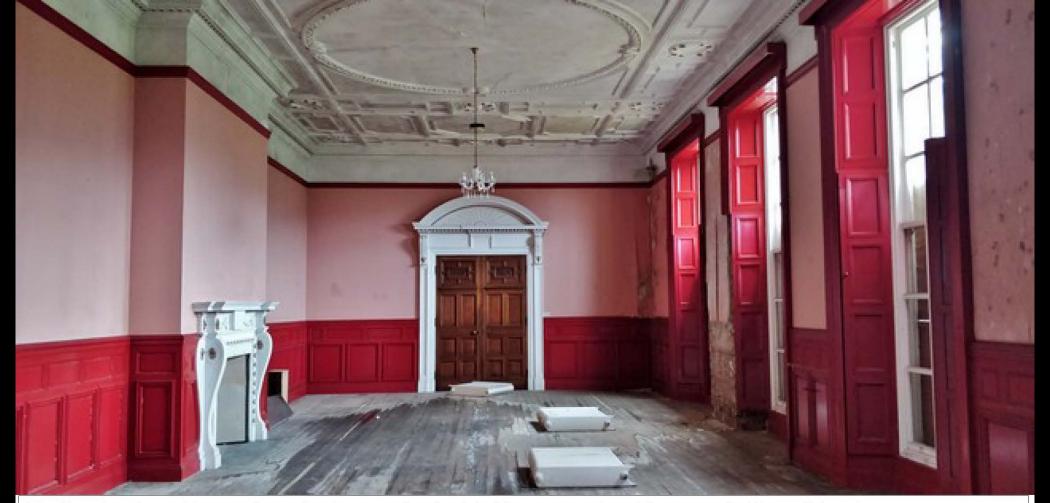
The Drawing Room. The wood paneling is as previously stated the wrong colour. The removal of the radiators is a new occurrence. The damage to the fireplace was done in October 2013

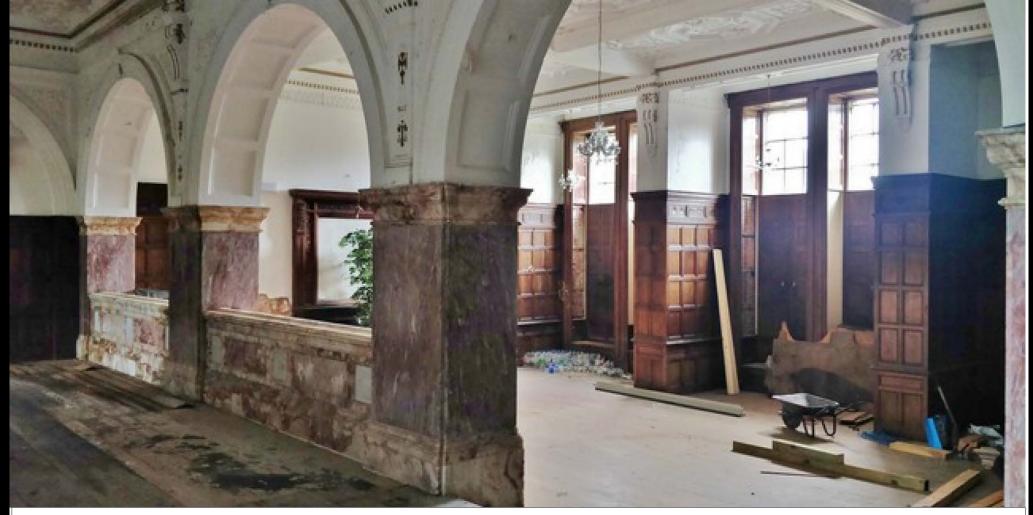
The Sunken Lounge.

The fireplace seen here comes from another estate in Cheshire. The correct fireplace is in Kinmel Manor Hotel.

The bottled water visible in the corner is there because the mains supply to the Hall needs repairing

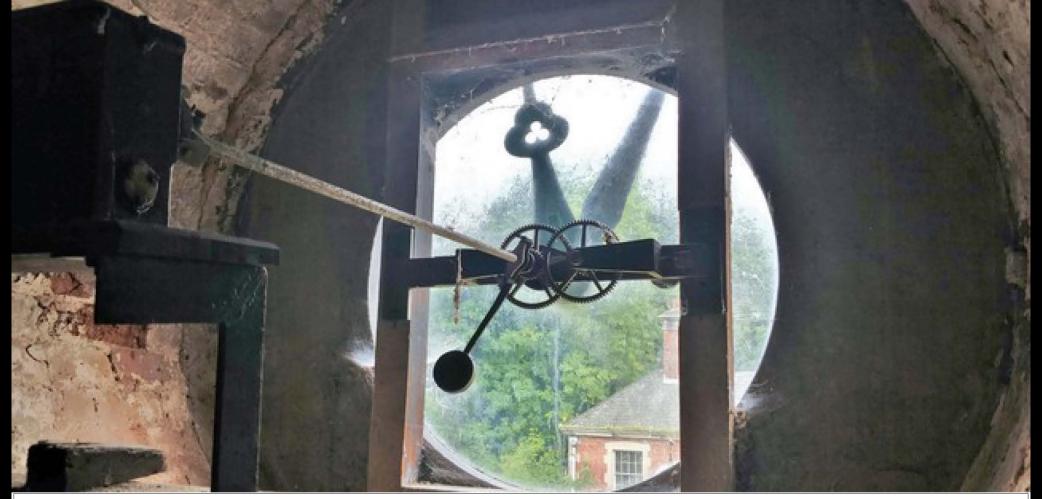
The workings of the Clock in the Clock Tower looking towards the Mews Building. This is accessed from the toilets on either side of the Clock Tower. It was used as a Fire Escape for the bedrooms during the Conference Centre days.

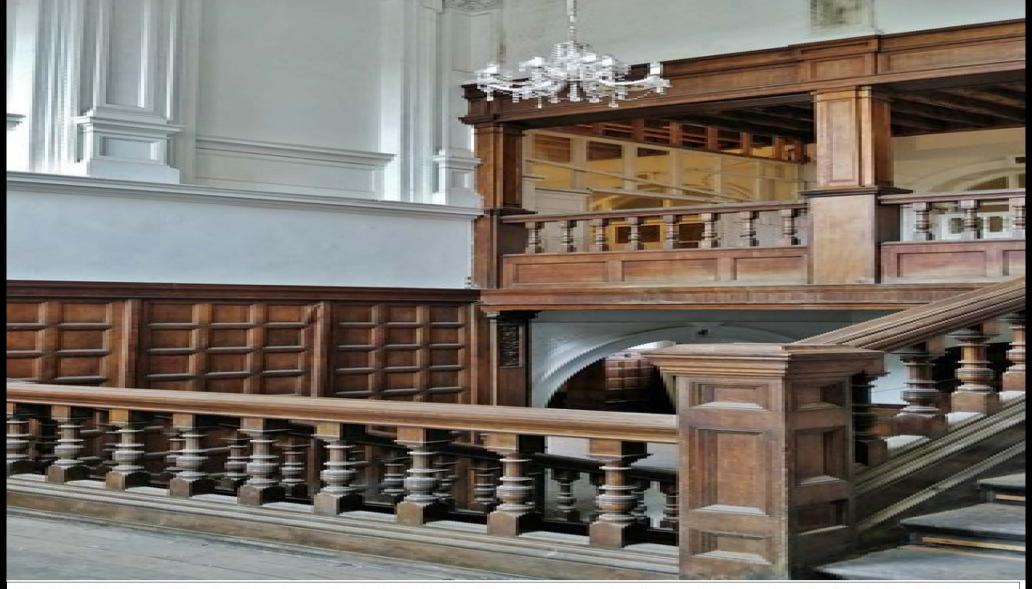
The Main Staircase. Showing the false ceiling installed by the Vinces to reduce heating cost and create a fire break. Nesfield's original ceiling is above this

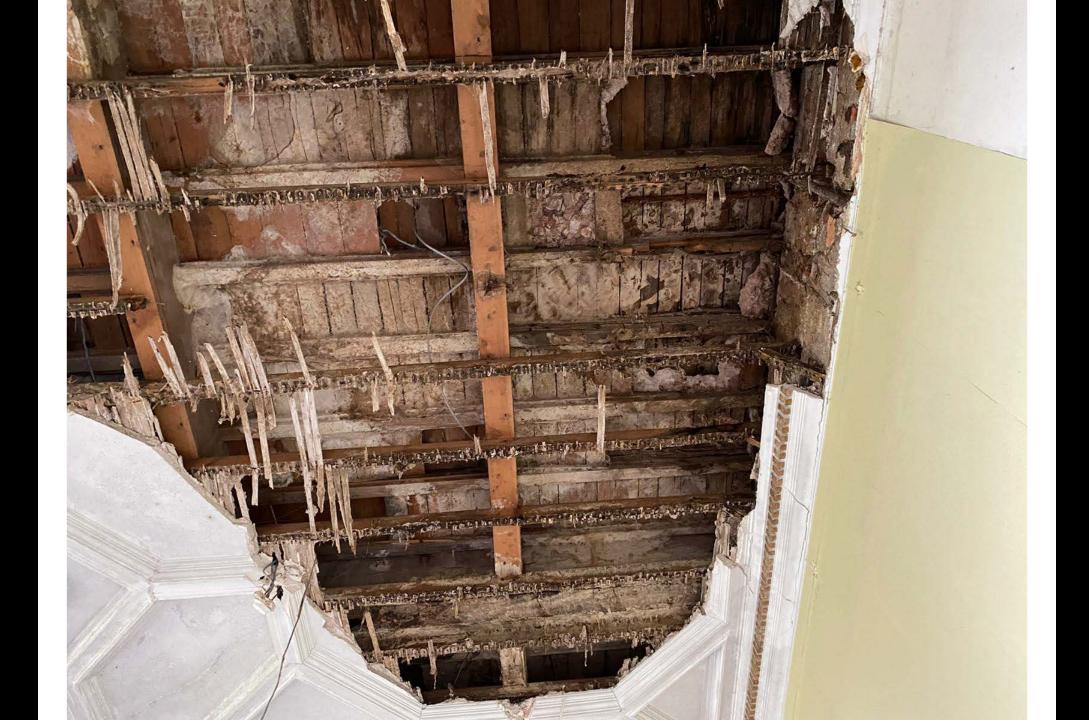
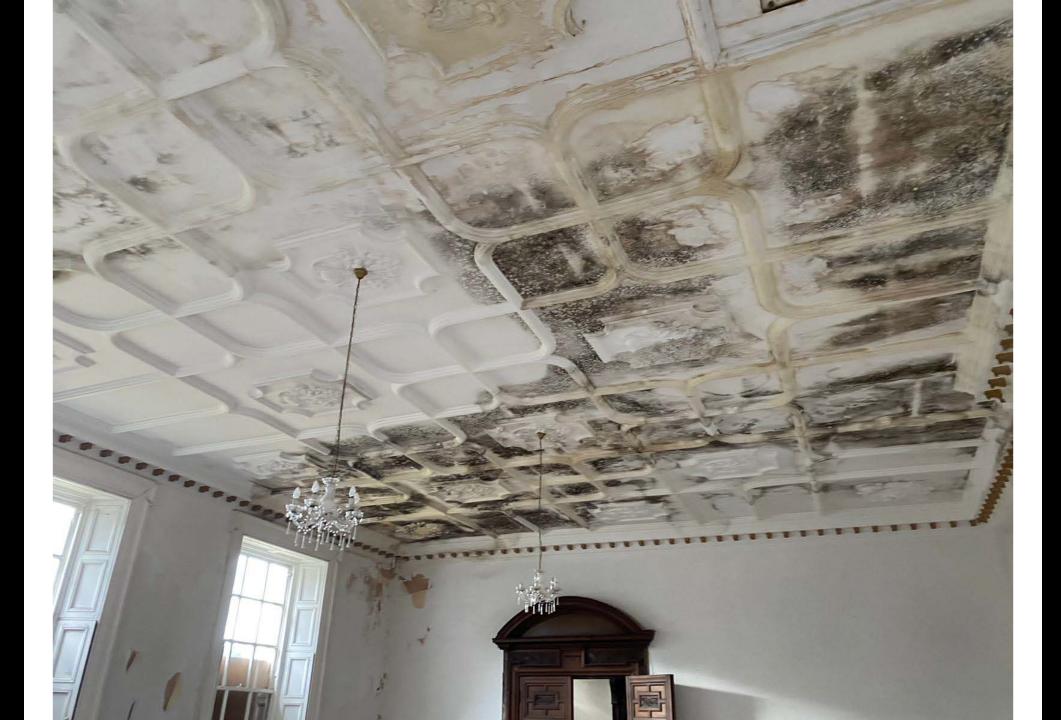
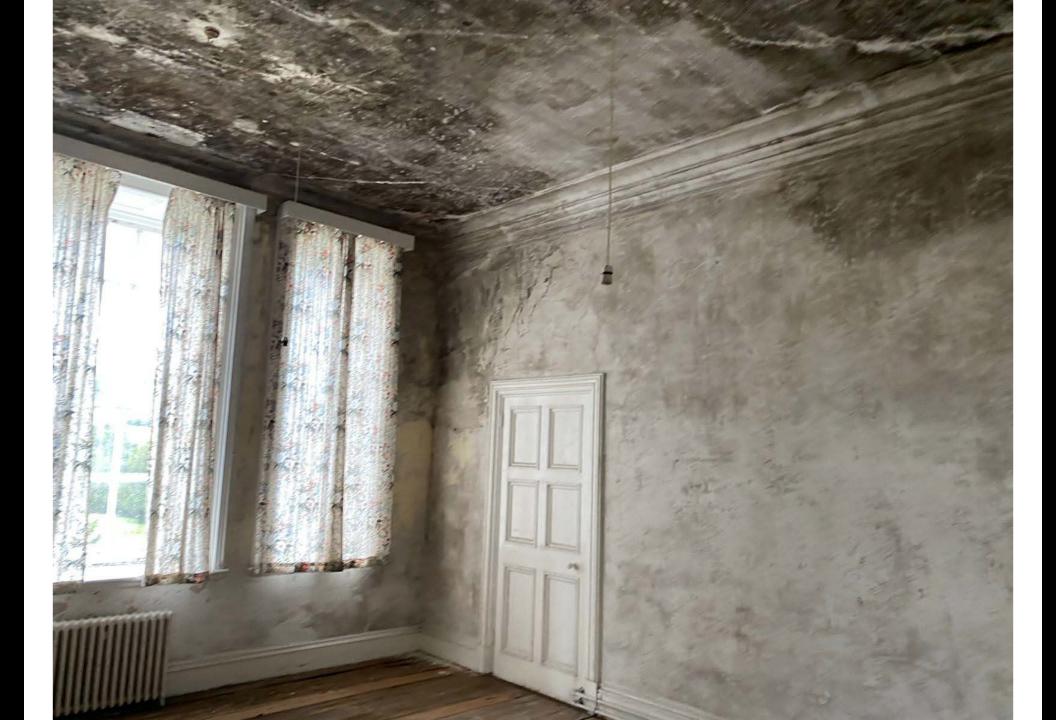
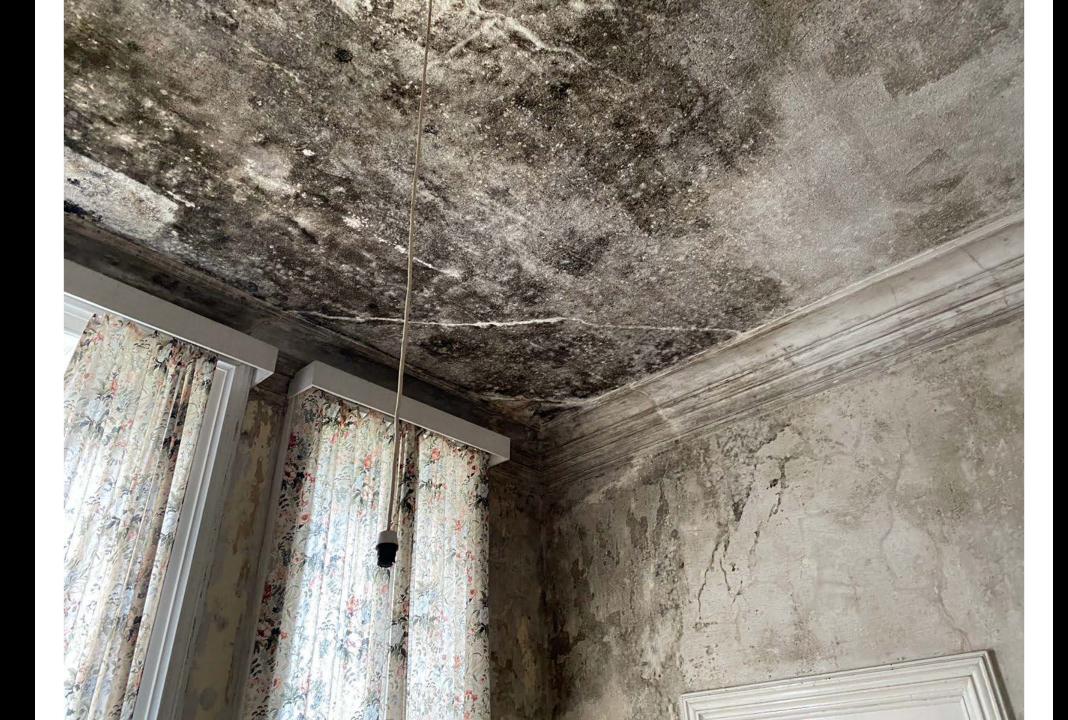
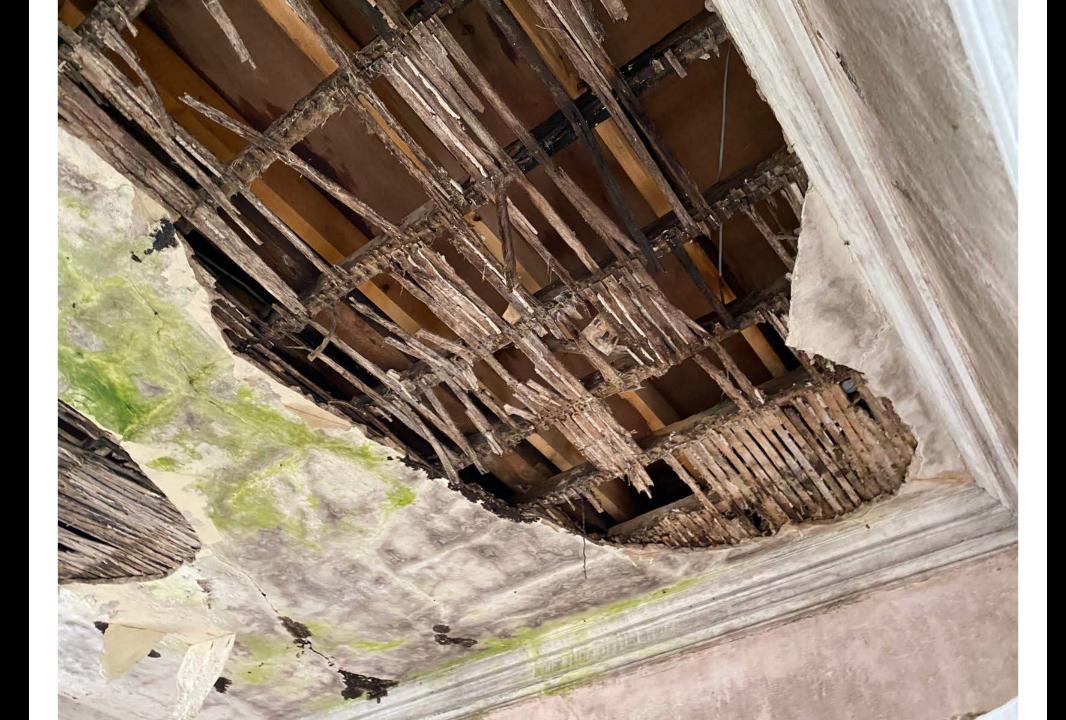
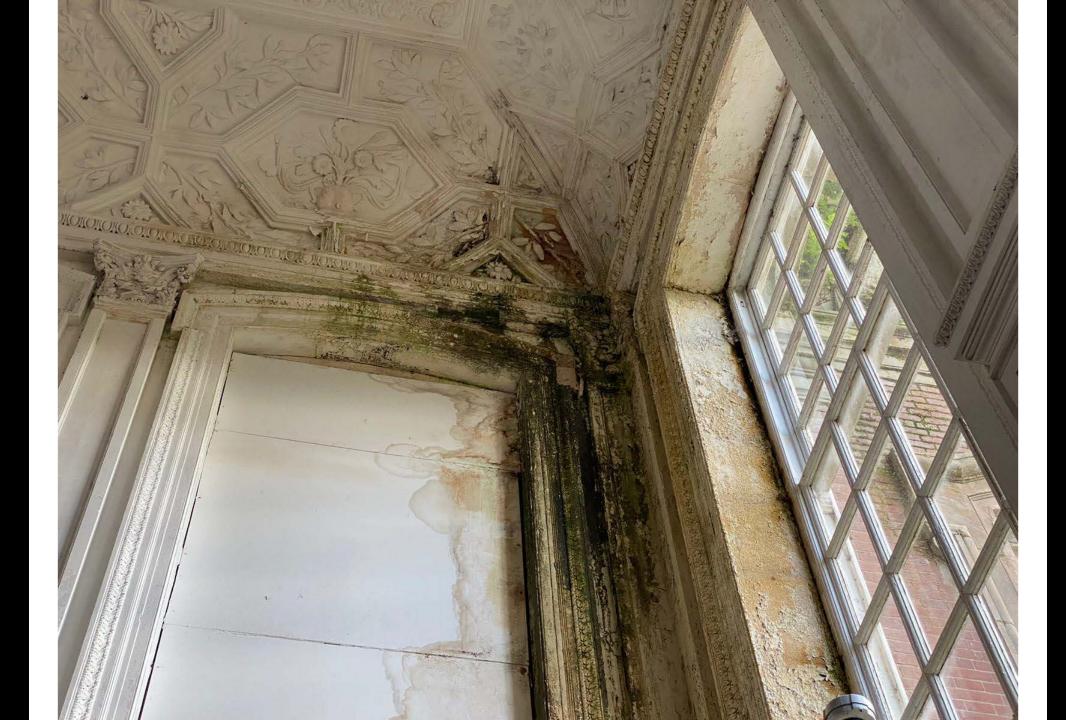
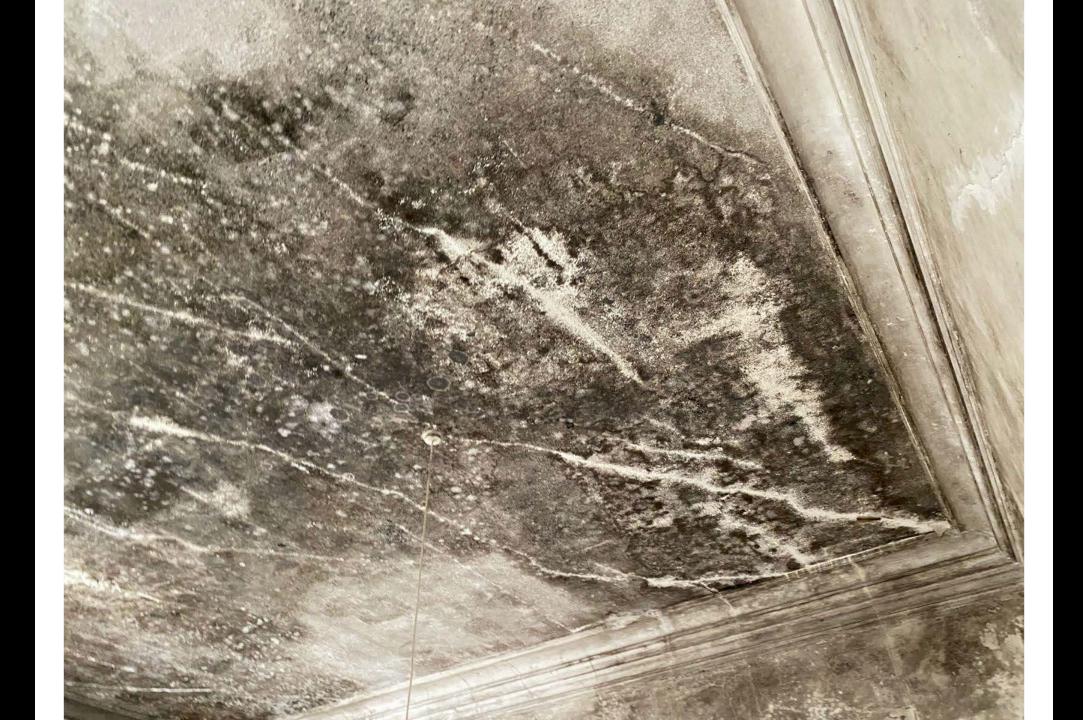
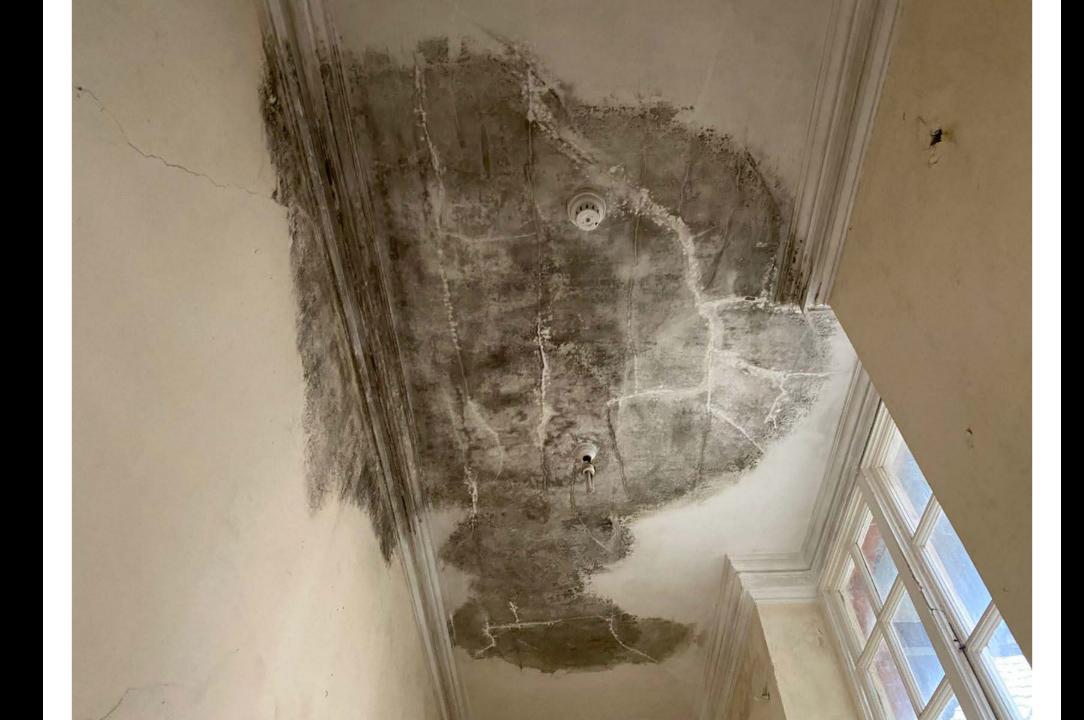
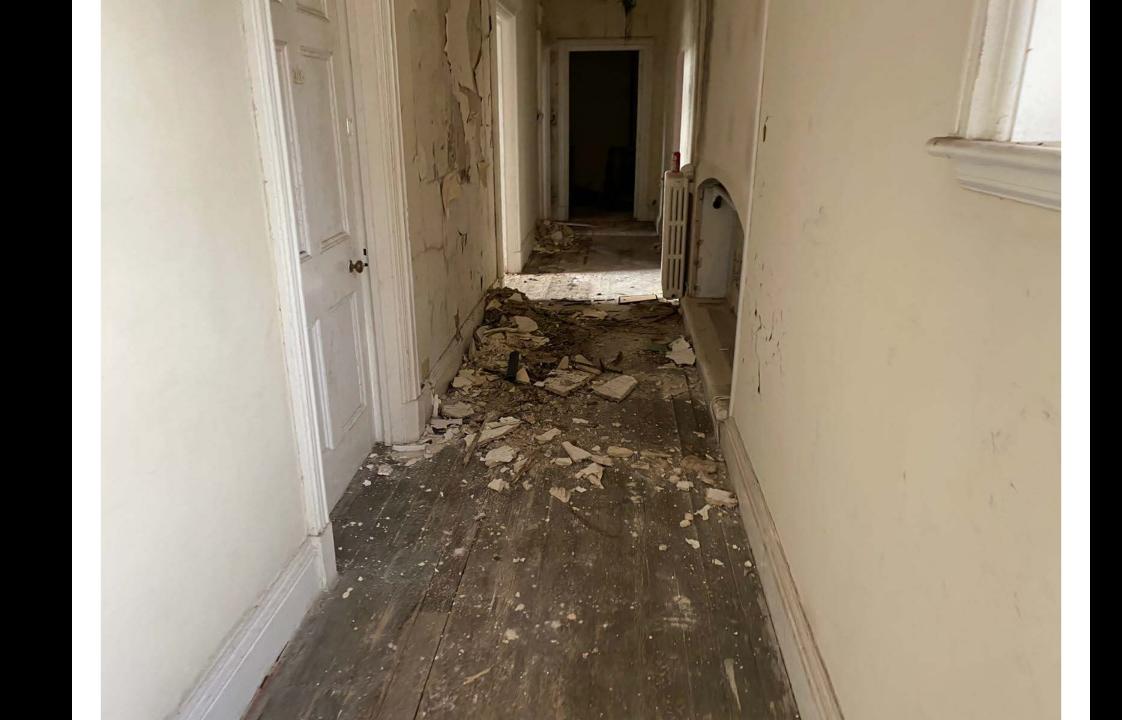
On the 17th October 2020 work was supposedly carried out to make the Hall Totally Secure.

Sadly this has been proved not to be the case as can be seen from these images: -
