A Report on the Current Condition of the Hall

FOREWORD
'TRAGEDY TO TRIUMPH'
Courtesy of Mrs Elaine Boxhall nee Southern
PE Teacher 1950 – 55
Clarendon school for Girls
KINMEL HALL
1946 – 1975

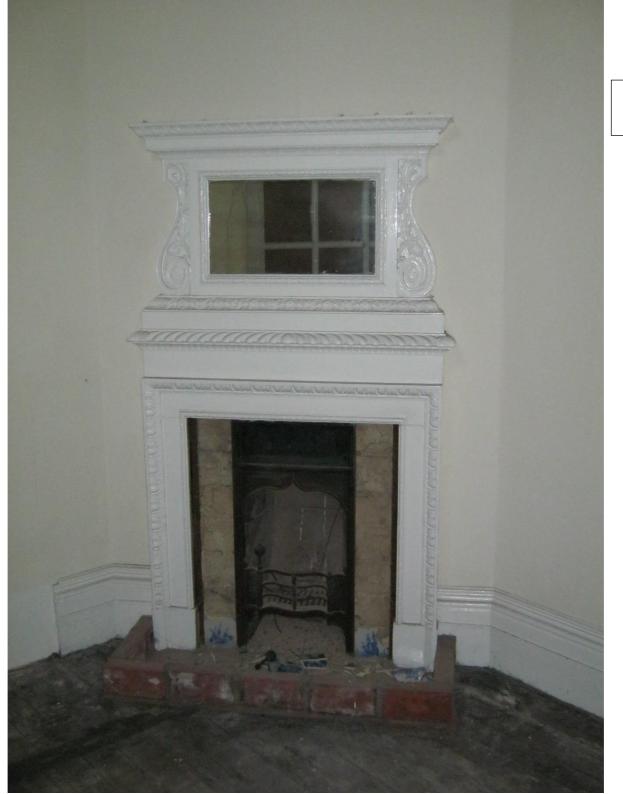
SAFE IS ON THE RIGHT OF THIS FIREPLACE

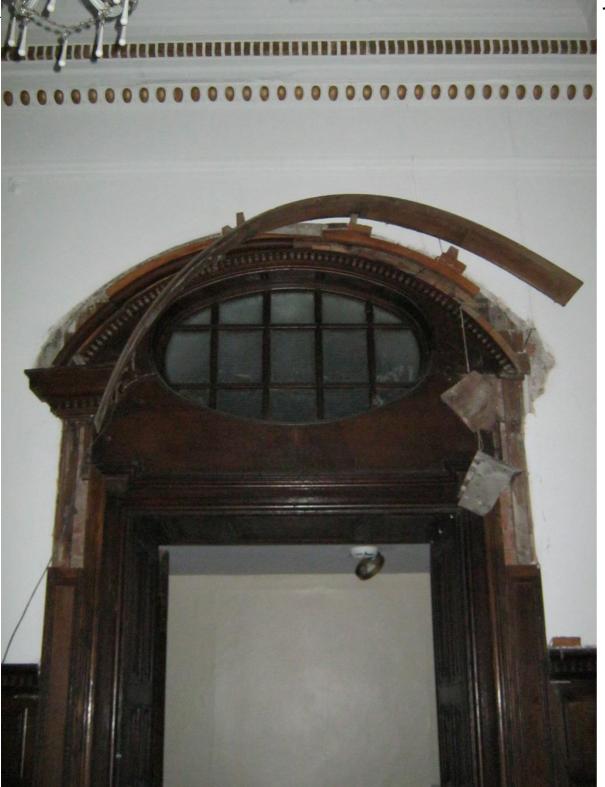
This is the door way from the Main Hall leading to the Reception.

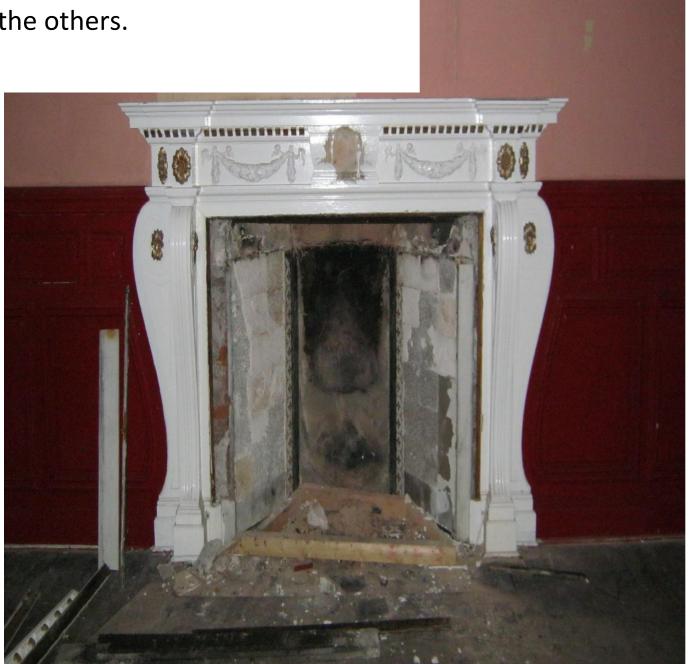
This is the Fire place on the West facing wall of the Drawing Room it was damaged at the same time as the others.

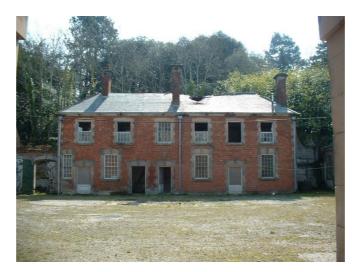
THIS SECTION OF THE HALL WAS STILL BEING USED BY PAYING GUESTS AS LATE AS OCTOBER 1995 AND MAYBE EVEN LATER.

THE AREA WHERE THE ROOF HAS COLLAPSED CONTAINS BATHROOMS AND SHOWERS.
WHILST I HAVE NOT BEEN IN THIS PART SINCE THE 90'S IT IS MY UNDERSTANDING THAT
THIS COLLAPSE HAS BROUGHT DOWN THE SECOND FLOOR INTO THE FIRST FLOOR

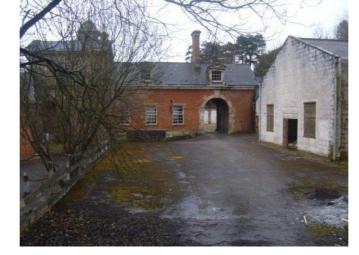
THE SPORTS HALL AND GARAGE WERE BUILT AROUND 1932. THE BIG WHITE BUILDING HAS AN ASBESTOS RIBBED ROOF.WHEN EDDIE VINCE LEASED THE HALL BETWEEN 1978 – 2000 HE OPENED UP THE TWO BUILDINGS INTO ONE BIG BUILDING.THIS WAS SO THAT IT COULD BE USED BY THE BIGGER GROUPS WHO BOOKED THE ENTIRE HALL OR MULTIPLE SECTIONS ON BLOCK. IT WAS THE VINCE FAMILY WHO PUT THE SUSPENDED CEILING INTO THE HALL AND AN RSJ IN PLACE OF THE DIVIDING WALL.

THERE IS A CENTRAL HEATING SYSTEM AT THE BACK OF THE SMALLER HALL WHICH WAS NOT INSPECTED WHEN THE FIRE RISK ASSESSMENT WAS CARRIED OUT IN 2012 AND AS THE RECEIVERS WERE NOT AWARE OF ITS EXISTENCE IT WAS NOT DRAINED.

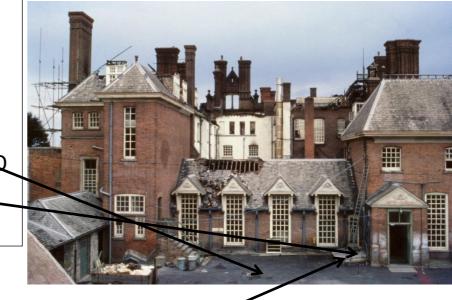
DURING MY VISIT ON THE 14TH AUGUST IT WAS DISCOVERED THAT THE PIPE THAT SUPPLIES WATER TO THE THREE FIRE HOSE REEL POINTS IN THE MAIN HALL HAD BEEN SMASHED AND WATER WAS POURING OUT OF IT, INTO A BARREL OF FAT AND FROM THERE INTO THE GRID IN THE FLOOR OF THE CELLAR WHICH FEEDS INTO THE SEPTIC TANK IN THE PARK. AT THE NORTH END OF THE HALL THE LAST TWO GRIDS IN THE FLOOR OF THE CORRIDOR WERE UNDER AT LEAST 7 INCHES OF 'WATER' WHICH WAS A CLEAR SIGN THAT THERE IS A PROBLEM WITH THE SEPTIC TANK OR THE PIPE TO IT.

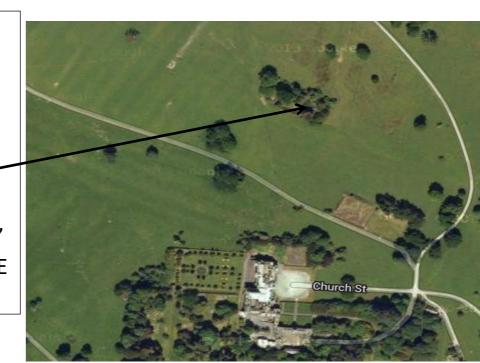
DURING MY VISIST ON THE 11^{TH} OCTOBER 2013 I DISCOVERED THAT THE FIRE HYDRANT PIPE WAS NO LONGER POURING WATER.

THE BUILDER HAD CAPPED THE PIPE OFF AND CONVERTED IT TO A DOMESTIC SUPPLY USING POLY PIPE.

THE BLUE POLY-PIPE WAS FED THROUGH THE CELLAR AND UP TO THE FIRST FLOOR WHERE IT TERMINATED AT THE WALL MOUNTED WATER HEATER IN THE VICTORIA SUITE KITCHEN.

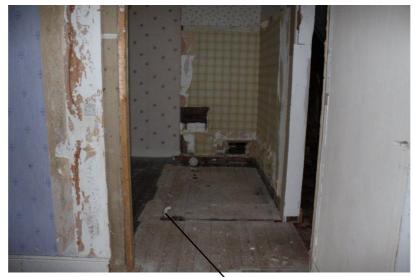
WHEN DERBYSHIRE INVESTMENTS REMOVED THE EN-SUITE BATHROOMS AND TOILETS THEY REMOVED ALL THE PARTITION WALLS LEAVING GAPS IN THE FLOORS BUT MORE IMPORTANTLY THEY DID NOT CAP OFF THE WATER PIPES. INSTEAD THEY SIMPLY CRIMPED THE ENDS OF THE PIPES AS IS THE CASE WITH THE PIPES IN THIS ROOM ON THE WEST FRONT OF THE HALL ON THE FIRST FLOOR AS A RESULT THERE IS A STRONG POSSIBILITY THAT IF THE MAINS ARE TURNED BACK ON FROM THE STOP TAP BY THE CROSS ROADS. THE HALL WILL FLOOD

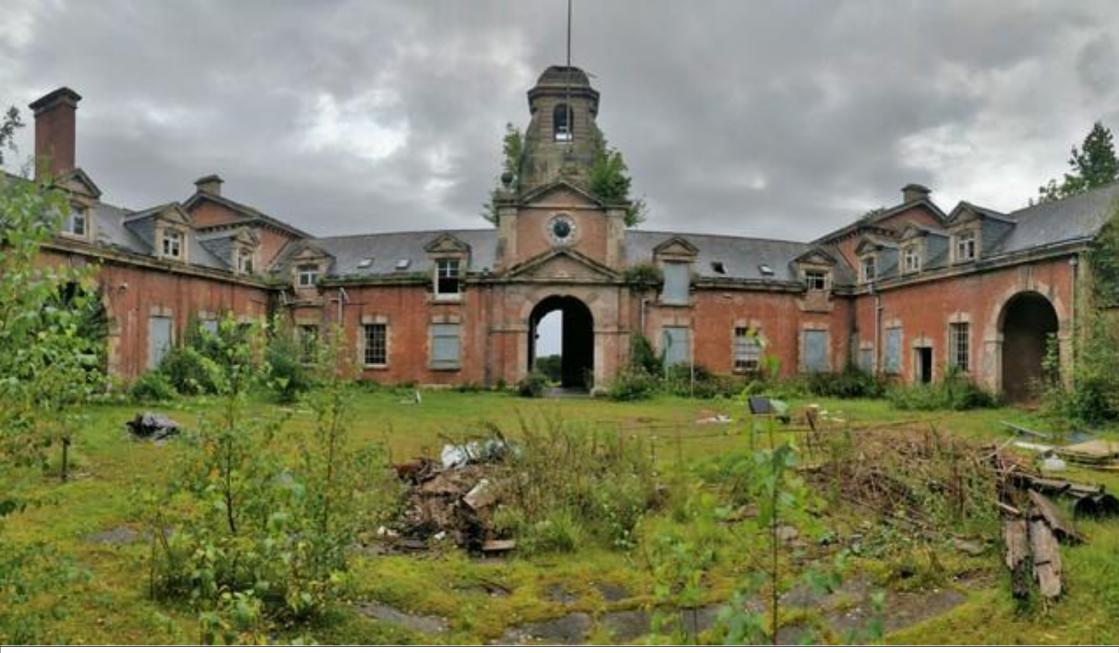
The Courtyard of the Stable Block (known as Kinmel Court) These rooms were used as Classrooms during Clarendon and Kinmel Boys School and Hospital wards during War time. The slates currently on the roof of the Clock Tower section of the Hall came off the roof of the garage which cannot be seen in the corner of the buildings to the right of the picture. The archway to the right gives access to the Sunken Driveway which brings you out in front of the Hall at the Cross Roads.

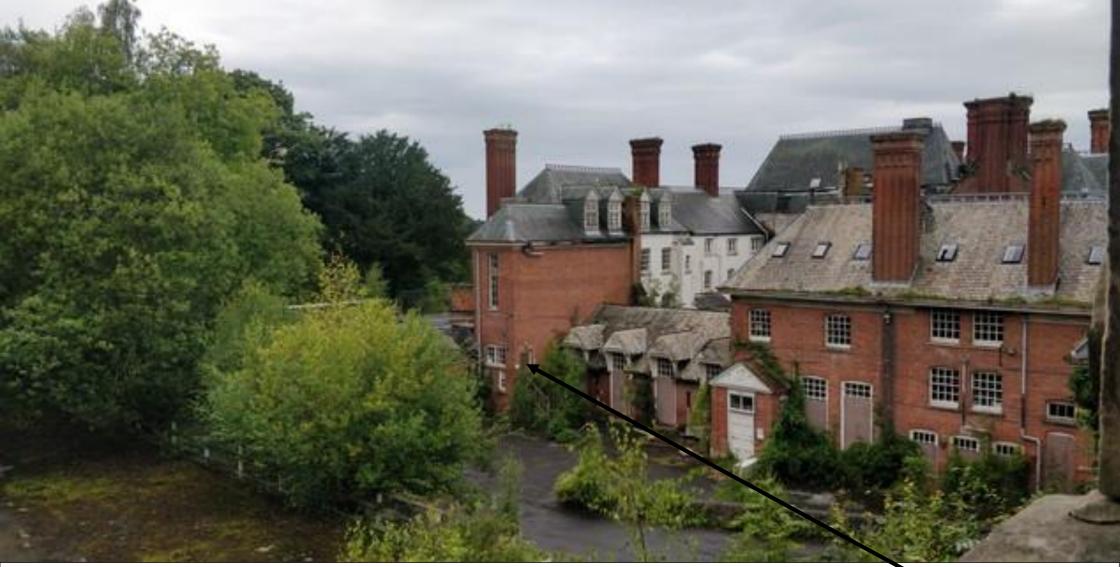
Martins Yard giving access to the old Servants Quarters, formerly the Biology labs from Clarendon and the Gymnasium from the Rheuma Spa. It was known as the Link and Close when Kinmel was a Conference Centre. The Link entrance can be seen in the form of the big white door in the middle of the image. The Close is accessed via the door hidden behind the foliage here

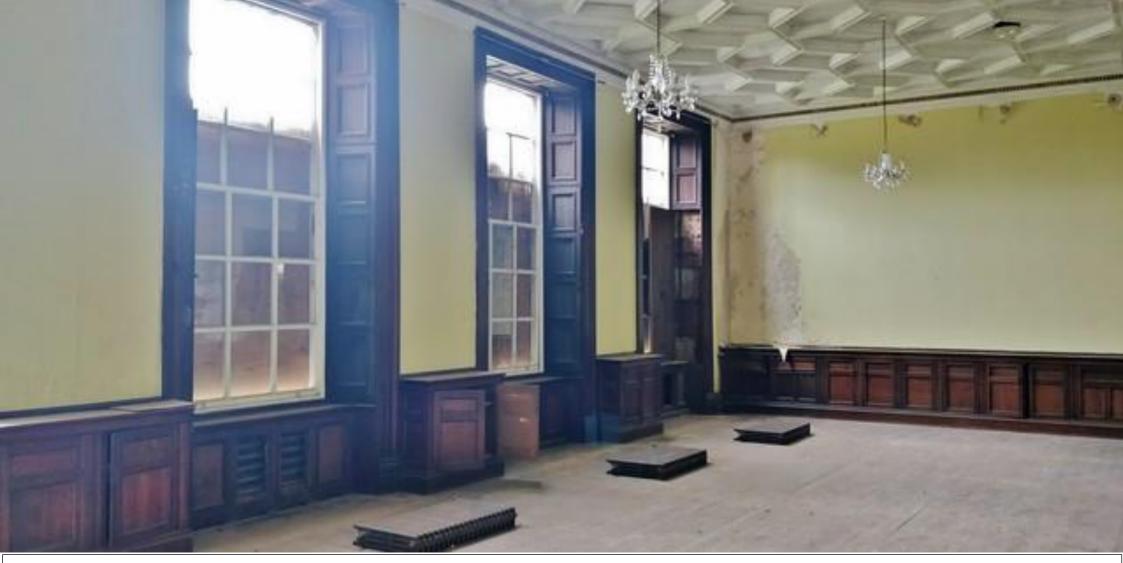
Three of the Full height windows in the Library. Surprisingly in these image the original oak shutters which survived the '75 fire are open. On my last visit they were bolted shut through the window frames!

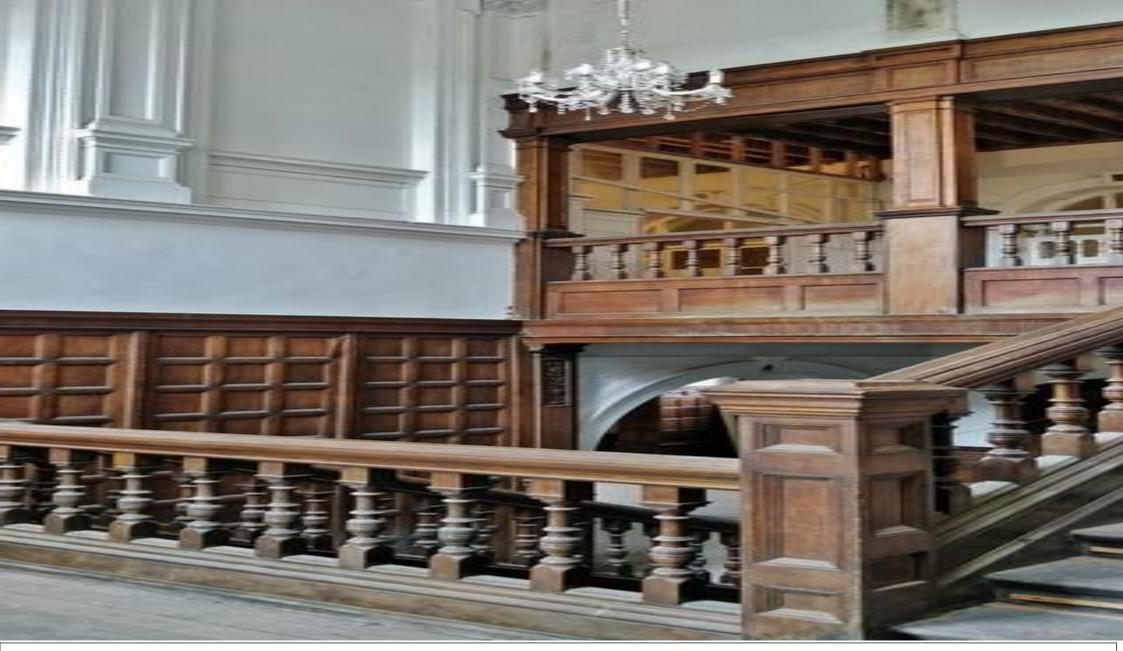
The Main Staircase. Showing the false ceiling installed by the Vinces to reduce heating cost and create a fire break. Nesfield's original ceiling is above this

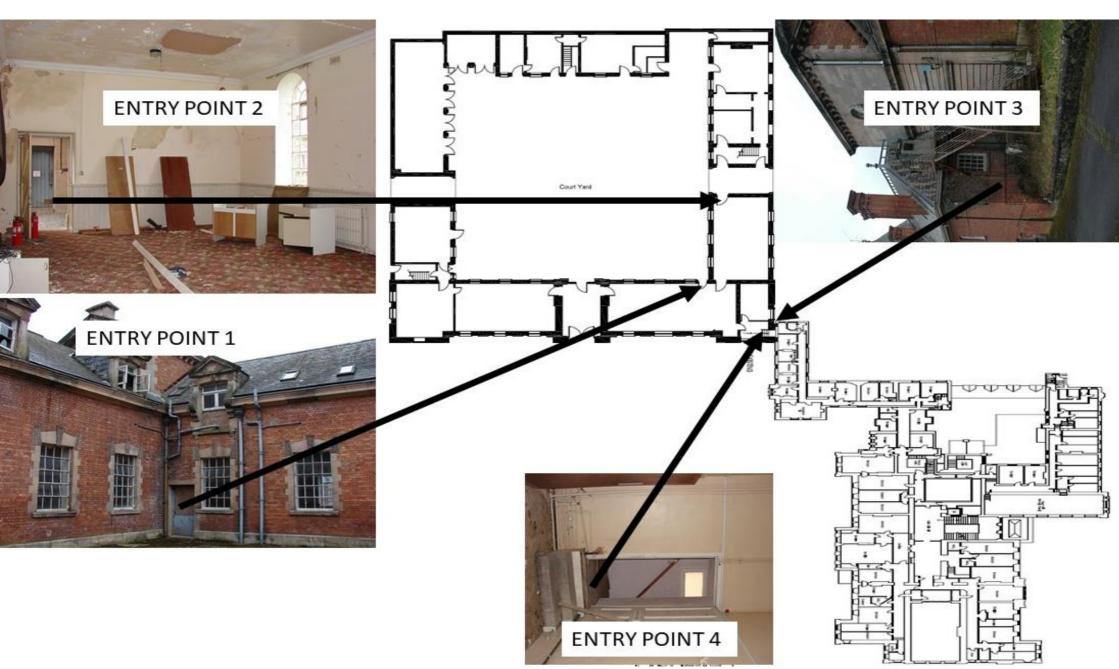
On the 17th October 2020 work was supposedly carried out to make the Hall Totally Secure.

Sadly this has been proved not to be the case as can be seen from these images: -

THIS STAIRCASE BRINGS YOU OUT TO THIS STAIRCASE OR THE FIRST FLOOR LANDING OF THE MAIN HALL BY THE LIFT

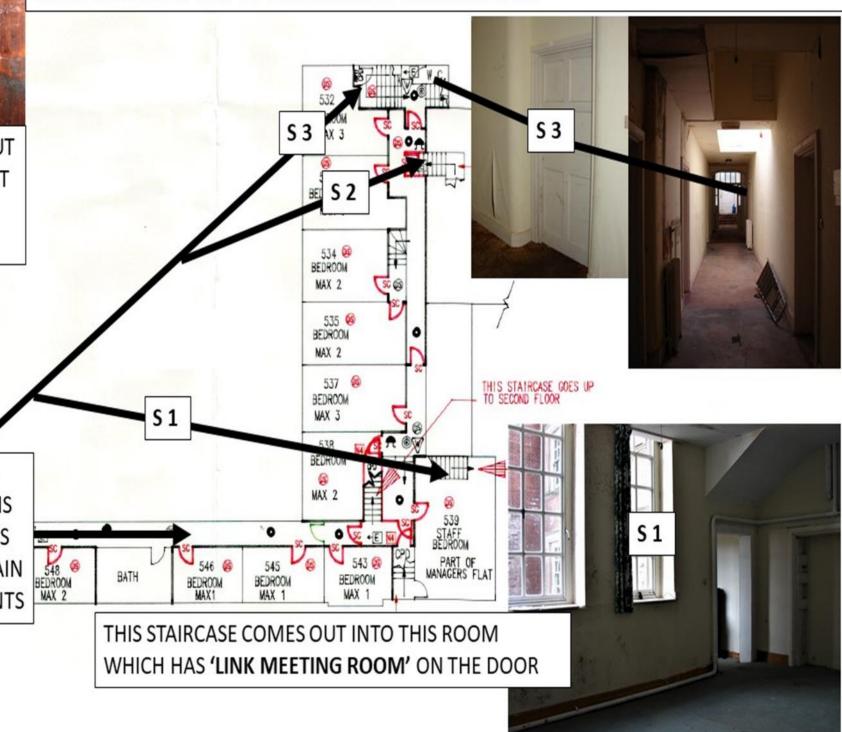
ENTRY POINTS 1, 2, 3, 4
ALL GIVE ACCESS TO THIS
CORRIDOR WHICH GIVES
YOU ACCESS TO THE MAIN
HALL FROM THESE POINTS

THIS STAIRCASE BRINGS YOU OUT TO THIS STAIRCASE ON THE 'STONE PASSAGE' THAT RUNS FROM THE SOUTH END OF THE HALL INTO THE MAIN HALL

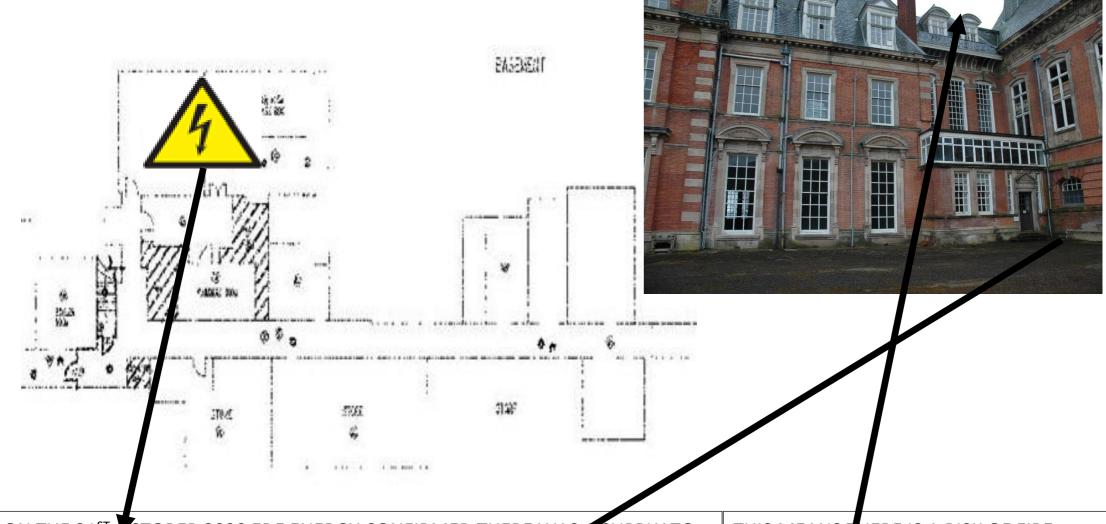
ON THE 21ST OCTOBER 2020 EDF ENERGY CONFIRMED THERE WAS A SUPPLY TO THE HALL. THEIR RECORDS SHOW THEY HAVE HAD NO CONTACT WITH THE OWNERS SINCE 2014 AND THERE IS A CONSIDERABLE AMOUNT OWED ON THE ACCOUNT.

SCOTTISH POWER NETWORK DISTRIBUTION CONFIRM THERE IS SUPPLY TO THE HALL THAT ENTERS THE HALL UNDER THE CHAPEL BY THE METAL AND GLASS GRID SHOWN IN THE IMAGE
